## HOME INSPECTION REPORT

Luis Turner Inspections, LLC

235 Joe Ayscue Road

Henderson NC 27537

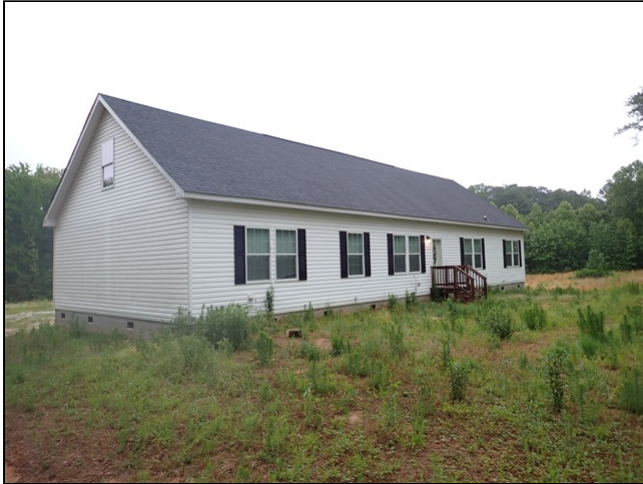
2.0 Item 3(Picture) Left front corner of house

(2) Exterior perspective photographs are provided below to show the home at time of inspection. This comment is for your information.

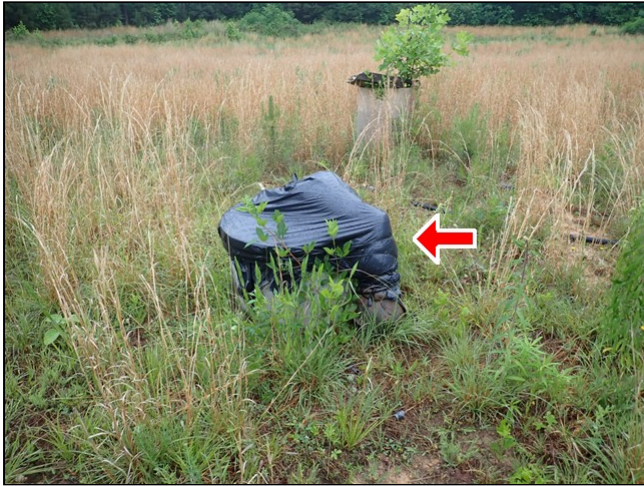
4.1 Item 7(Picture) Well head

(2) Although the well provided water during the inspection, the water supply well is not part of the home inspection report. See photographs below. If more information is needed, a qualified contractor can evaluate the well system, provide further information, and perform repairs as needed.

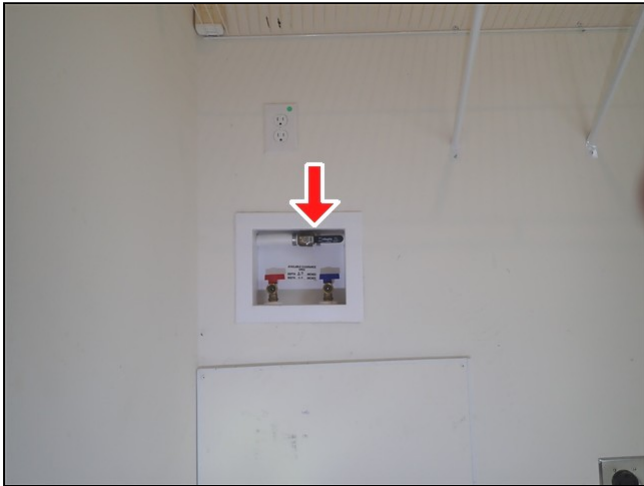
4.2 Item 1(Picture) Main water shut off valve

The main water shut off valve is located in laundry at top of washing machine outlet box. See photograph below. The water supply system can also be shut down at the laundry breaker panel.

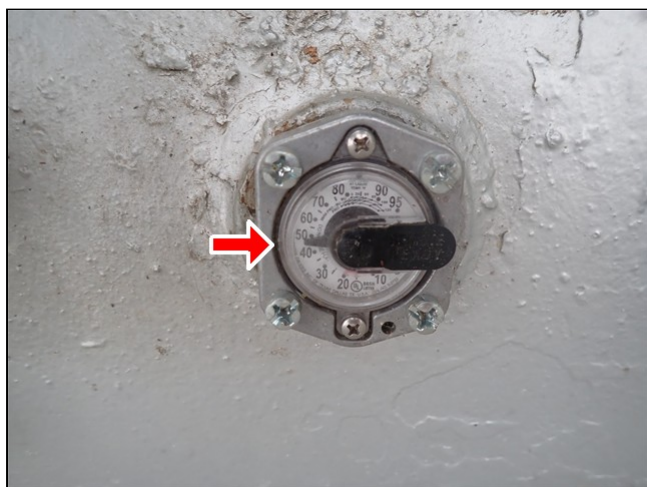
The main fuel shut off is at the exterior propane gas tank. The tank is approximately 45% full. See photograph below. The cooktop is the only gas-fired appliance.

4.8 Item 1(Picture) Propane tank approximately 45% full
