# INSPECTION REPORT

1.4.1 This house is approximately 80 years old and was built in 1946

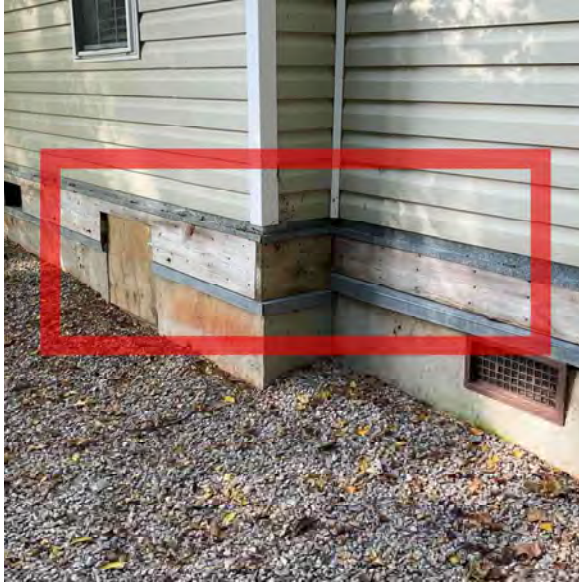
**2.2.2** Around the rear of the home, they were exposed boards between the foundation and siding. This is not consistent with typical building practices. Current configuration could lead to accelerated deterioration of the wood and surrounding components. Have a licensed general contractor assess to determine level of concern and what remedies are needed. All work performed should be conducted by qualified contractor and supervise by licensed general contractor. (Exterior Rear)

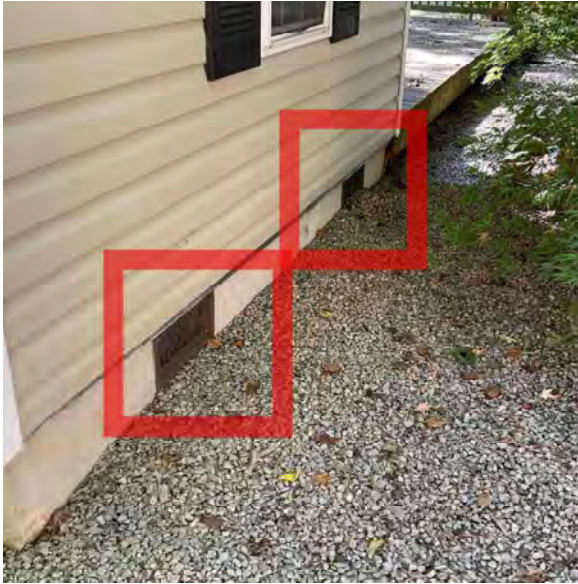
2.2.4 The crawlspace vent(s) are / is at the same level as the grade of the landscape. Have a qualified contractor install window wells or provide clearance to reduce moisture intrusion into the crawlspace and subsequent damages. (Exterior Front)

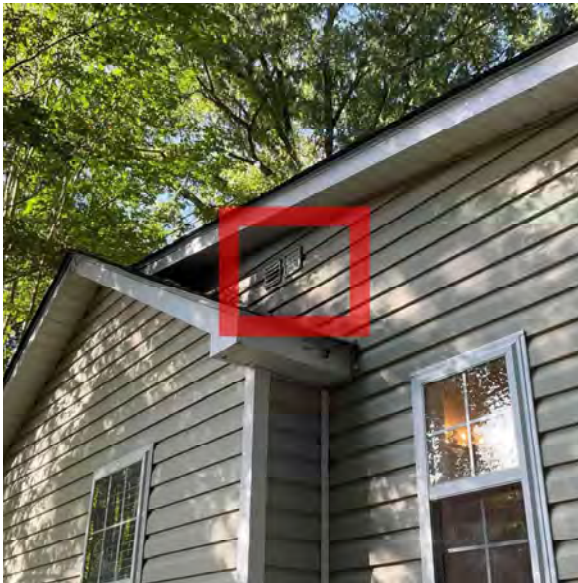
2.3.1 Exterior exhaust vent is not opening when in use and may be obstructed or clogged. A non-functioning vent could prevent moist air from exiting the bathroom and lead to undesirable living conditions. Have a qualified contractor correct to ensure proper functionality. (Exterior Rear)

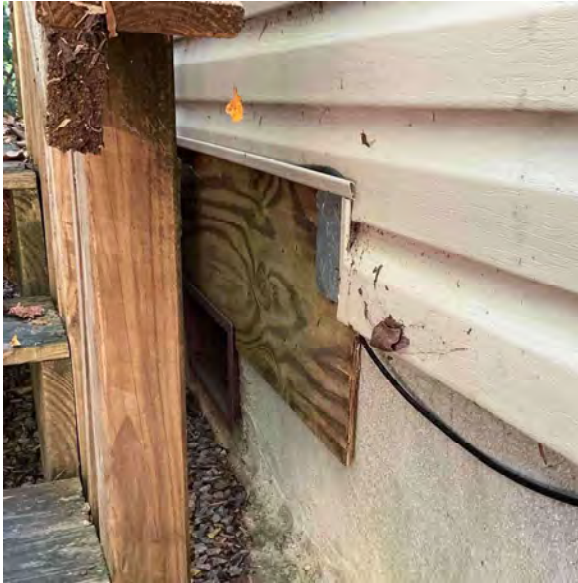
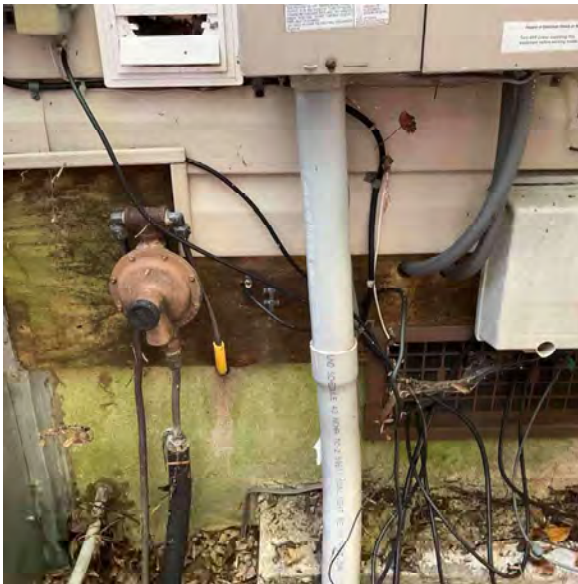
**2.3.2 The substructure underneath the electrical panel and side door is exposed. Proper siding and covering and flashing as needed to prevent subsequent damages. Have a licensed general contractor evaluate, investigate for hidden damage and correct as needed. (Exterior Left)**

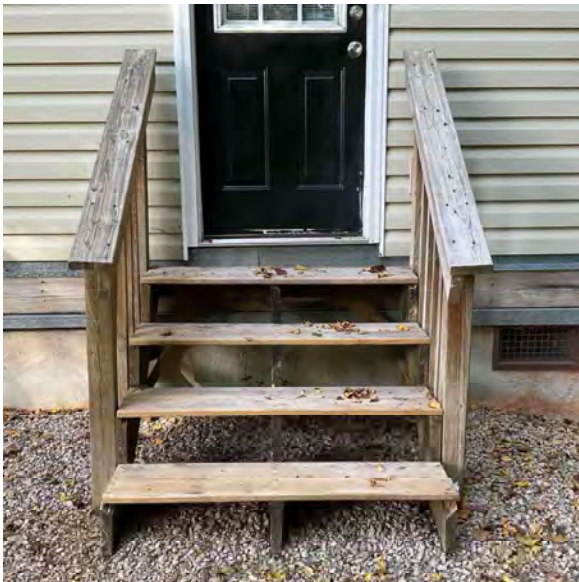
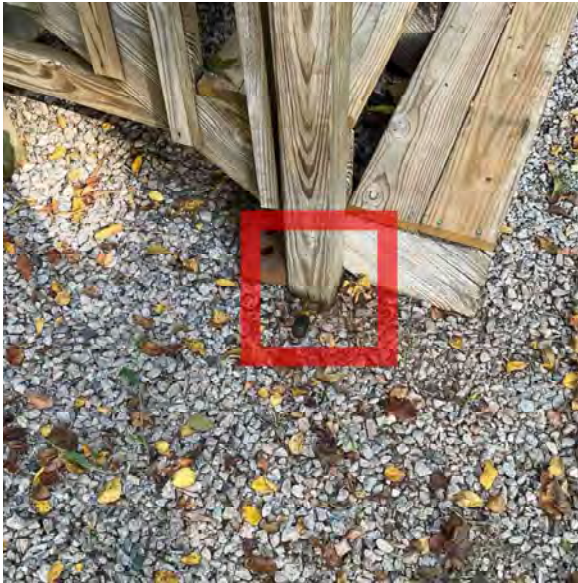
**2.5.1** The wood entry stairs have some noted safety and/or structural concerns that could lead to personal injury. Further evaluation by a licensed general contractor is required to assess the deck and to determine appropriate corrective actions to provide adequate functionality and safety.

- The handrails and posts on the staircase to the porch are loose/wobbly and present a safety hazard
- Open risers present trap hazard
- Damage was noted at the bottom of a post (Exterior Rear)

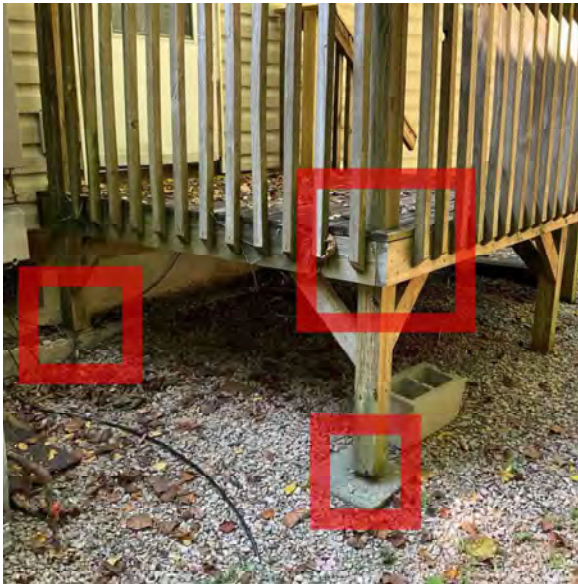
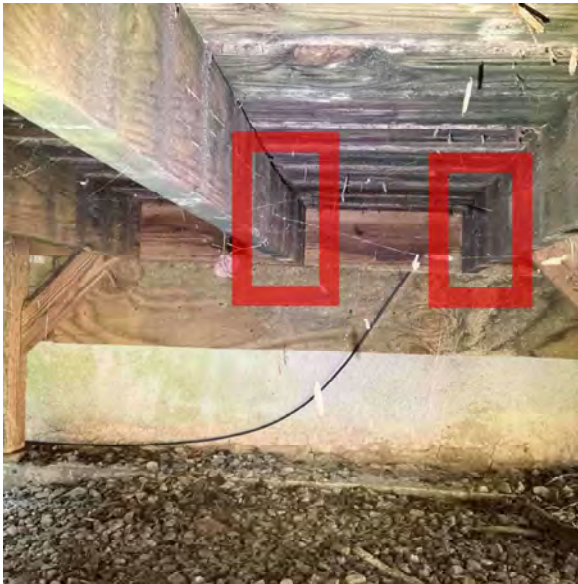
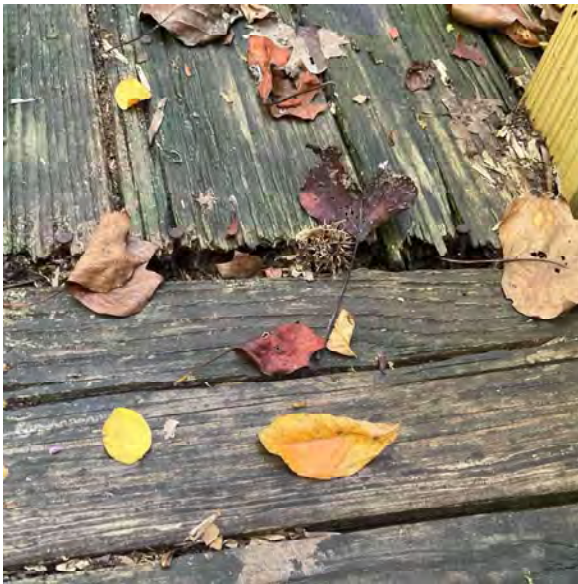
**2.5.2 The side wood porch has some noted safety and/or structural concerns that could lead to personal injury. Further evaluation by a licensed general contractor is required to assess the deck and to determine appropriate corrective actions to provide adequate functionality and safety.**

- The footings are above grade, and the posts are not properly secured
- The joist are supported by nails alone. Typically hangers or ledger are required for proper support and strength.
- Support posts were not attached using bolts or bearing directly under girder which is needed for intended support
- There are open risers in the staircase, which presents a trap hazard, and the handrail is too wide and not graspable.
- Damaged boards were noted on the stairs and platform (Exterior Left)

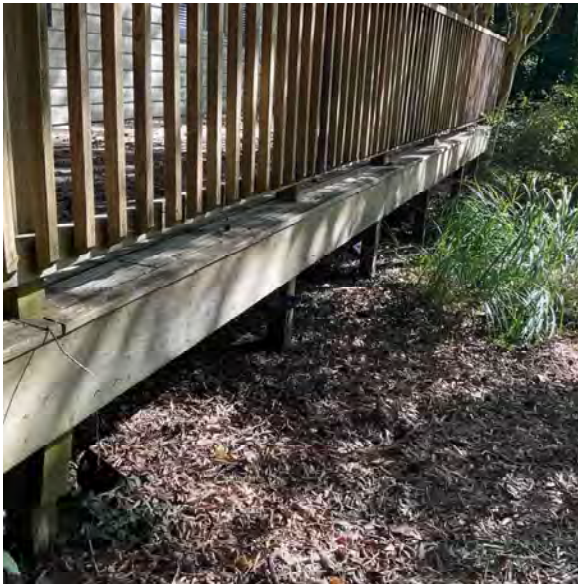
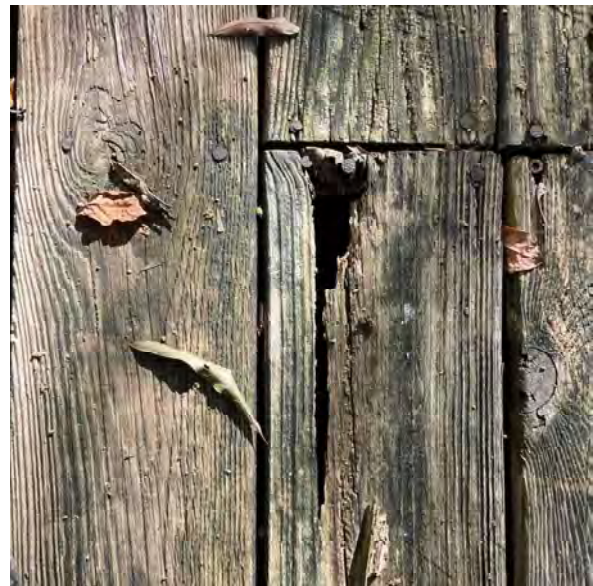
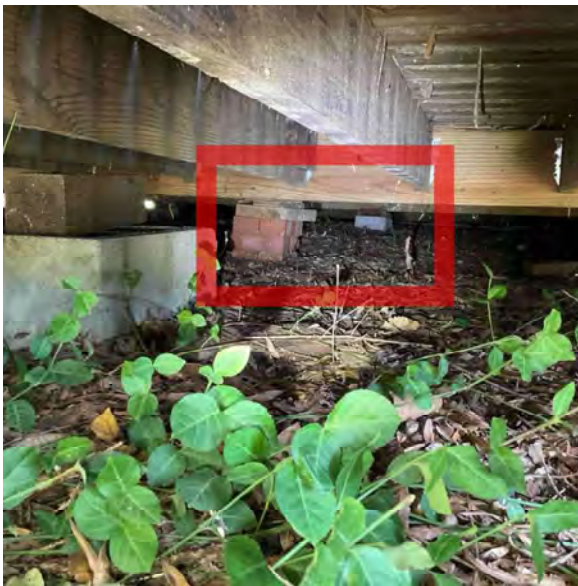
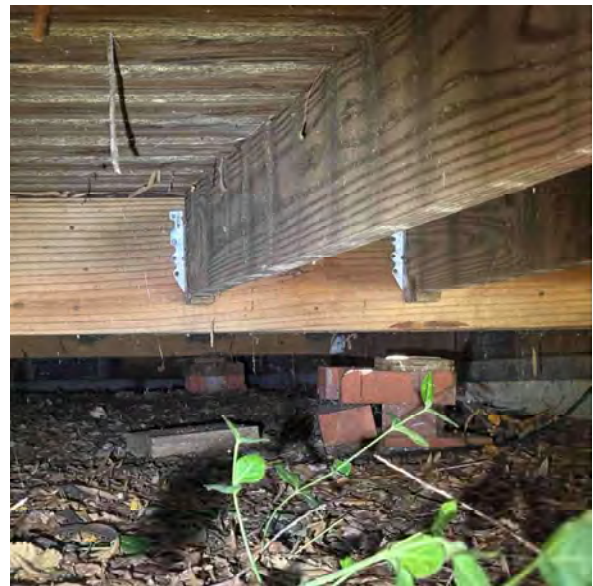
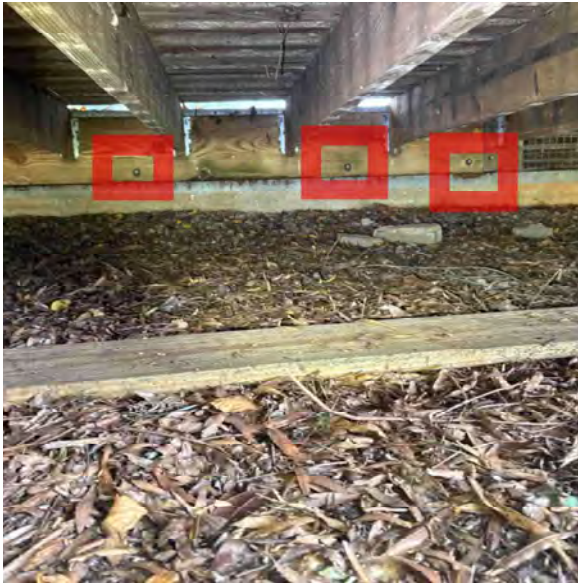
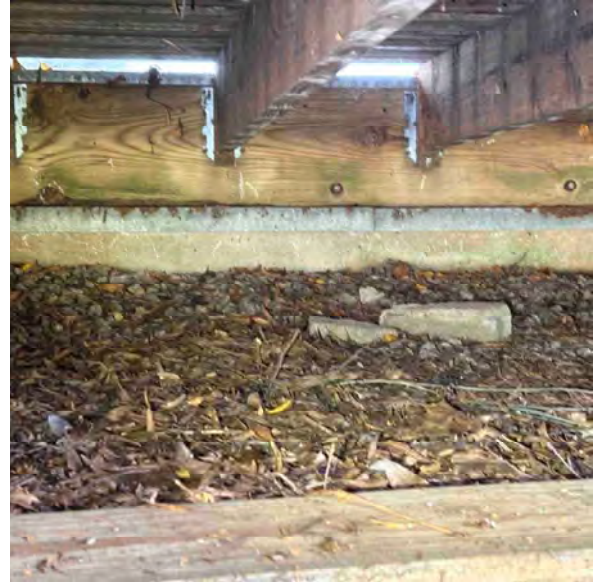
**2.6.1 The wood deck has multiple noted safety and/or structural concerns that could lead to personal injury. Further evaluation by a licensed general contractor is required to assess the deck and to determine appropriate corrective actions to provide adequate functionality and safety.**

- There were "open risers" present between the stair treads creating a potential trip/fall hazard.
  - Support posts were not attached using bolts or bearing directly under girder which is needed for intended support
  - There were damaged boards noted on the deck floor
  - Underneath the deck, there were multiple stacks of blocks and bricks suggesting there is overspend joists, damaged wood, and or deflection.
  - Rust and corrosion was noted on and around several bolts / fasteners that can lead to weakening and failure
- Exterior Front
  - Exterior Right

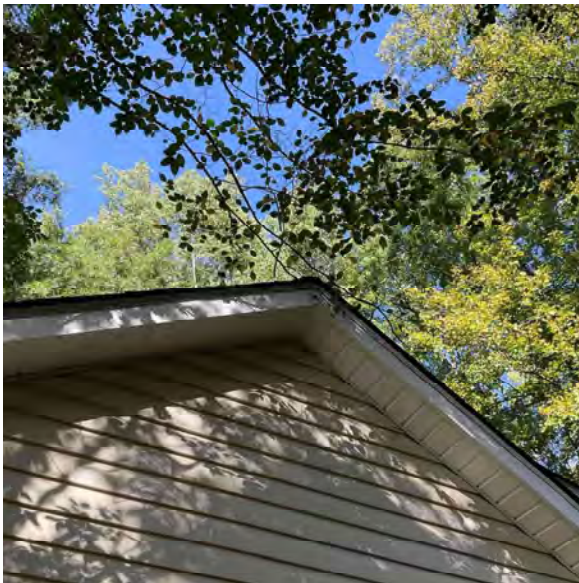
**3.3.2 There are tree limbs in contact or hanging over the roofing surface. This can lead to accelerated deterioration and promote animal / pest activity. Have a qualified contractor assess and trim back the tree limbs that are touching the rear slope of the house to reduce damage to the roof covering and accessories. (Exterior Rear)**

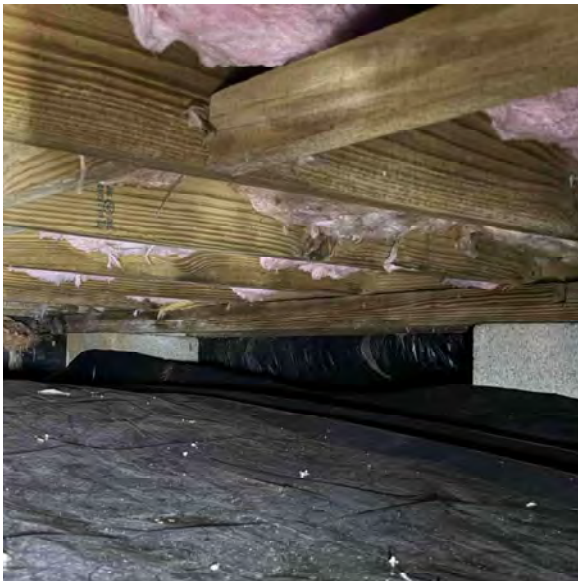
6.2.1 Limitation: The inspector could not enter the front and middle part of the crawlspace due to low hanging wood members and air ducts. Therefore, structural concerns and plumbing in that area could not be inspected. If the buyer wishes further evaluation, consult a licensed general contractor that specializes in crawlspaces.

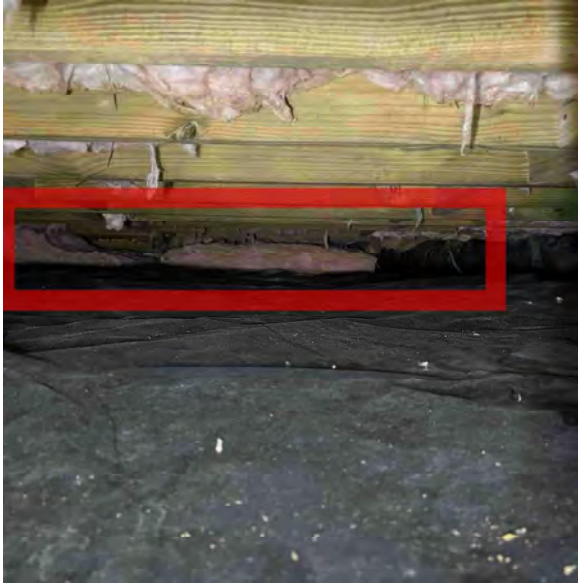
6.3.1 Have a qualified contractor resecure fallen/missing insulation batts between joists and replace any that are damaged to improve heating and cooling efficiency. (Crawlspace)

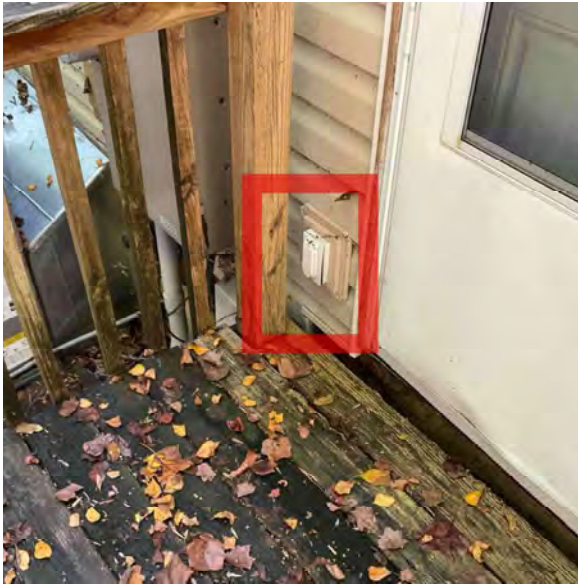
**7.7.2 The receptacle has an open gap that can allow moisture penetration and subsequent damages. A licensed electrician should correct receptacle as required for electrical safety. (Exterior Left)**

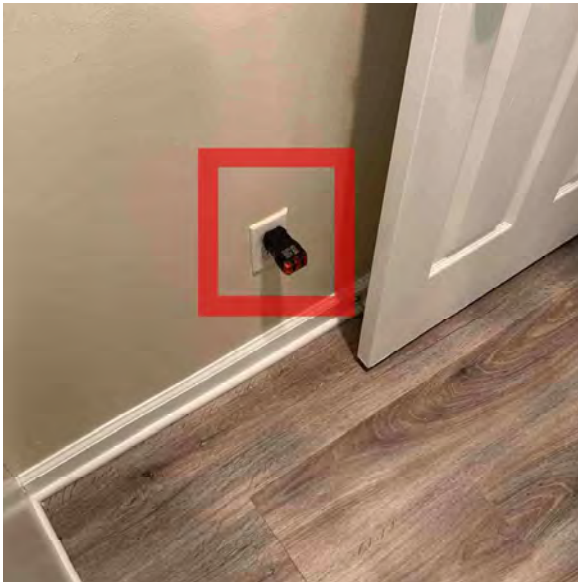
**7.7.3 The bathroom receptacle is not functioning as intended. This should be protected by Ground Fault Circuit Interrupters (GFCI). It is being supplied power, but will not trip when tested. Have a licensed electrician repair/replace as needed to avoid safety hazard. (Hall Bath)**

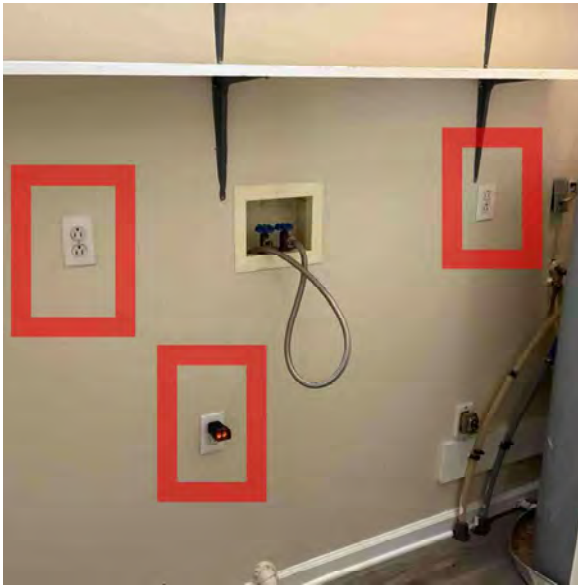
**7.7.4 The electrical receptacles on the wall are in close proximity to the laundry water valve and is not GFCI protected. Any receptacles in close proximity to the water source should have GFCI protection. Have a licensed electrician correct as needed to provide personal safety protection to prevent electrical shock. (Laundry area)**

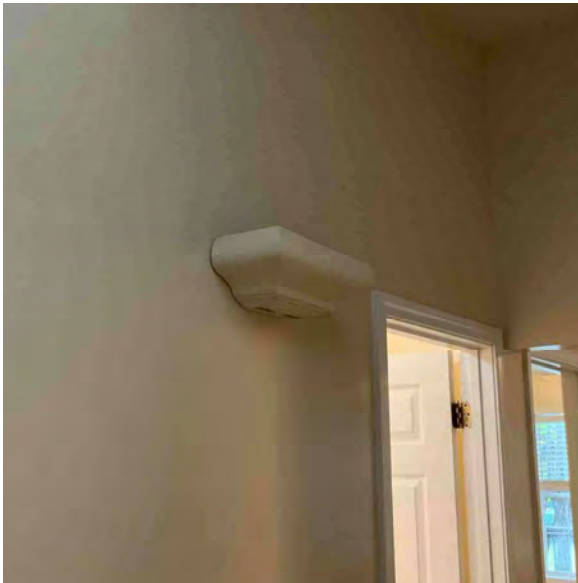
**7.8.1 Light did not responding to the switch. Check/install bulb first prior to evaluating the fixture. Have a licensed electrician evaluate and repair as needed to allow safe and proper operation. (Hallway)**

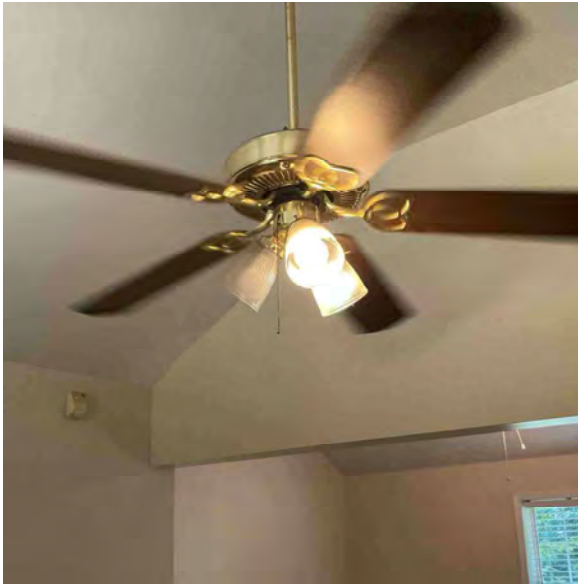
**7.8.2 The light in the dining room flickered and would not incrementally illuminate with the dimmer switch. Have a licensed electrician correct as needed for proper functionality. (Dining room)**

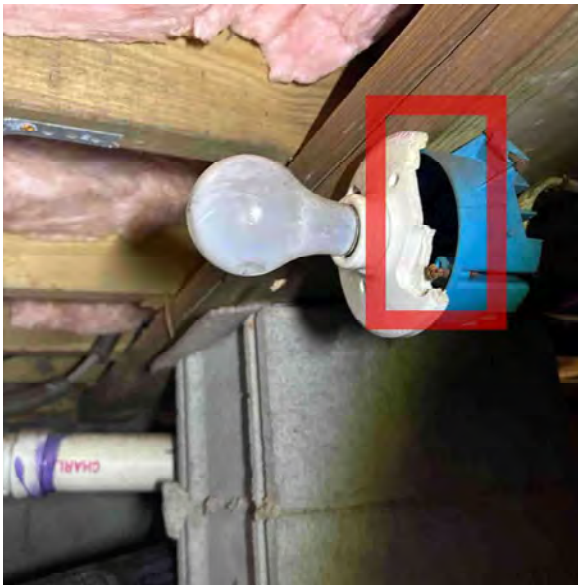
**7.8.3 The junction box for the light in the crawlspace is damaged and electrical components are exposed. Have a licensed electrician correct as needed for electrical safety.**

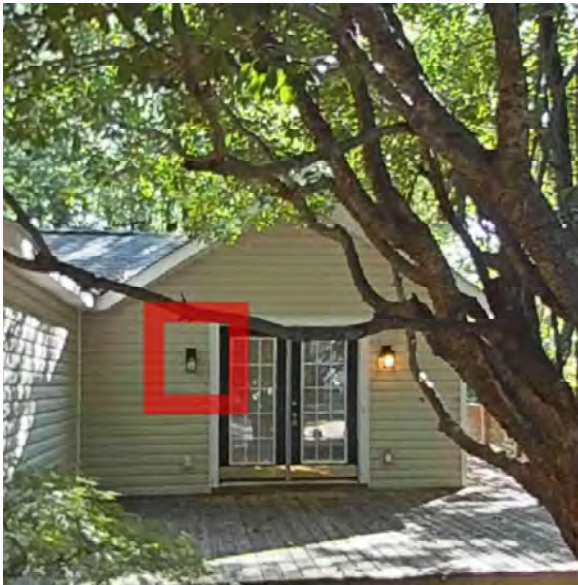
**7.8.4 Light did not responding to the switch. Check/install bulb first prior to evaluating the fixture. Have a licensed electrician evaluate and repair as needed to allow safe and proper operation. (Exterior Front)**

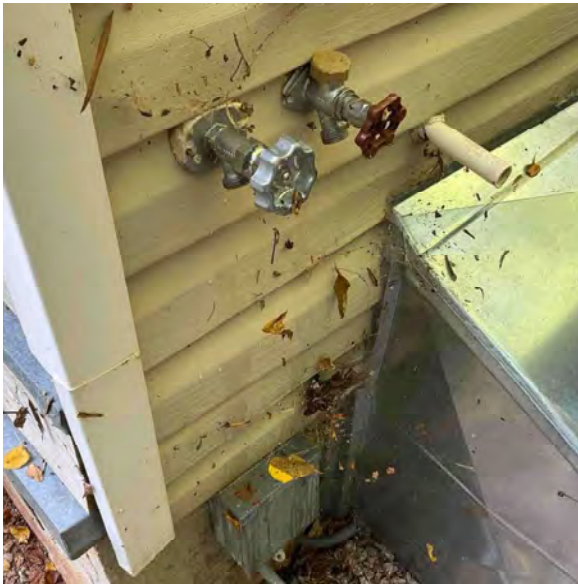
8.3.1 **The air conditioners electrical disconnect has a missing panel cover. The exposed wiring presents a shock hazard. A licensed HVAC technician or licensed electrician should further assess and correct as required for safety. Additionally, this disconnect is directly below two water faucets. Although these boxes are designed for exterior exposure, direct running water is not recommended. Have a licensed electrician assess to determine if relocation is necessary and make any needed corrections. (Exterior Left)**

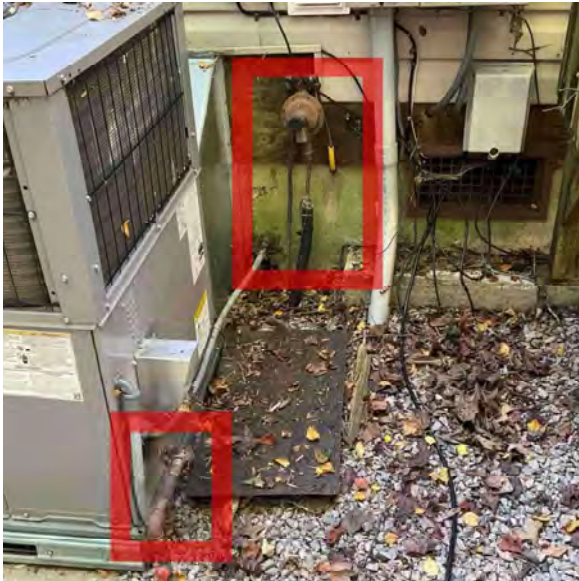
8.6.1 The metal gas line is rusted. Rust can cause damage to gas line leading to leaks and subsequent hazards. Have a licensed plumber or licensed HVAC technician to evaluate to determine what repairs are needed an correct. (Exterior Left)

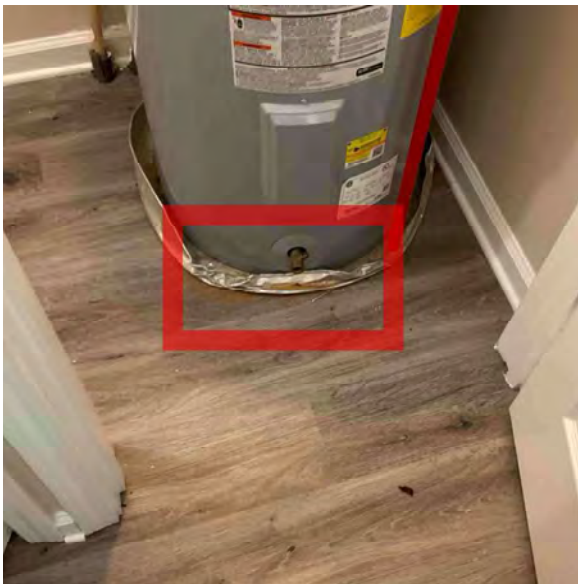
9.6.4 The pan below the water heater is damaged and may not contain water as intended. Have a qualified contractor correct as needed. (Laundry area)

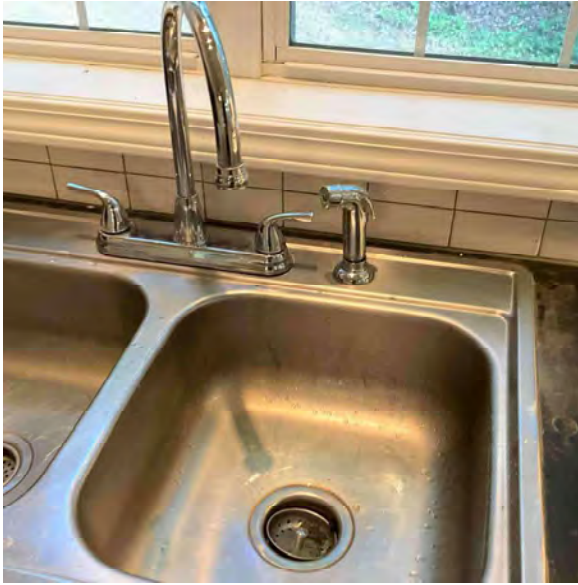
**9.7.1 The accessory spray nozzle for the kitchen sink did not fully divert water from the main faucet. This could have an adverse effect on water pressure and functionality. Have a licensed plumber repair/replace as needed for proper functionality. (Kitchen)**

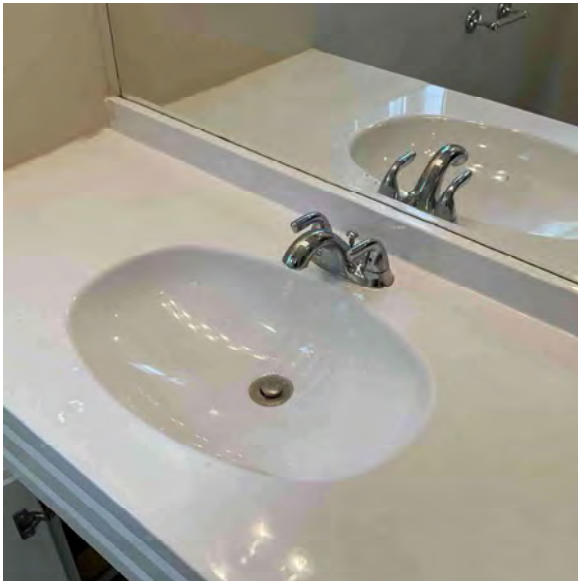
**9.7.2 Limitation: the bathroom sink faucets would not function at the time of the inspection. Have a licensed plumber assess and correct as needed for proper functionality.**

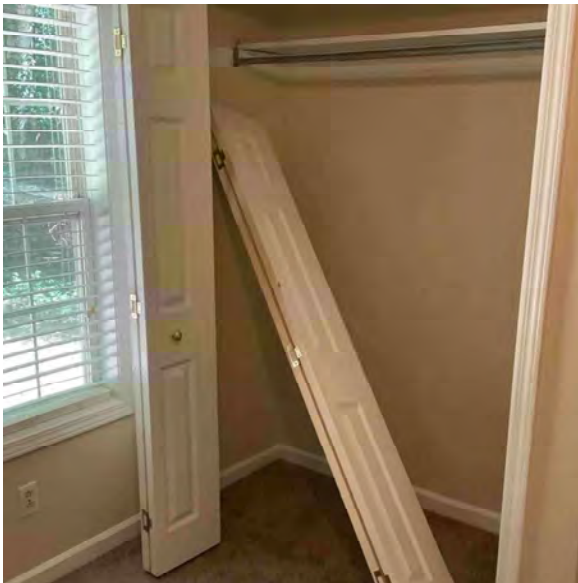
**10.4.2 The closet door is not properly hung on the track. Have a qualified contractor correct as needed for proper functionality and condition. (Front Bedroom)**

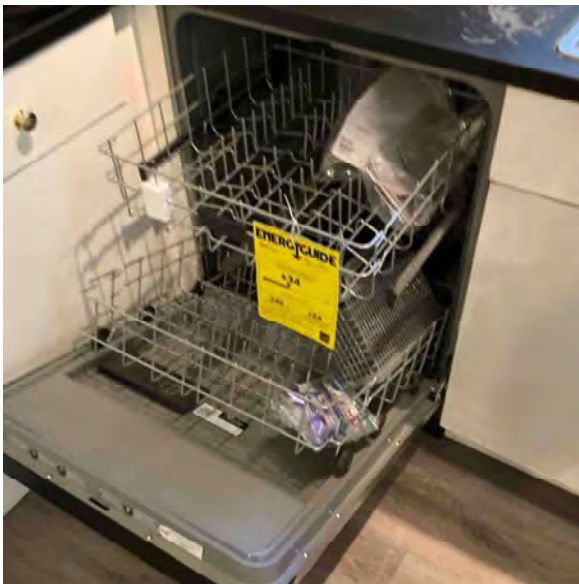
11.3.1 Limitation: did not test functionality of dishwasher due to new installation and has not been fully unpacked.

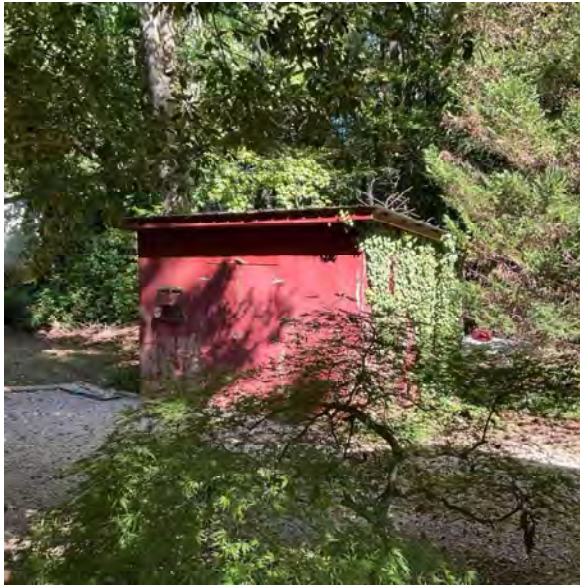
12.1.1 Outbuildings/sheds are outside the scope of the home inspection. If evaluation is desired, refer to a qualified contractor.
