# Inspection Report

03.12.26

3421 Oak Trail  
Clayton, NC 27520

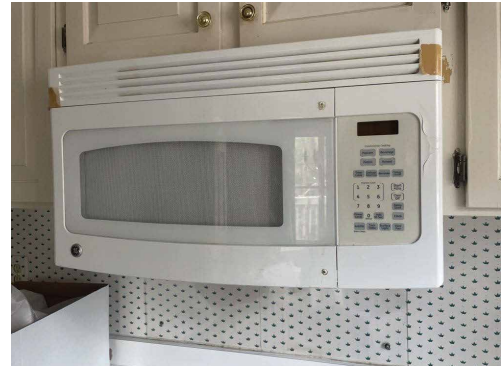
### B) Information: Microwave - Life Cycle Expectancy -

Microwave appears to be over twelve years old and is at the end or exceeded expected life cycle as defined by most major manufacturers.

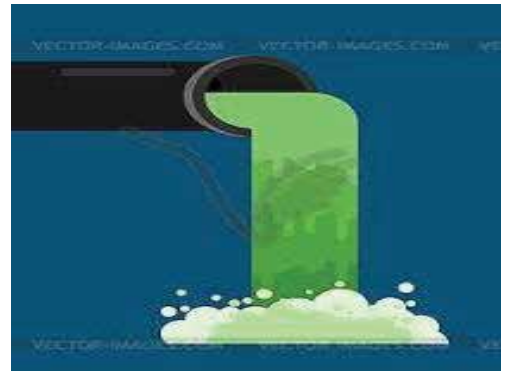
#### 37. Information/Inspection Limitation: Main Waste Line –

The interior of the main waste line was not inspected as part of this home inspection. Underground plumbing can develop hidden problems such as root intrusion, cracks, poor installation, blockages, or even rodent activity. These issues may result in sewage backups or complete line failure. Repair or replacement of a buried sewer line can range from several thousand dollars to well over \$10,000, depending on location and depth. A professional sewer scope inspection is recommended to determine the current condition of the line before purchase.

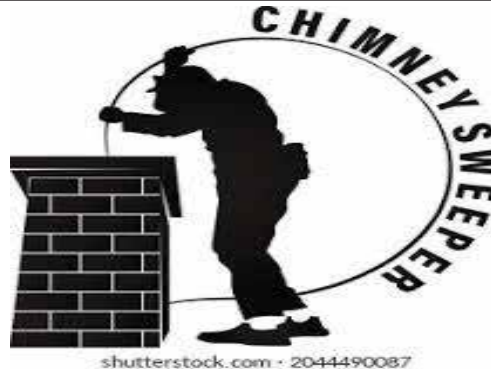
The inspector is unable to fully evaluate the fireplace flues due to limited visible areas above the firebox. It is suggested that the seller be consulted about the last time the flues have been inspected, cleaned, or scoped. The National Fire Protection Association (NFPA 211) recommends annual chimney inspections because creosote buildup and hidden flue damage are leading causes of chimney fires, which are a significant source of residential fires in the U.S.

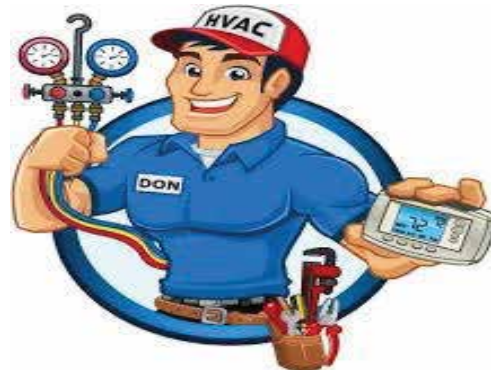
### 43. Information/Recommendation: General HVAC Maintenance -

Manufacturer recommended maintenance service cleaning to be provided annually on all HVAC systems. It is known that an A/C system can lose up to as much as 10% operating efficiency a year if not being properly maintained. At a minimum, maintenance service should be provided no less than every three years in order to maintain operating efficiency above seventy percent. If preventative maintenance records cannot be provided demonstrating that the system has been serviced in the past 3 years, it is strongly suggested that a HVAC contractor provide further evaluation of this system including cleaning the evaporator and condensing coils, checking refrigerant levels/pressures and a visual inspection of the heat exchanger (gas furnaces only) as part of a scheduled maintenance service. If more than 1/2 pound of refrigerant was required to refill the system, leak checking should be performed in order to ensure that a leaking condition is not present in the system. If records are provided, it is recommended to review the service receipt in order to determine what services were provided.

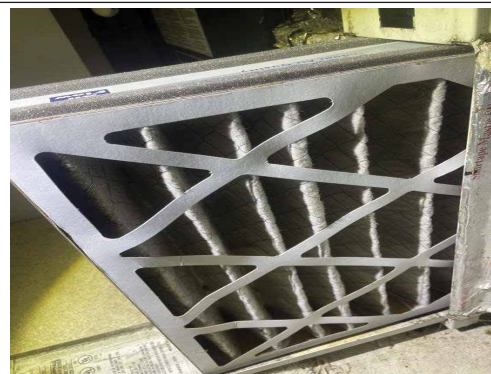
44. Information: Whole Duct Cartridge Filtration System - Cartridge filters are installed in the return air duct housings just before the furnace/air handler serving each floor. The combination of a whole duct cartridge filter and individual filters in the duct return vents provides for a very clean air environment.

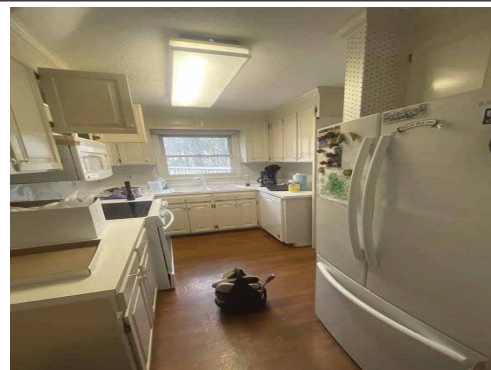
46. Information: Appliances - Life Cycle Information - Some of the appliances in the kitchen appear to be over twelve years old and are nearing/exceeding the end of their expected life cycle as defined by most major manufacturers.

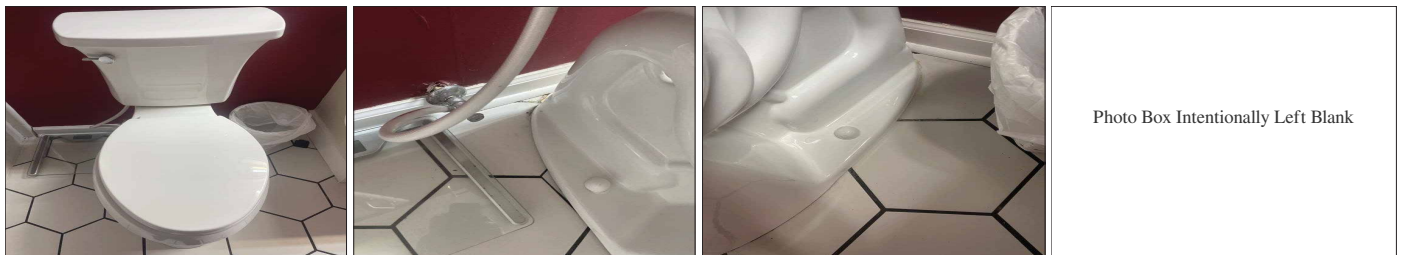
**13. Needs Repair: Bathroom Toilet Loosely Installed at Floor -**  
The primary bathroom toilet is loosely connected to the floor. This can result in damage/leaking. Recommend that a professional plumbing contractor fully evaluate the toilet and make the necessary repairs for proper installation and long term serviceability.

Needs Repair: Bathroom Toilet Loosely Installed at Floor -

The primary bathroom toilet is loosely connected to the floor. This can result in damage/leaking. Recommend that a professional plumbing contractor fully evaluate the toilet and make the necessary repairs for proper installation and long term serviceability.

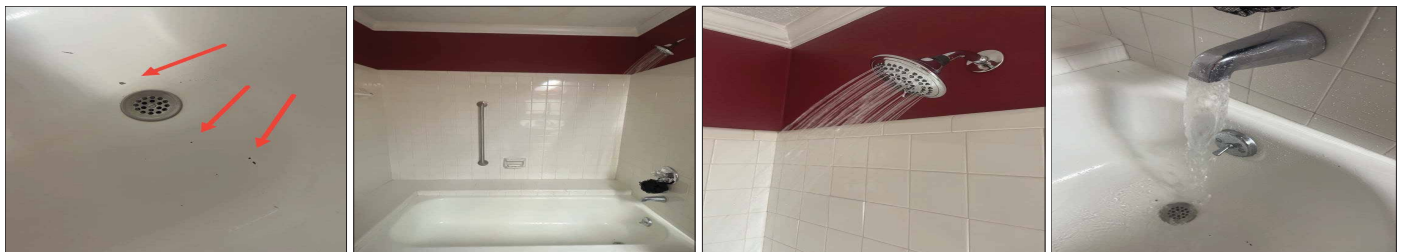
**14. Needs Repair: Bathroom Bathtub Surface Damaged -**

There is an area of surface damaged to the primary bathroom bathtub. Damaged tub surfaces can result in increased damage and/or leaking. Have an authorized manufacturers representative repair contractor evaluate the entire tub and make repairs so that the product warranty is maintained in effect.

Needs Repair: Bathroom Bathtub Surface Damaged -

Needs Repair: Bathroom Tub/Shower Diverter Not Working Properly -

The bathroom tub/shower valve does not fully divert water to the shower head. This can limit use and is inefficient. Have a professional plumbing contractor evaluate the fixture and make the necessary repairs for proper operation.

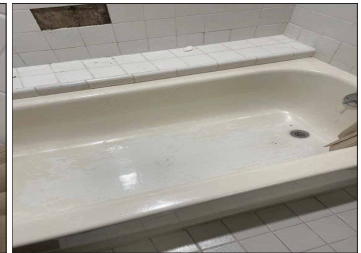
Needs Repair: Deteriorated Shower Floor Tile/Grout in Bathroom -

The basement shower floor tile has evidence of cracking/separation present. ( missing tile ) This can allow water to infiltrate behind the floor tile which can result in damage. Recommend that a professional contractor provide a full evaluation of the shower area and any repairs necessary to prevent possible water penetration. Hidden damage and fungal growth may be present.

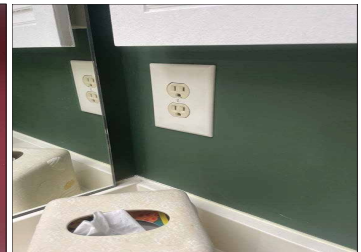
Needs Repair: Ground Fault Protection - Not Tripping/Not Protected -

Ground fault circuits, where present and accessible, were tested by simulating a fault. The circuit outlets serving the exterior, the bathrooms and the kitchen would not trip when a fault was simulated. Have a professional electrical contractor service these ground fault circuits so that proper operation is known to be occurring when conditions are necessary.

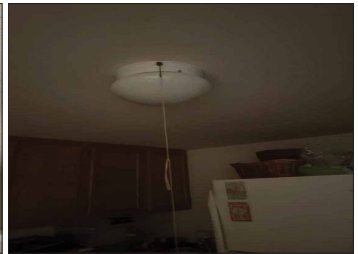
B) Needs Repair: Lighting, Fans & Switches - Missing Globes -

Observed light fixtures to be missing globes over the light bulbs. Globes over the bulbs limit exposure to damage from contact. Recommend that a globe be installed at all light fixtures where not currently present.

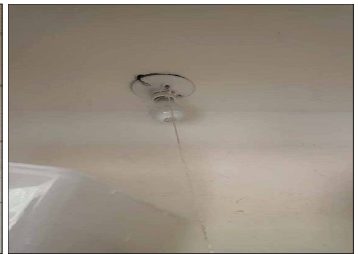
B) Needs Repair: Exterior Lighting, Fans & Switches - Missing Globes -

Observed light fixtures to be missing globes over the light bulbs. Globes over the bulbs limit exposure to damage from contact. Recommend that a globe be installed at all light fixtures where not currently present.

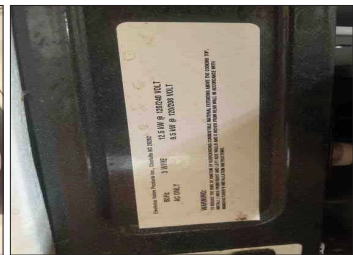
Needs Repair: Range - Missing Anti-Tip Bracket -  
The anti-tip bracket required for safety on all freestanding ranges, was not installed at the time of the inspection. The anti-tip device can prevent personal injury/damage caused by the appliance tipping over due to weight added to the open door. Recommend a professional appliance installation contractor install this anti-tip device as required to prevent damage and personal injury.

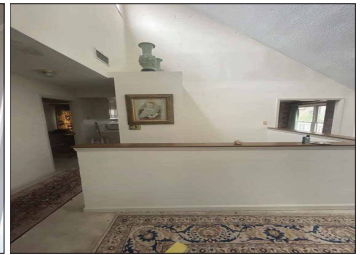
**Lighting**

Satisfactory: The interior and exterior lights were turned off prior to locking up the home.
