## SUMMARY

3421 Oak Trail, Clayton, NC 27520

July 20, 2026

Jason Ross  
NC License #3561  
New Leaf Home Inspections  
9105848502  
[jason@newleafinspections.com](mailto:jason@newleafinspections.com)

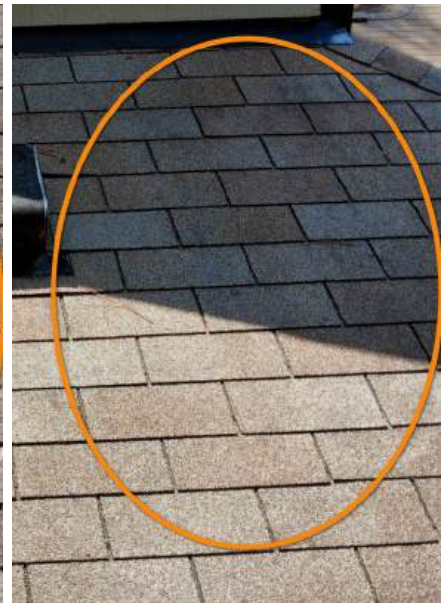
There was mineral granule loss on the roof coverings in several locations. Loss of granules can contribute to a shortened roof lifetime if found to be accelerated. There are many possible causes including, but not limited to, age, foot traffic, contact with vegetation, defective products, improper installation, hail damage, etc. We recommend monitoring this for future leaks or accelerated wear and contacting a qualified roofing professional for further evaluation if desired.

There was mineral granule loss on the roof coverings in several locations

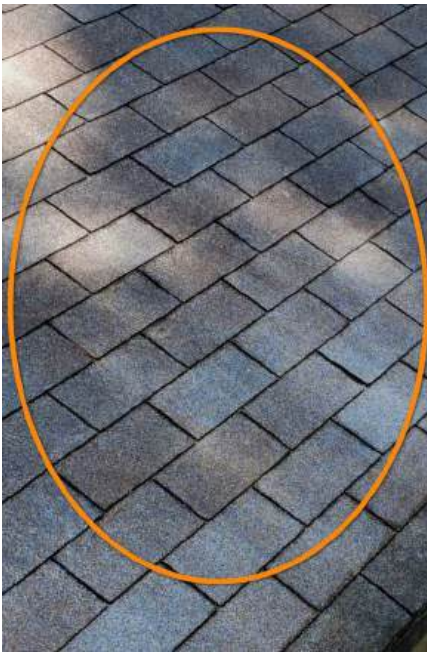
There was mineral granule loss on the roof coverings in several locations

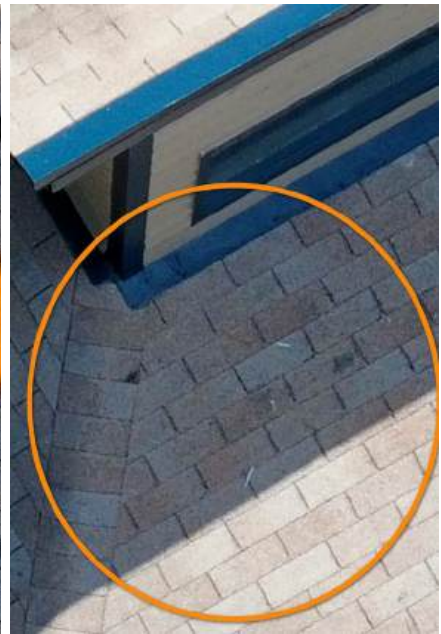
There was mineral granule loss on the roof coverings in several locations

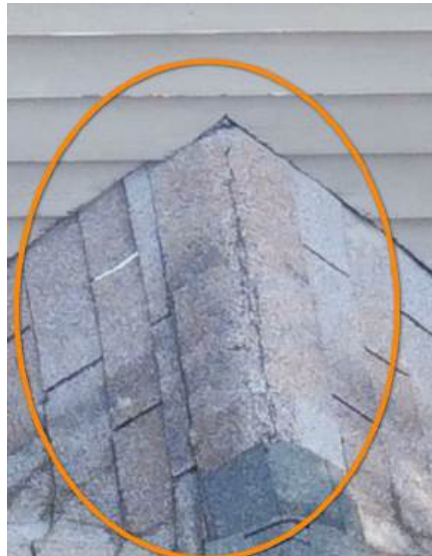
There was mineral granule loss on the roof coverings in several locations

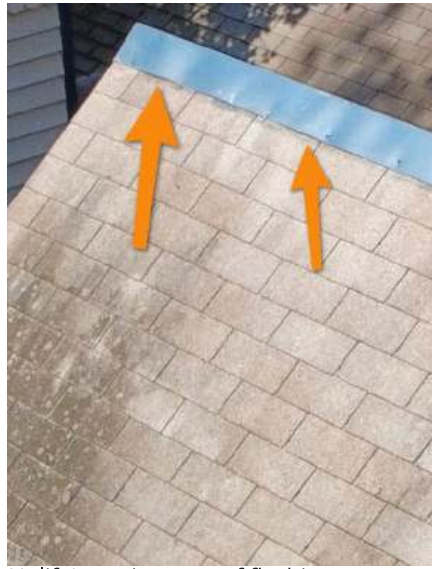
The flashing was either damaged, incorrect, or missing. This can indicate improper repairs, or allow moisture intrusion if not flashed properly. Recommend roofing or siding contractor evaluate and replace / repair as needed.

Uplift/gaps in areas of flashing on middle roofing of home

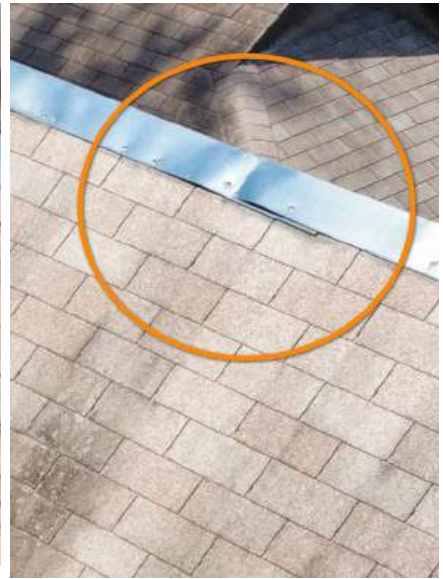
Uplift/gaps in areas of flashing on middle roofing of home

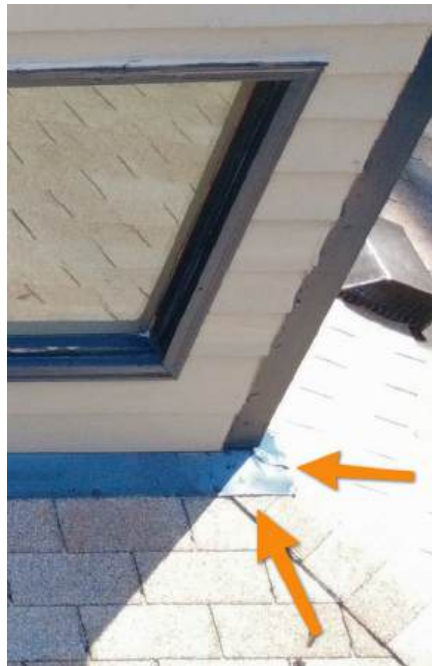
Uplift/gaps in areas of flashing on middle roofing of home

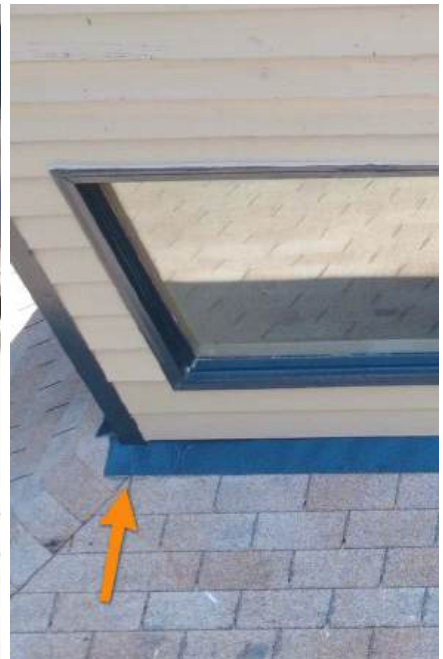
Uplift/gaps in areas of flashing on middle roofing of home

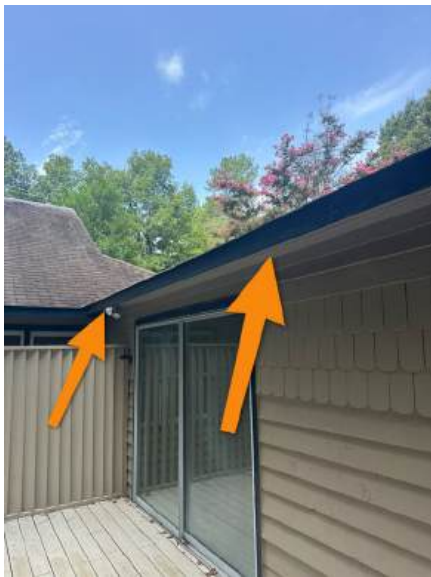
There are no or partial gutters present on the structure. This can allow water to impact the foundation of the home or increase moisture levels in crawlspace areas over time. We recommend a qualified contractor install gutters on the entire structure, or missing areas if so desired and possible.

No gutters installed on rear of home

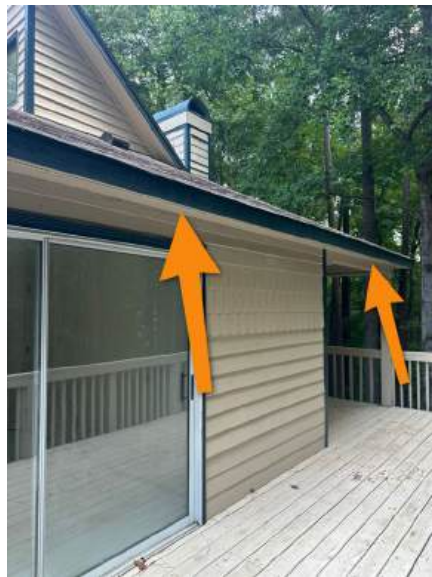
No gutters installed on rear of home

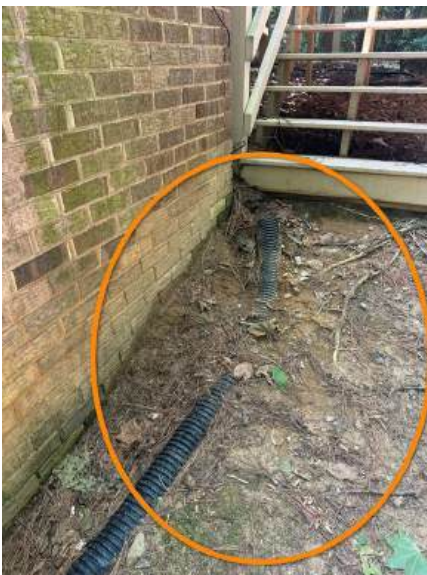
The grading in areas around the home appeared to have areas of higher erosion. This can sometimes affect surrounding components like drainage lines from the home, deck attachments ect. Recommend landscaper or qualified contractor further evaluate and adjust or advise as needed.

Evidence of soil erosion (left side exterior)

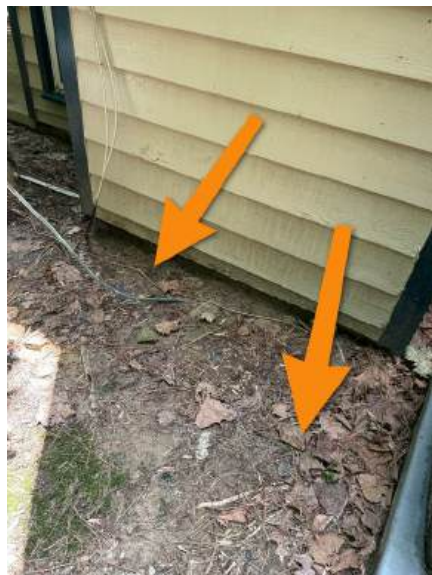
Evidence of soil erosion (left side exterior)

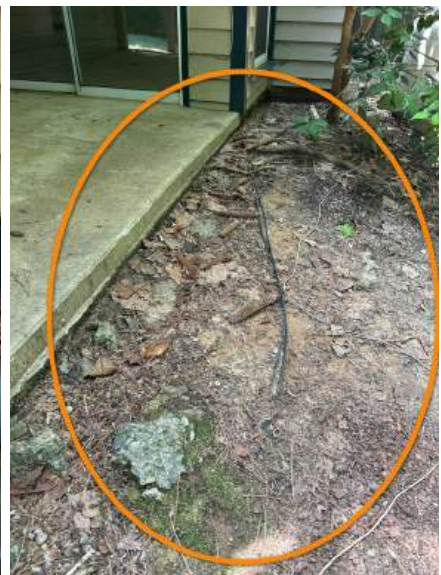
Evidence of soil erosion (left side exterior)

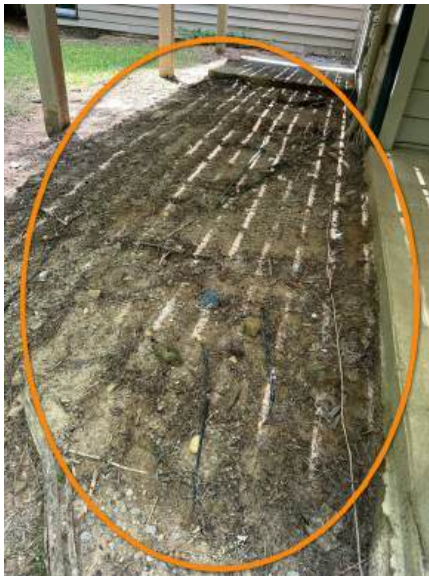
Evidence of soil erosion (rear exterior)

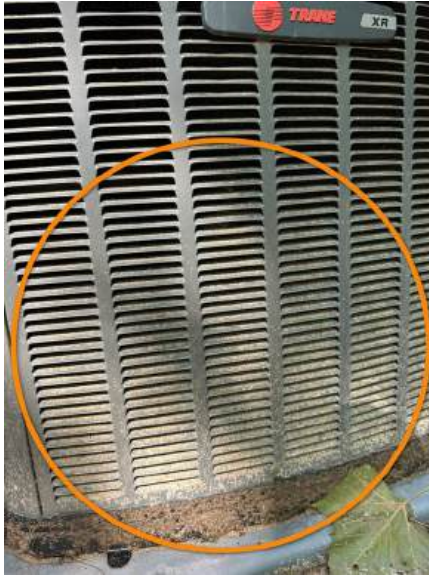
The HVAC system(s) should be cleaned and serviced periodically, especially in scenarios of older age to ensure proper chemical levels and operation as a typical home inspection can only determine proper operation with the use of normal controls. Recommend a qualified HVAC contractor clean and service to ensure proper operation.

Condenser fins need cleaning on exterior HVAC condenser unit/heat pump

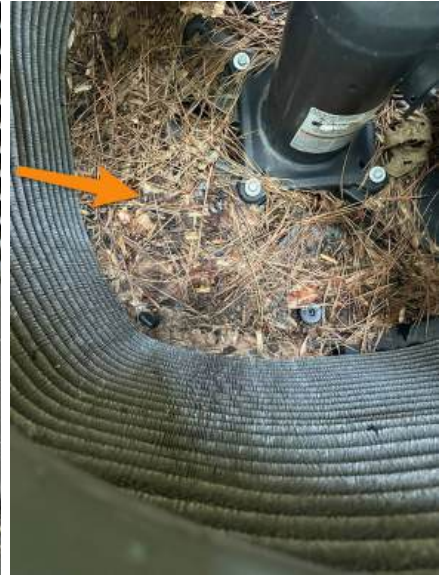
Organic debris present in main housing of exterior HVAC condenser unit/heat pump

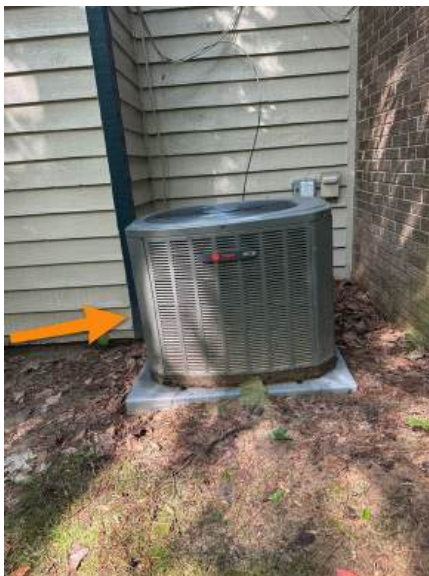
The HVAC unit is on an unlevel surface. The vibrations from running the unit can cause the unit to slide off damaging the unit. We recommend licensed HVAC technician or builder further evaluate and repair as needed.

Exterior HVAC condenser unit/heat pump is not sitting level

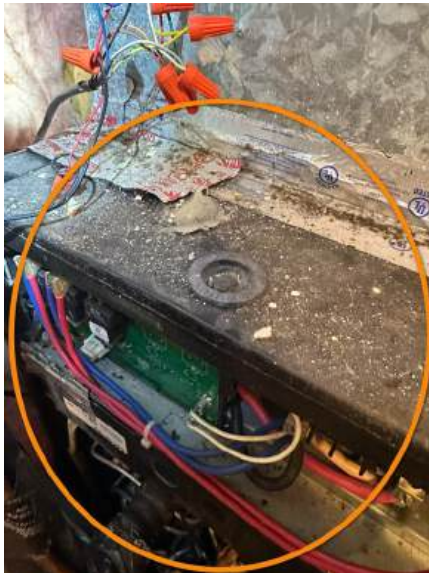
The HVAC system should be cleaned and serviced periodically. This is especially true in scenarios of older age, to ensure proper chemical levels, as a typical home inspection can only determine proper operation through use of normal controls. Recommend a qualified HVAC contractor clean and service per manufacturers recommendations.

HVAC air handler & evaporator coil need cleaning

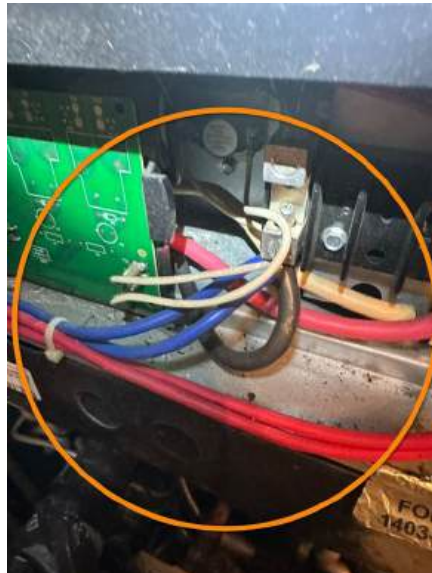
HVAC air handler & evaporator coil need cleaning

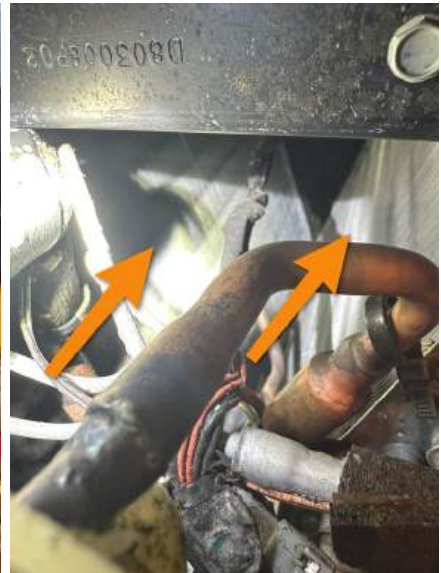
HVAC air handler & evaporator coil need cleaning

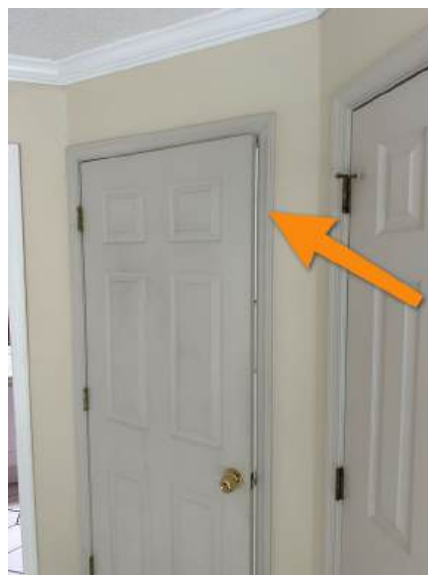
A door, or component of it, was not operating correctly in some way. This can worsen over time if not corrected or damage surrounding components. In some scenarios this is only an aesthetic concern. Recommend qualified contractor repair / adjust as needed.

Main level primary bedroom door is binding against frame at top when closed

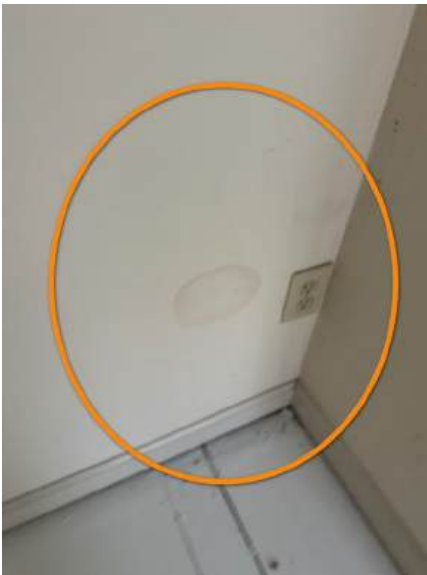
There was a moisture stain during the time of inspection. This could indicate current or past moisture intrusion within the structure, or from surrounding components. We recommend a licensed contractor further evaluate and make appropriate repairs as needed.

Moisture staining observed on rear wall in main level right front bedroom

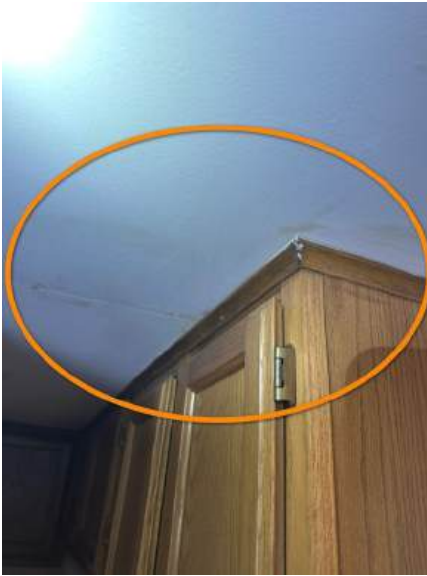
Moisture staining observed on ceiling in lower level front bonus room

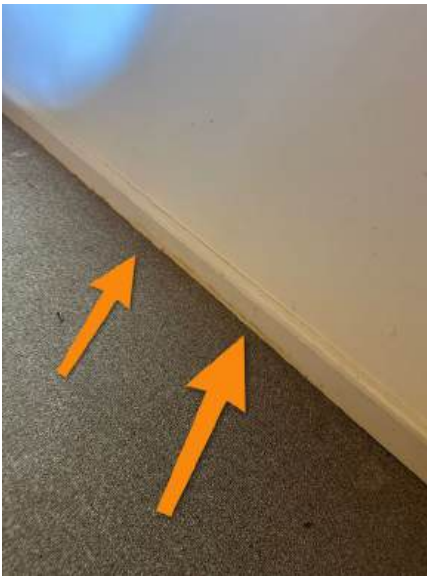
Moisture staining observed on baseboards in several locations throughout lower level of home

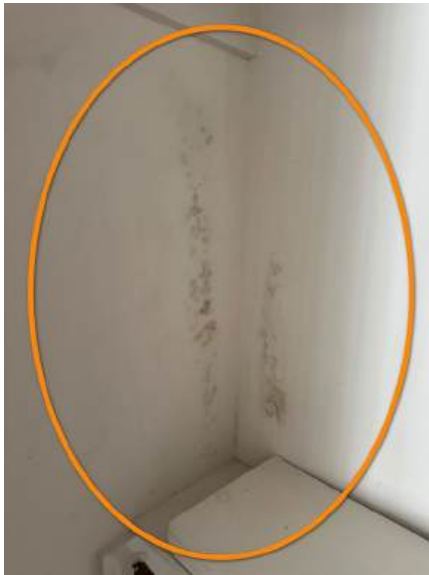
There appear to be signs of organic growth on the interior of the home. It is unknown if this is a safety hazard. We recommend an air quality test is performed and source of higher moisture is determined and mitigated to ensure the health and safety of occupants. **All areas of organic growth should be remediated by a licensed general contractor or qualified professional.**

Suspected organic growth observed on walls in main level right front bedroom closet

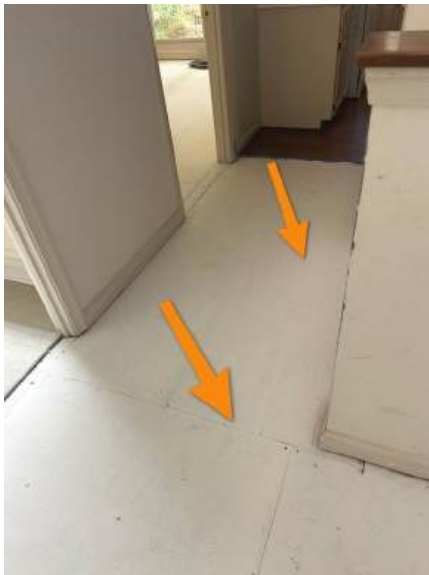
The floor in one or more areas of the home were creaky at the time of inspection. This could indicate improper installation, minor shifting of building materials or in some cases can be common with materials. We recommend further evaluation of these areas and repair if needed by a qualified professional.

Areas of flooring are creaky on main level of home (middle hallway)

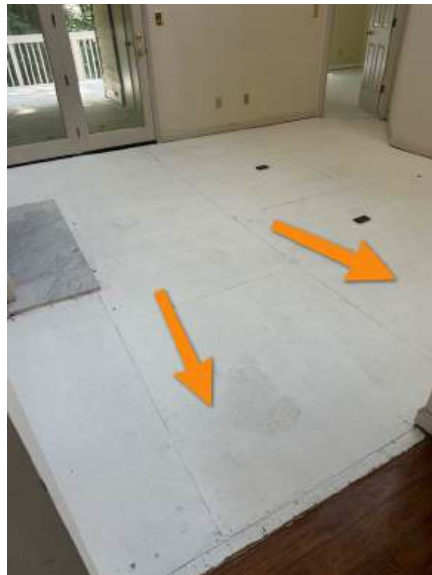
Areas of flooring are creaky on main level of home (living room)

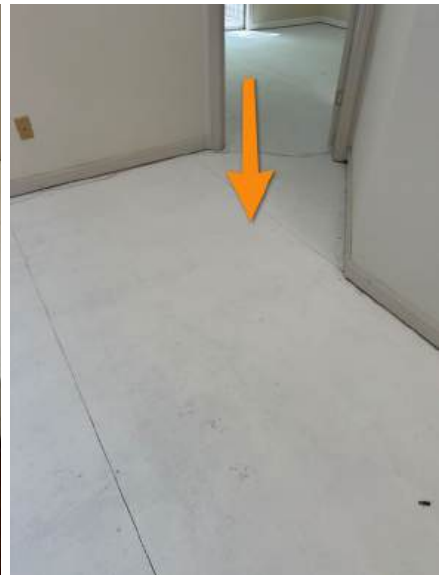
Areas of flooring are creaky on main level of home (living room)

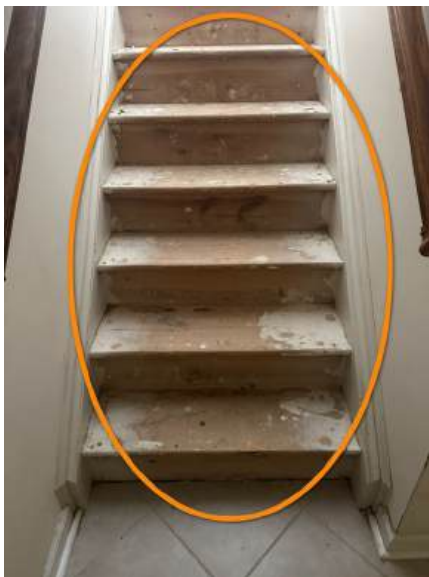
Several step treads are creaky on interior stairwell

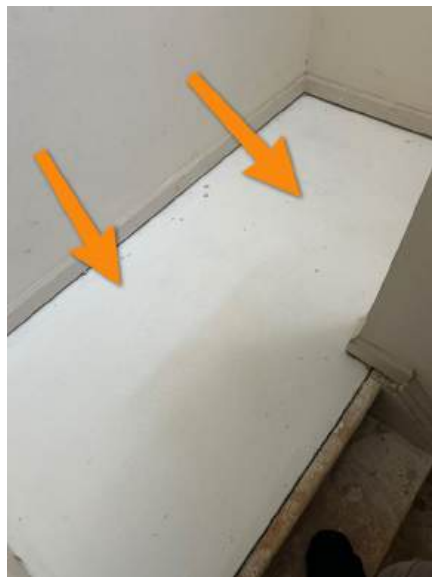
Flooring is creaky on middle stairwell landing

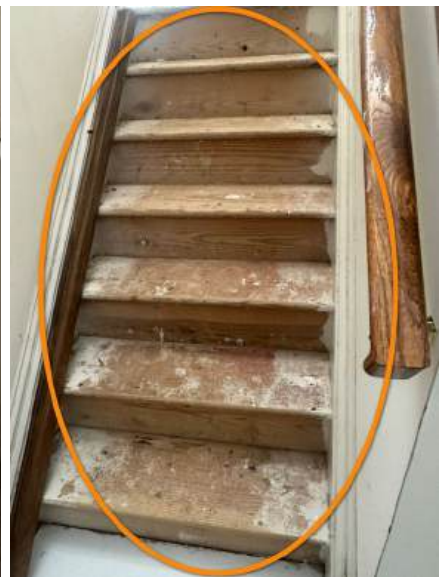
Several step treads are creaky on interior stairwell

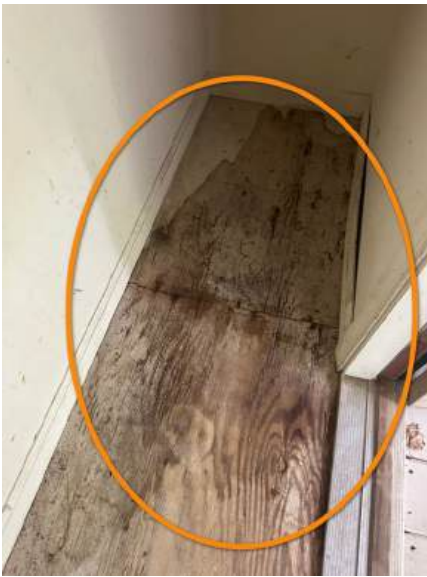
Subflooring had areas of possible moisture intrusion. This can accelerate deterioration and damage surrounding components over time. Recommend a qualified flooring contractor evaluate & repair areas affected as/if needed.

Subflooring had areas of possible moisture intrusion (Rear attached utility closet, main level)

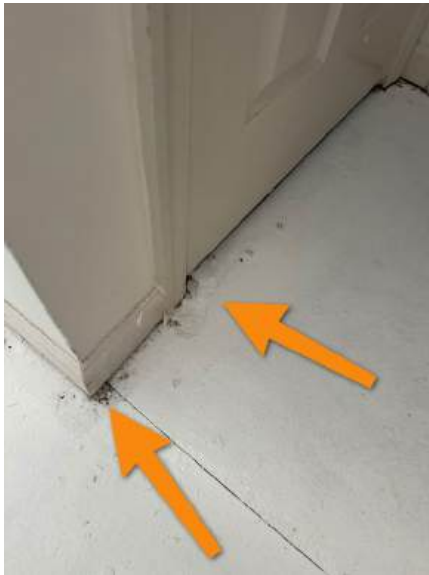
There was an area of deterioration in areas of the subflooring. This can indicate a moisture intrusion and can damage surrounding components. Recommend licensed contractor further evaluate to determine source of moisture intrusion and repair/replace all affected areas/components as needed.

There was an area of deterioration in areas of the subflooring (main level, middle hallway)

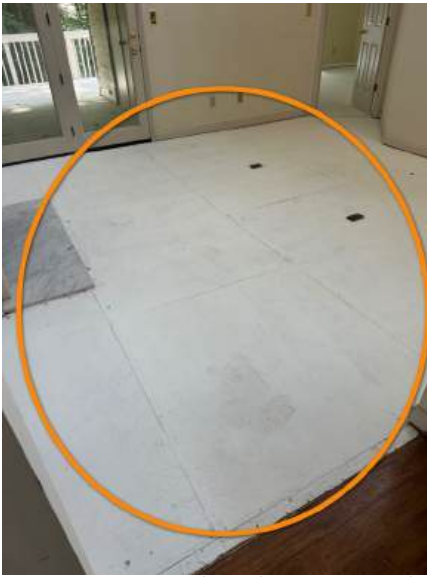
Flooring materials have been removed in numerous locations throughout interior of home and subflooring / slab are exposed. Recommend installation of flooring material (carpet, LVP, Tile, etc.) by a qualified flooring professional.

Flooring materials have been removed in numerous locations throughout interior of home (Main level, living room)

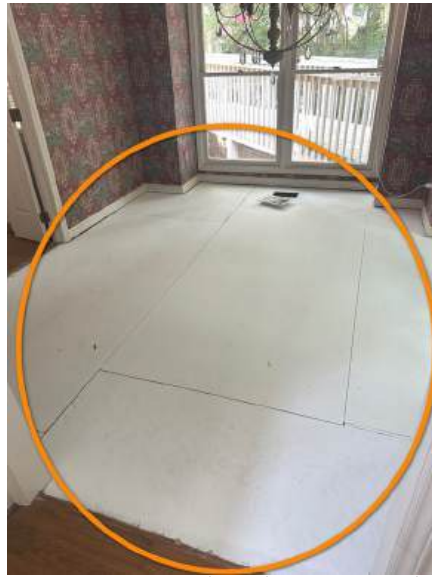
Flooring materials have been removed in numerous locations throughout interior of home (Main level, dining room)

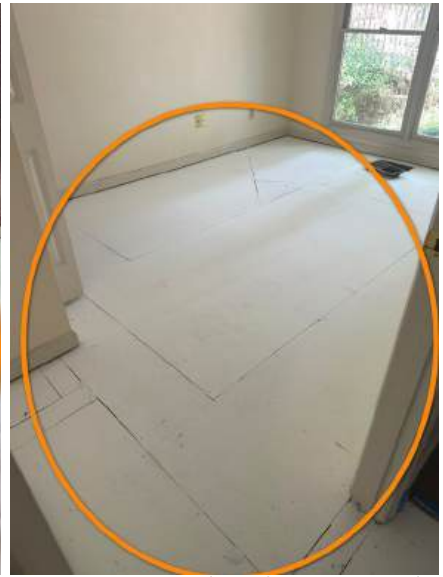
Flooring materials have been removed in numerous locations throughout interior of home (Main level, right front bedroom)

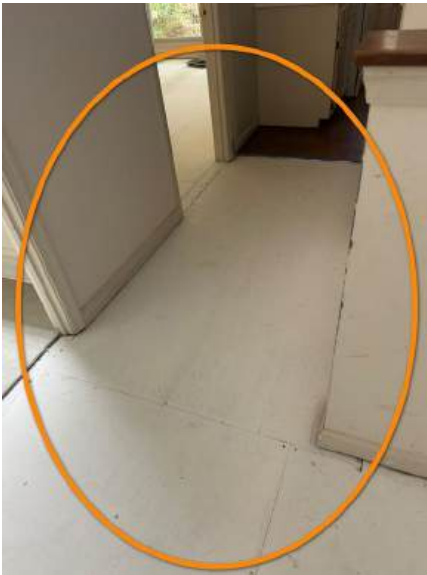
Flooring materials have been removed in numerous locations throughout interior of home (Main level, middle hallway)

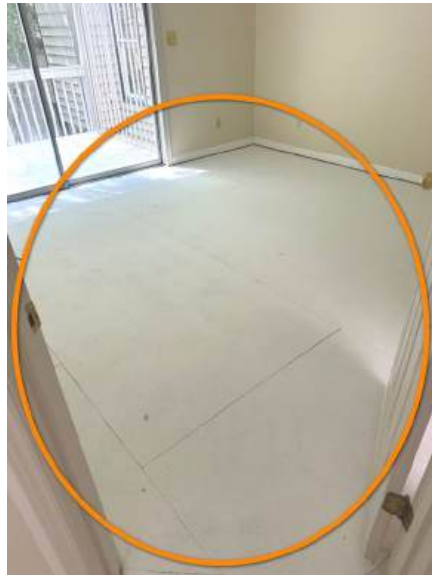
Flooring materials have been removed in numerous locations throughout interior of home (Main level, primary bedroom)

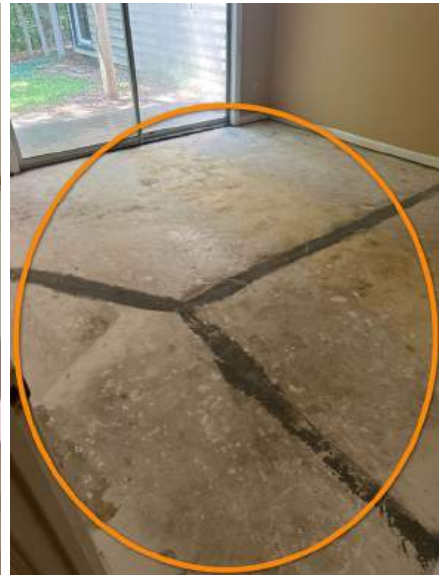
Flooring materials have been removed in numerous locations throughout interior of home (lower level, right rear bedroom)

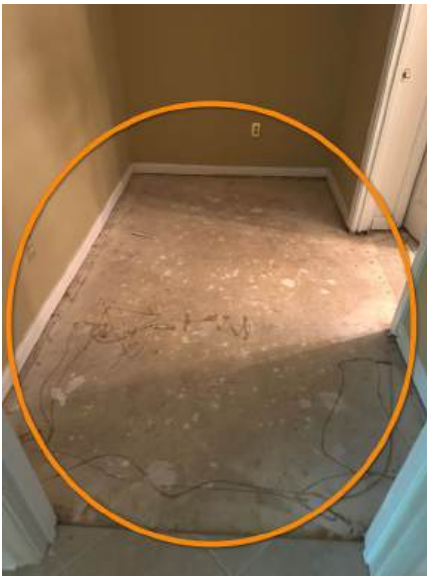
Flooring materials have been removed in numerous locations throughout interior of home (lower level, middle bonus room)

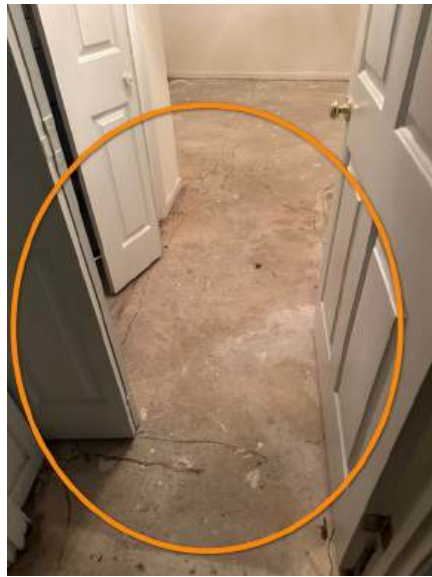
Flooring materials have been removed in numerous locations throughout interior of home (lower level, middle hallway)

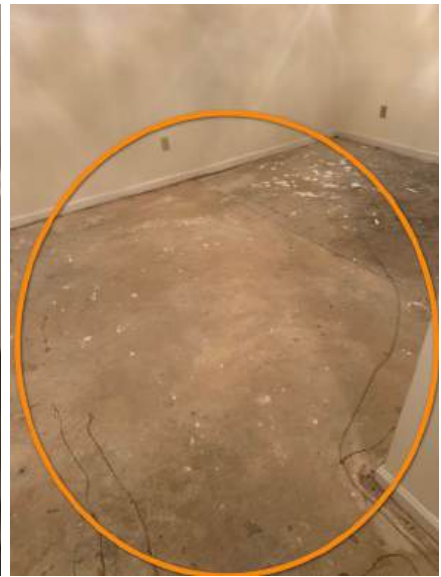
Flooring materials have been removed in numerous locations throughout interior of home (lower level, front bonus room)

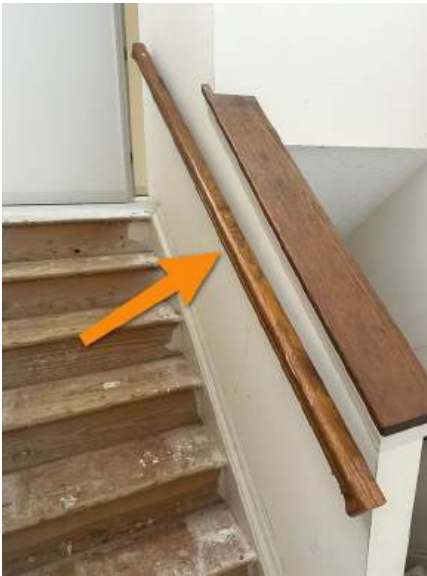
There was a loose component of the stairwell. This can worsen over time and could cause a fall hazard. Recommend loose component is tightened or replaced by a qualified professional.

Left side upper handrail is loose on interior stairwell

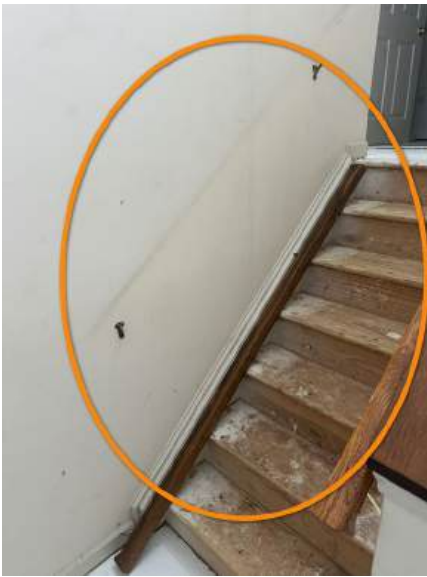
A component of the steps or stairwells was damaged or loose at the time of inspection. This can pose a tripping or safety hazard. Recommend qualified contractor evaluate and replace.

Right side upper handrailing is damaged and has detached on interior stairwell

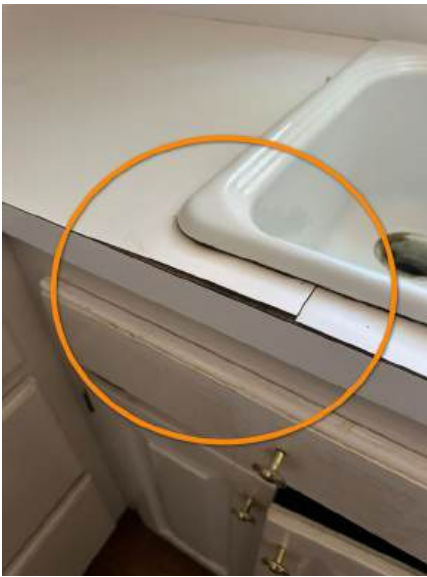
The cabinets or countertops show signs of delamination in noted areas. This could allow moisture intrusion or may not function as intended aesthetically. Recommend repair or replacement by a qualified professional.

Area of countertop is delaminating at sink in kitchen

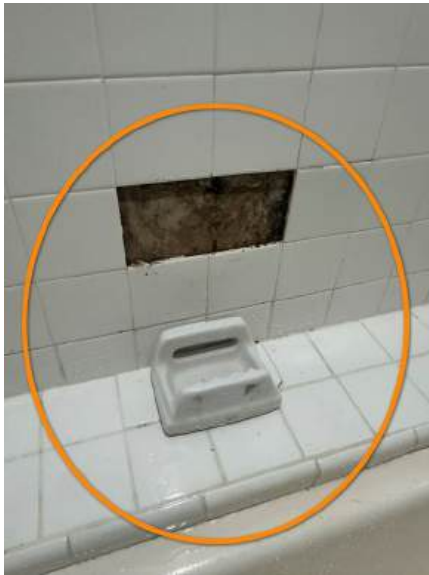
One or more fixtures, components, or Shower/Tub areas were damaged, missing, or detaching. This can hinder proper operation, allow moisture intrusion, or cause damage to surrounding components. We recommend a qualified contractor further evaluate to determine if moisture intrusion has occurred to components around fixture and to make appropriate repairs / replacements as needed.

Areas of tile are damaged / detaching and missing in lower level bathroom shower area

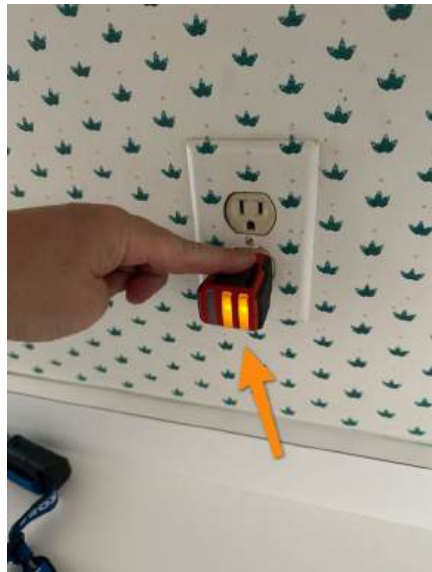
No GFCI protection present in one or more locations. This can contribute to electrical shock. Recommend licensed electrician upgrade by installing or repairing existing ground fault receptacles in all required locations.

No GFCi protection present in kitchen electrical receptacles

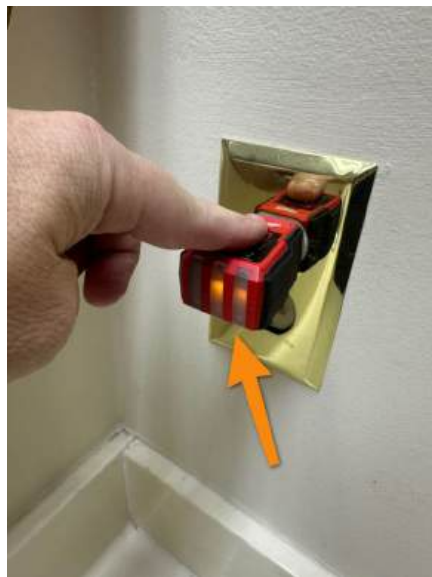
No GFCi protection present in main level hallway bathroom electrical receptacle

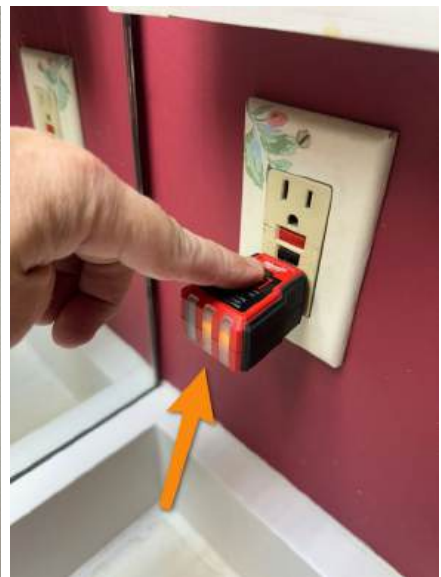
No GFCi protection present in main level primary bathroom electrical receptacle

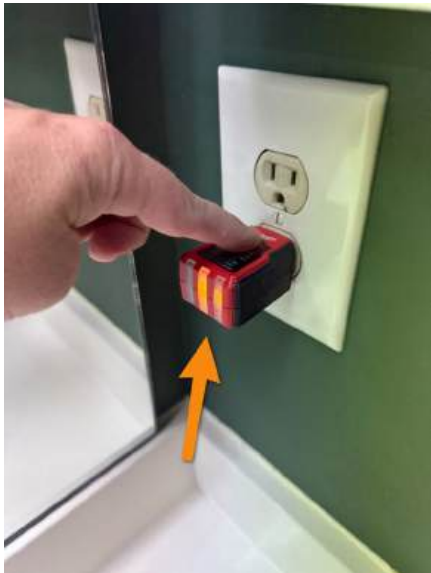
No GFCi protection present in lower level bathroom electrical receptacle

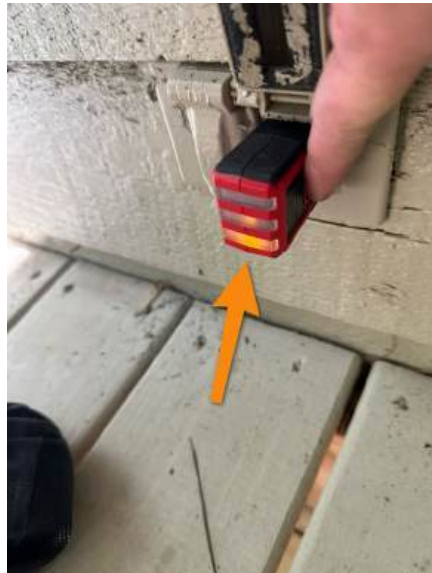
No GFCI protection in exterior electrical receptacles

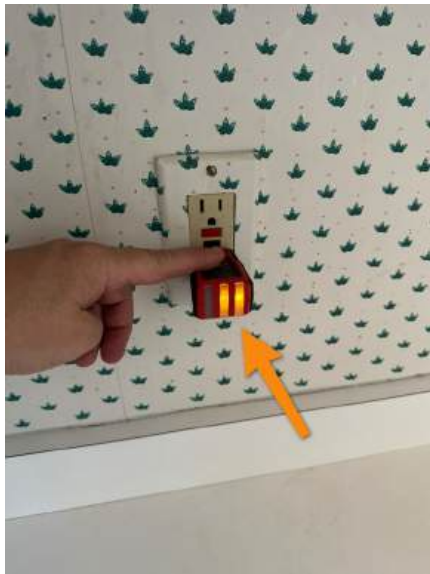
The GFCI receptacle in the did not work/trip off when tested at the time of inspection. This can cause a potential safety hazard and nullifies GFCI protection at all receptacles on the circuit. Recommend a qualified professional replace/repair as needed.

The GFCI receptacle in the did not work/trip off when tested at the time of inspection (Kitchen, left side)

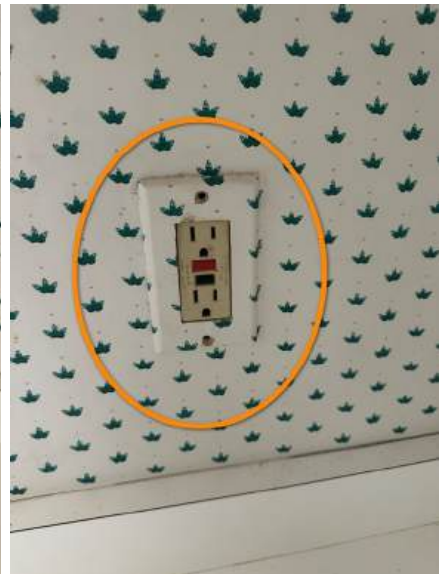
The GFCI receptacle in the did not work/trip off when tested at the time of inspection (Kitchen, right side)

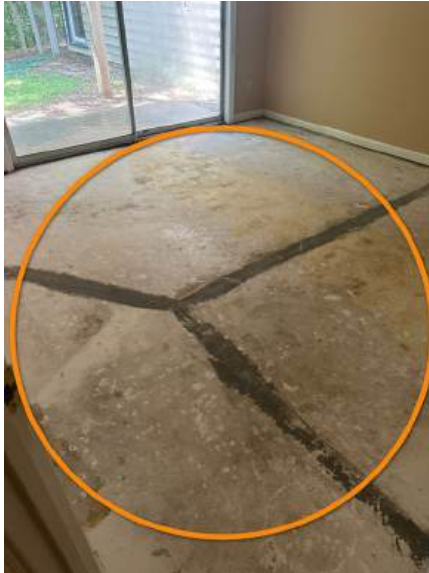
The interior foundation/slab flooring was cracked in noted areas. This can sometimes prevent proper installation of flooring, be noticeable once flooring is installed, or may indicate minor settlement in some scenarios. Recommend qualified professionals repair/seal as needed or further evaluation by a structural engineer if desired.

Interior foundation slab cracks observed in lower level right rear bedroom

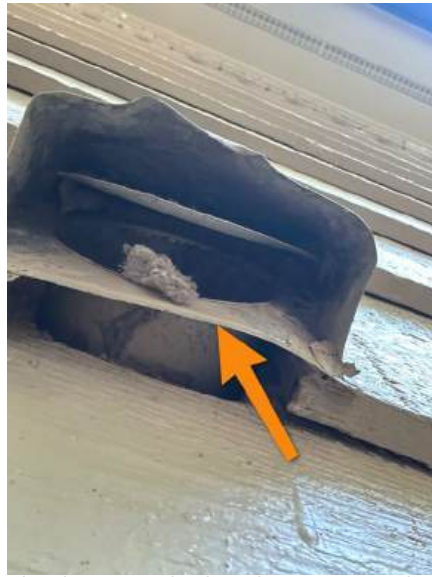
The dryer vent had lint built up on right side exterior of home. This can pose a fire hazard. Recommend a qualified contractor clean vents.

The dryer vent had lint built up on right side exterior of home
