Inspection report for the property at  
228 Kelso Ct, Cary, NC 27511

This report is prepared exclusively for **Sam Watson**  
Inspected On: **05-19-2026**

Matthew Betts, NCHILB #4129

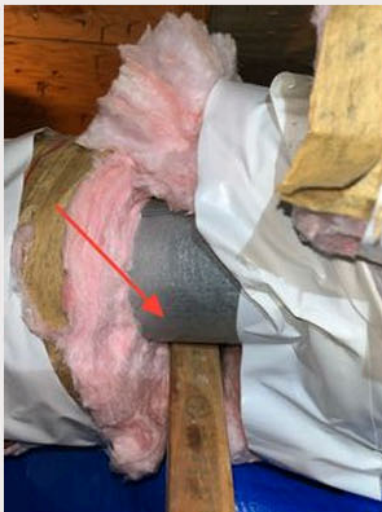
*Furnace flue contacts wood truss in the side attic*

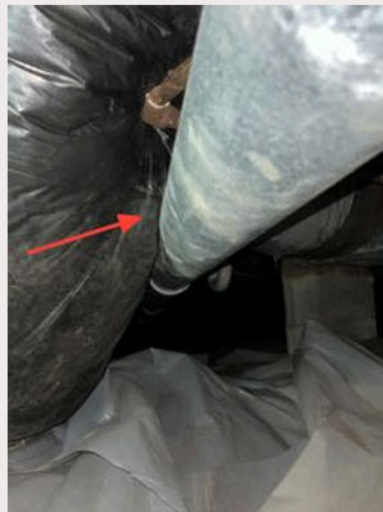
*Furnace flue contacts ductwork in the crawl space*
