EMB Home Inspections

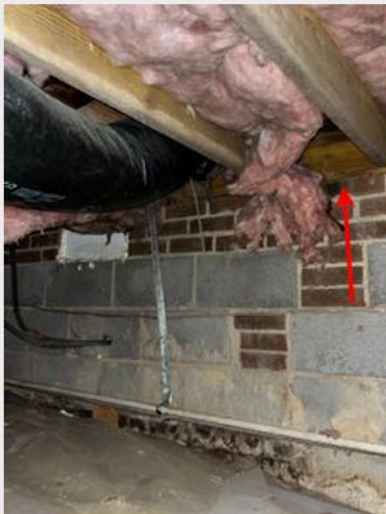
*Location*

✂ **SC-1** 🏠 **Structural Components - Floor Structure:** Water stains and localized areas wood rot were noted at the subfloor and band joist underneath the sliding glass door frames serving the living and master bedrooms at the rear side of the unit. Additional damage could occur if not corrected. A professional home maintenance specialist should **evaluate** this situation further prior to putting your home on the market and provide you with recommendations and estimates for any necessary repairs or improvements.

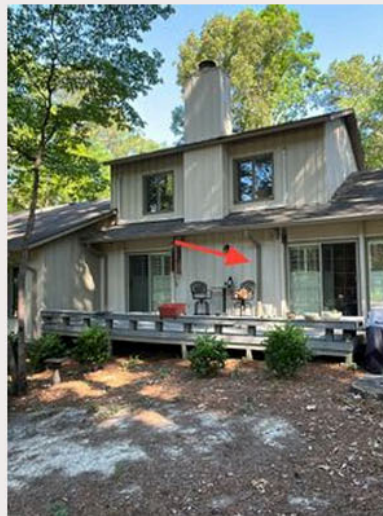
*Location*

✂ **RFCG-3** **Roof, Flashings, Chimney and Gutters - Roof Drainage System:** A downspout underneath the rear deck is clogged with organic debris and requires cleaning. This is important regular maintenance to ensure reliable drain paths off this roof. Clogged

gutters increase the risk of overflowing/leakage which can cause damage to components and moisture intrusion into the crawl space if not corrected. A professional home maintenance specialist or qualified person should make a simple **repair(s)** as necessary. Once cleared, be sure to have an extension installed to drain water four to six feet away from the foundation. Consult your home owners association regarding maintenance responsibility.

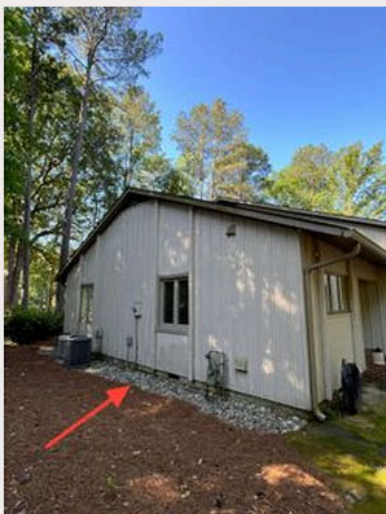
**Exterior - Grounds:** The grading is mildly reversed at the front side(s) of the unit. This may allow water to collect near the foundation rather than draining away. Proper grading requires the ground to slope away from the house at a rate of 1 inch per foot for at least the first 10 feet around the home's perimeter. Additionally, a minimum clearance of 6 inches between the soil level and the first course of siding is recommended. Insufficient grading increases the risk of moisture intrusion into the crawl space (or basement), as well as soil saturation or water ponding near the exterior, potentially leading to structural damage and other moisture-related issues. A professional landscaping contractor or home maintenance specialist should **evaluate** this condition before putting your home on the market and provide you with recommendations and estimates for any necessary repairs or improvements. Consult your home owners association regarding maintenance responsibility.

*Left side of unit (drainage system installed here)*

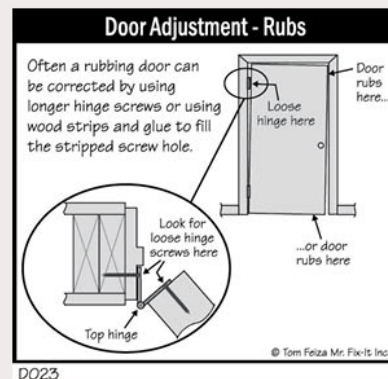
✂ **I-1 ■ Interior - Interior Doors:** Doors rub on the frame when closing. This condition risks damage if not corrected. A professional home maintenance specialist should evaluate this situation further and **repair** or **replace** as necessary.

*Closet door right rear bedroom door excessive*

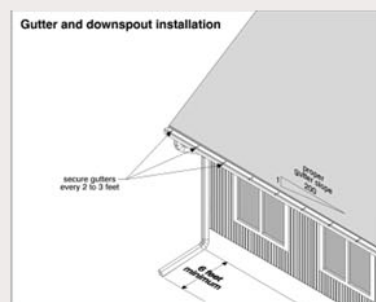
*Right front corner*

Downspouts discharging above grade at the front side of the building need extensions installed to carry water away four to six feet away from the building to reduce the risk of moisture intrusion and damage to components if not corrected. See an additional comment in the "Structural Components - Crawl Space" section of this report regarding efflorescence and dark stains on the foundation walls that is likely related to this issue. This is a simple **repair** for your information.

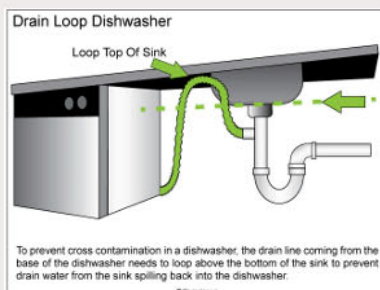
**BKA-1 Built-In Kitchen Appliances - Dishwasher:** The dishwasher drain line should be secured by an appliance technician or qualified person to ensure proper drainage to avoid cross-contamination from possible back siphoning of dirty water into the dishwasher. Low-hanging areas are not allowed. Simple **repairs** will correct this condition (see diagram).

*Elevate and secure*

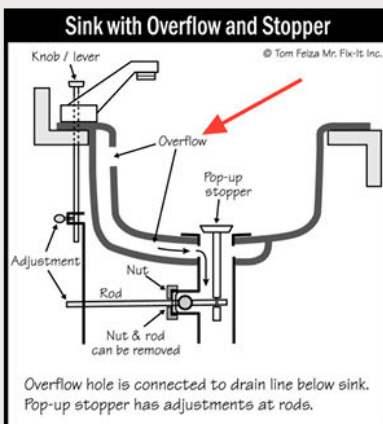
**PS-8** **Plumbing System - Fixtures:** Sink and bathtub overflow drains are not tested during a home inspection for liability reasons due to the risk of leaks and damage occurring to interior finishes. This is for your information. Consult with a licensed plumber for additional advice and testing prior to the expiration of your due diligence period if this issue is of concern to you.

*Overflow drains are not tested*

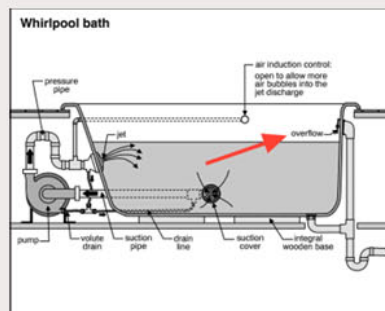
*Overflow drains are not tested!*

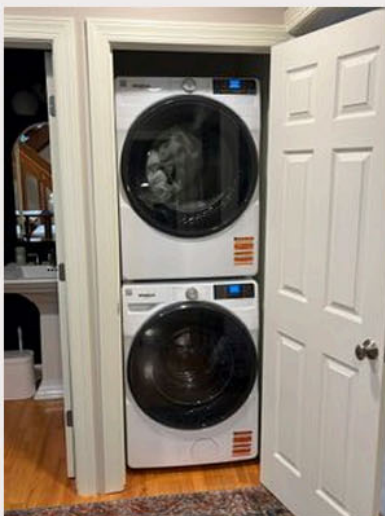
The stacked washer/dryer has been installed inside a closet, which means the hoses plumbing connections, waste connections and piping were not visible for inspection.

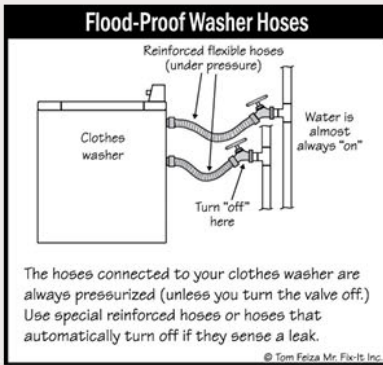
An inspection of washing machines and components (hoses) is outside the scope of this report. This is for your information. I recommend that you install "flood-proof" washer hoses. Information is readily available regarding these products. Refer to diagram.

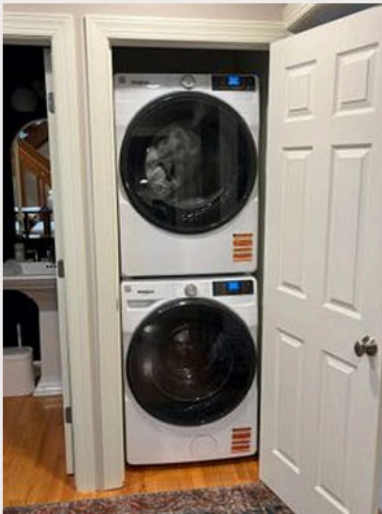
The dryer has been installed inside a closet, which means the electrical and vent connections were not visible.
