# ***CLB Home Inspections, LLC***

## **Home Inspection Report**

9208 Holly Springs Rd, Apex, NC 27539  
Inspection prepared for: Jon L'eplattenier & Rebecca Russell  
Date of Inspection: 6/26/2026 Time: 8:00 am  
Age of Home: 48 Years / Built 1978 Size: 1,964 sq ft

Inspector: James Gillie  
License #2741

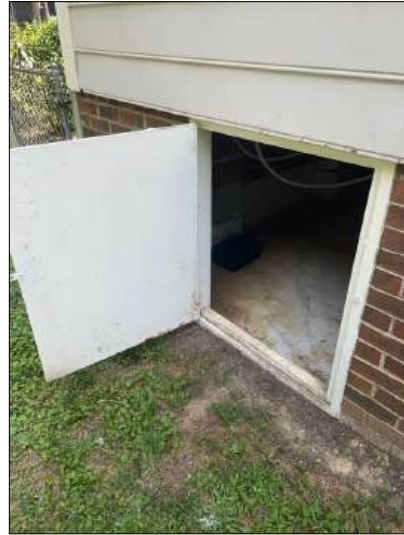
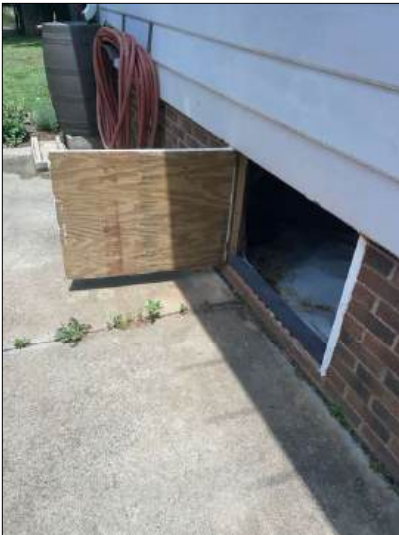
With a closed crawlspace, the access should be insulated and air sealed.

- See comments regarding the absence of insulation and air sealing of the crawlspace access panels, in the "Foundation/Crawlspace" section of this report, as well as in the "Summary" section.

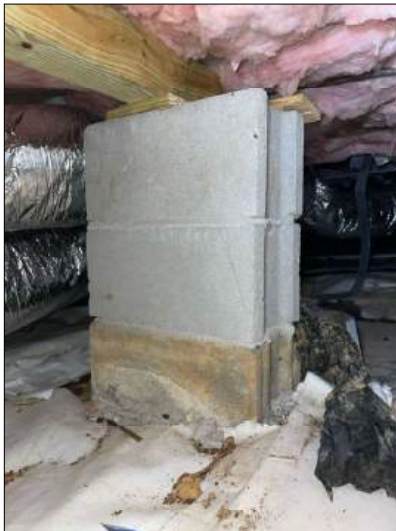
The addition of CMU piers and drop girders indicate foundation repair.

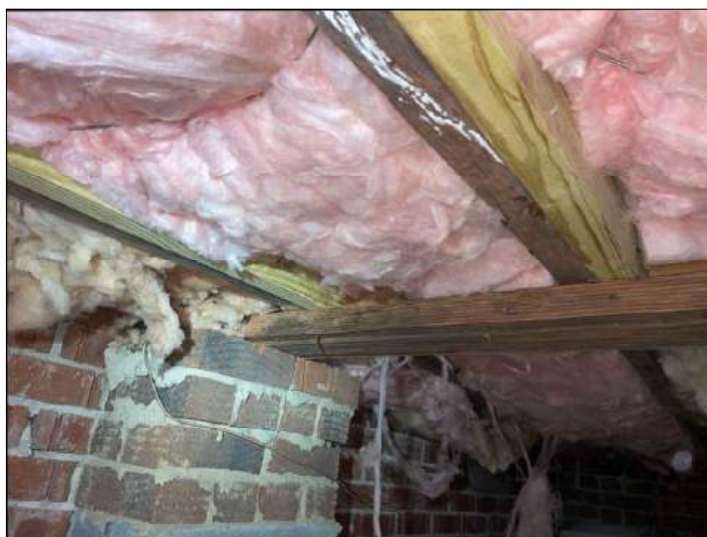
| Page 18 Item: 6<br><br>Remediated by RCS Crawlspace | Floor Structure | <ul style="list-style-type: none"> <li>There is sporadically located discoloration and light fungal growth on floor structure framing members and girders which indicates a history of periods in which the floor structure framing had elevated moisture levels. Elevated moisture levels encourage fungal growth and potential damage to the structural framing. A licensed general contractor who is experienced in foundation moisture control needs to evaluate and make recommendations as necessary. As decay of structural wood components is possible as a result of elevated moisture levels, a licensed general contractor should evaluate the structural framing and wood foundation components for damage, and make repairs/recommendations as necessary. When wood framing/interior components have surface discolorations and/or decay typical of growths such as mold, mildew, and wood destroying fungi, the home inspector is concerned with the moisture concerns and evidence of wood damage; however health related issues concerning mold are beyond the scope of the home inspection. If the buyer has additional concerns related to the presence of fungal growths such as mold, an industrial hygienst should be consulted.</li> </ul> |

Discoloration of the girder and on the bottom surface of the floor joist.

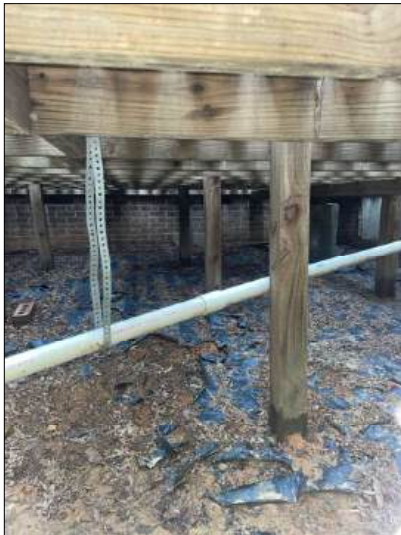
There are several supplemental support posts below the deck, which are commonly referred to as a stiff knee.

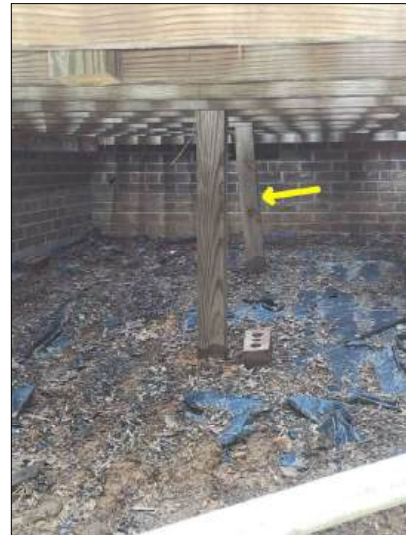
- There appears to be some level of wood decay at the base of deck floor structure stiff knee support columns. Rotted/decayed wood is a progressive problem that weakens the structural integrity of the columns, and will eventually lead to their failure. A licensed general contractor needs to evaluate and make repairs. Due to age, material and location similarities, it is probable that other wood foundation support columns have experienced a level of decay that can compromise their structural integrity as well. As such, the attending contractor should evaluate all sides of all deck related columns, and make repairs/recommendations as necessary.

The stiff knee support is leaning

| Page 28 Item: 11<br><br>New beams and new footings installed on 7/25/26 | Deck Columns | <ul style="list-style-type: none"><li>• There appears to be some level of wood decay at the base of deck floor structure stiff knee support columns. Rotted/decayed wood is a progressive problem that weakens the structural integrity of the columns, and will eventually lead to their failure. A licensed general contractor needs to evaluate and make repairs. Due to age, material and location similarities, it is probable that other wood foundation support columns have experienced a level of decay that can compromise their structural integrity as well. As such, the attending contractor should evaluate all sides of all deck related columns, and make repairs/recommendations as necessary.</li></ul> |

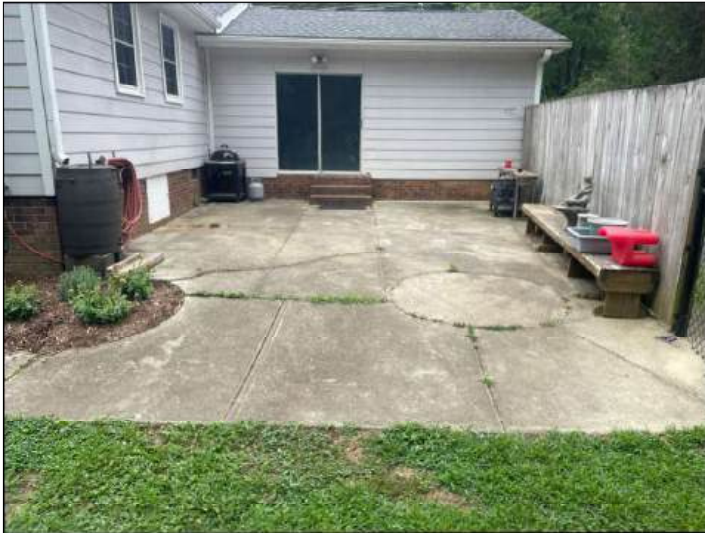
The patio

- There is a concrete patio located at the rear side of the house.
- There is cracking in the patio. The cracks should be sealed in order to deter water penetration, which can wash away and/or shift soil under the slab, thereby further encouraging patio slab stress. Moreover, the most significant crack has translation. As such, the standing edge presents a safety concern. A licensed general contractor or otherwise qualified repair contractor needs to evaluate and make repairs as necessary.

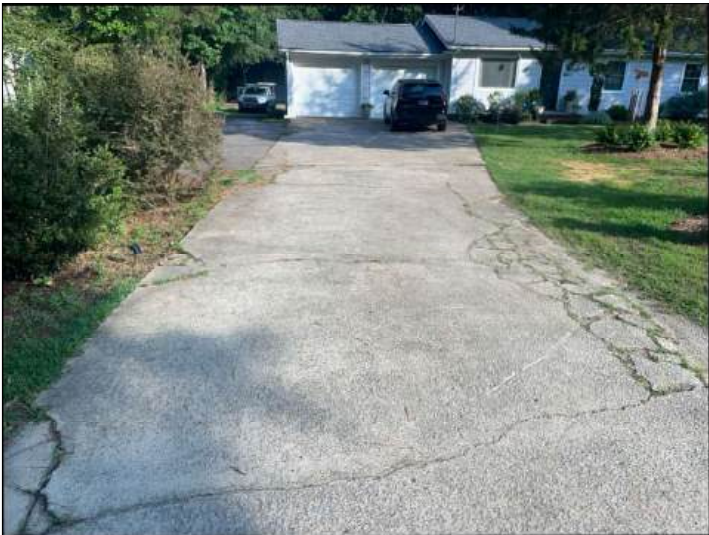
• The concrete driveway has areas that are broken into a myriad of small pieces. This results in many gaps through which water penetration occurs, primarily during rainy weather conditions. Water penetrating through the driveway saturates the soil below the driveway, thereby reducing the bearing capability of the soil, and subsequently encouraging sinking of the driveway. This should be considered to be a progressive problem, as sinking of the driveway results in low areas at which further water puddling occurs. I recommend evaluation by a qualified concrete contractor.

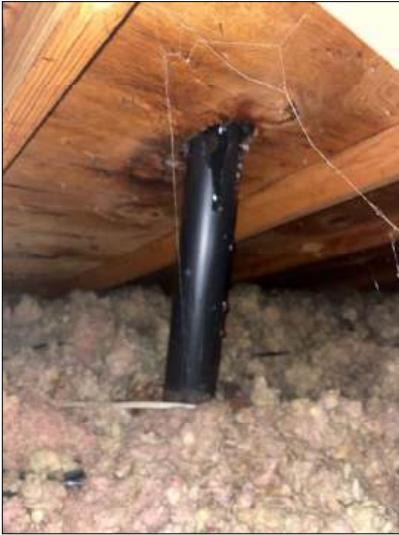
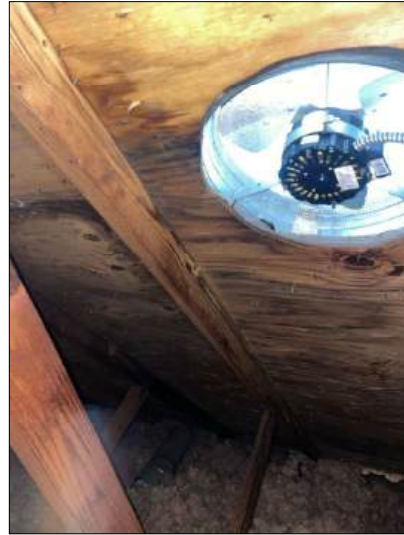
• There are a few spots of discoloration; including wood decay damage next to a plumbing vent pipe roof penetration in the main attic. The stained areas appear to be due to water penetration into the building envelope. Water penetration is harmful, in that it can cause damage to structural framing, as well as promoting undesirable environmental conditions, and stained interior finished surfaces. A qualified roofing contractor, or licensed general contractor needs to evaluate and repair the source of the leak as well as the damaged area(s).

The discoloration is indicative of water exposure to the roof structure.

| Page 36 Item: 3<br><br>Inactive, old stain only. Moisture reading showed dry spot. | Roof Structure | <ul style="list-style-type: none"> <li>There are a few spots of discoloration; including wood decay damage next to a plumbing vent pipe roof penetration in the main attic. The stained areas appear to be due to water penetration into the building envelope. Water penetration is harmful, in that it can cause damage to structural framing, as well as promoting undesirable environmental conditions, and stained interior finished surfaces. A qualified roofing contractor, or licensed general contractor needs to evaluate and repair the source of the leak as well as the damaged area(s).</li> </ul> |

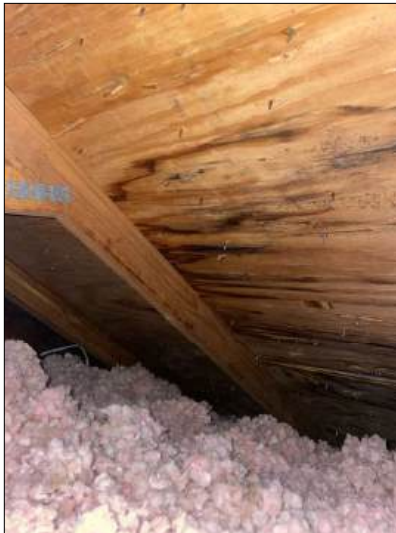
Roof structure discoloration located adjacent to the attic access ceiling scuttle, above the primary bedroom closet.

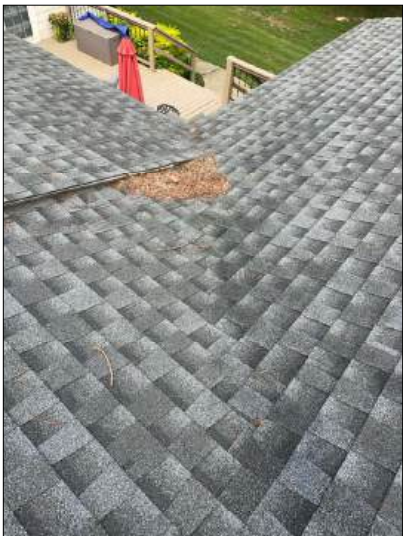
The roof valleys on this home are configured as woven. Roof valleys should be kept clear of organic debris.

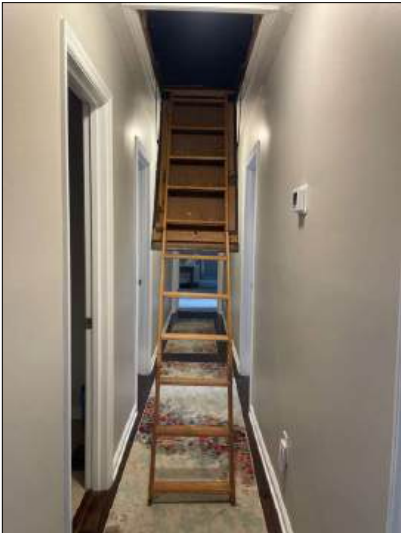
The main house attic access

• The attic access is generally a weak point in the efficiency of the home as this is where much of the conditioned air in the home is lost. As such, the attic pull down stairs should be insulated. Take care so that installed insulation does not encroach onto the ladder treads, as this can result in poor footing when moving up and down the ladder. An alternative to fiberglass batt insulation, is the use of rigid foam (styrofoam) insulation panels which can be cut to fit as necessary.

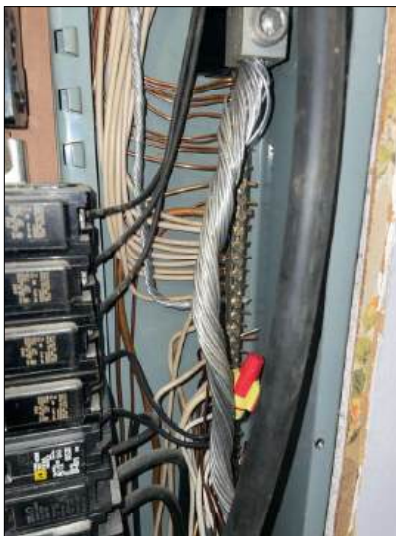
• Although the electrical system is grounded, as evidenced by ground bus connections in the main panel enclosure, I unable to locate the buried service ground.

Ground connections in the panelboard

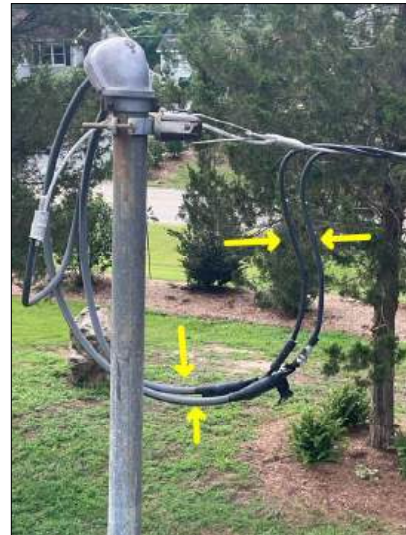
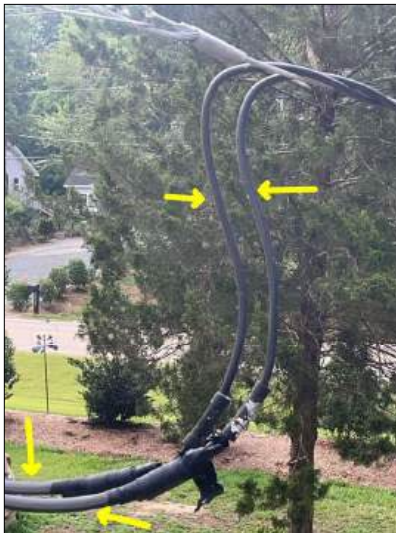
• The service entrance conductors from the transformer/power pole to the roof mounted mast head, are smaller than the service entrance conductors from the mast head to the electrical service meter. Although the service cables from the mast head to the main panelboard are sized at a 200 amp capacity, and the main breaker is rated at 200 amps, the cables from the power pole to the mast head appear to have a capacity that is less than 200 amps. Mismatched conductor size can result in overheating and subsequent electrical malfunction. The electrical service provider needs to evaluate and make repairs/recommendations as necessary.

There is an obvious gauge size difference between the conductors that are fed from the street, and the conductors that are fed to the panelboard.

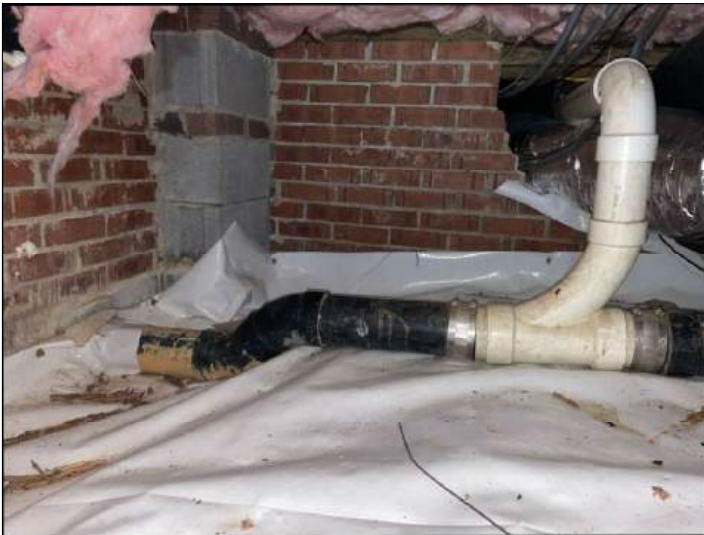
• The plumbing drain system in this home includes connections of ABS to PVC piping. While both pipe materials are poly (plastic) based, they are made up of differing materials. PVC is Polyvinyl Chloride and ABS is Acrylonitrile Butadiene Styrene. As such, the pipes expand and contract at different rates. Subsequently, leaks can occur at these glued connections. The preferred industry accepted practice is to mate these two different pipes by using a rubber based coupler, which is clamped to each pipe. I recommend periodic monitoring in order to ensure that leaks do not develop. You may wish to have an evaluation by a licensed plumber, who should then make recommendations as necessary.

The main waste line exits the home envelope as ABS, at the rear side right of the left crawlspace.

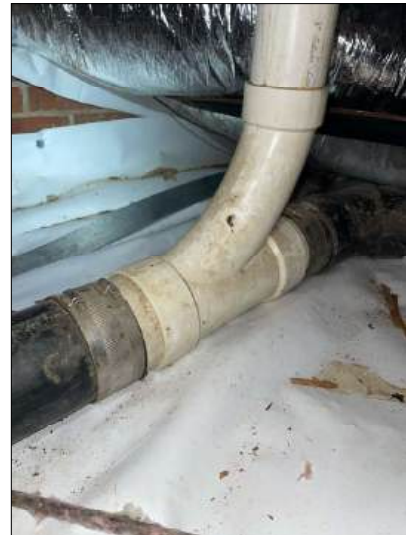
This photo shows the proper mating of PVC to ABS pipe, using coupler fittings.

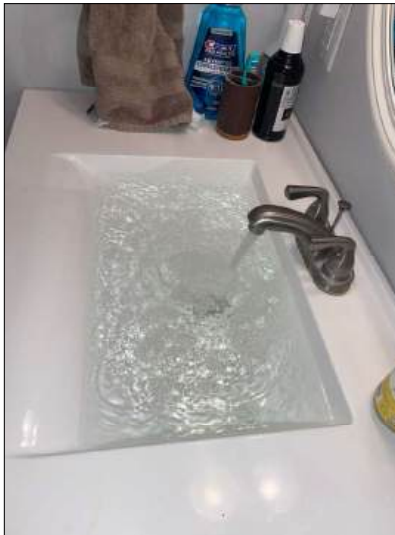
- There are sinks in this home are NOT equipped with overflow drains. The purpose of sink basin overflow drains are to prevent or minimize water dumped onto the floor in the event that the sink user becomes distracted and leaves the sink fixture running (flowing water). Water that is left flowing to the point that it overflows the basin, is then dumped onto the adjacent floor. This can result in water related damage to the floor structure, finished floor, the base of walls on the same floor level, walls below the basins, and finished surfaces below the sinks. When filling these basins with water, it is best to remain vigilant and within the same room as the sinks.

Be mindful when filling any sink that is not equipped with an overflow drain.

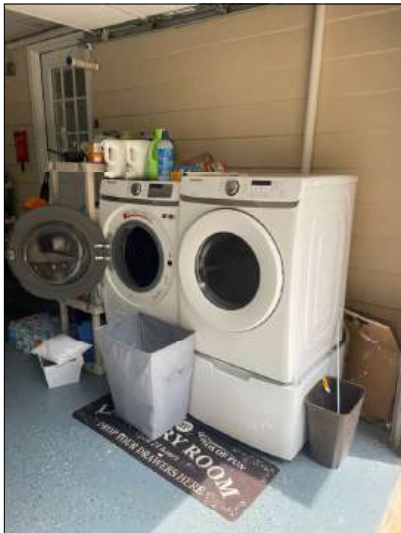
The laundry is in the garage

• As a preventative measure, the rubber clothes washer water supply hoses should be replaced with stainless steel braided flex hoses. Rubber clothes washer hoses have a considerably higher likelihood of failure, due to rupture. As the laundry water supply valves are typically left on, these hose are constantly under pressure from the water. This means that a ruptured hose is going to eject water at a rapid pace, until the valve(s) is shut off. If the rupture occurs while is home is vacant, considerable damage to both structure and interior building components will be the likely result. Stainless steel braided flex hoses are much stronger, and as such are much less likely to rupture. All laundry hoses, whether rubber, stainless steel braided flex, or poly braided flex should be inspected periodically. If any blisters, bubbles, tears, or other discrepancies are noted, the laundry valves should be immediately turned off and both hoses replaced.

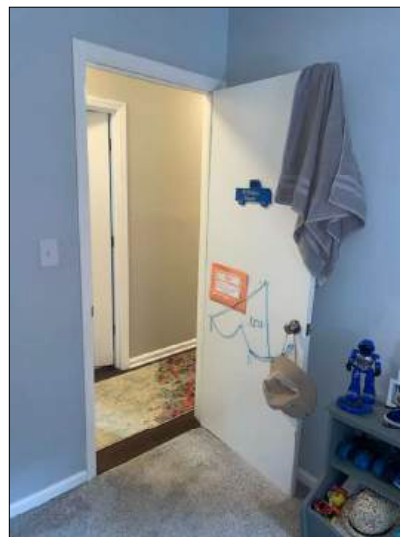
The entry door for the rear middle bedroom drags on the carpet, and contacts its frame.

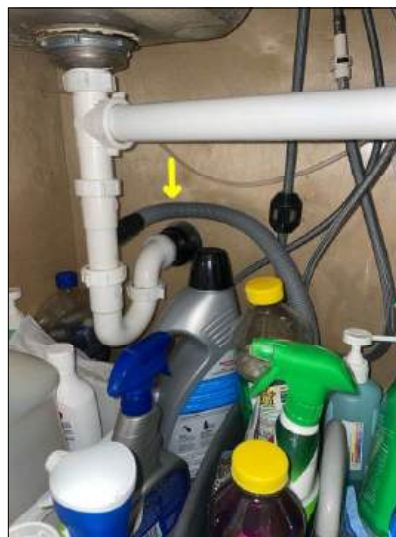
The dishwasher drain line should be configured with a high loop.

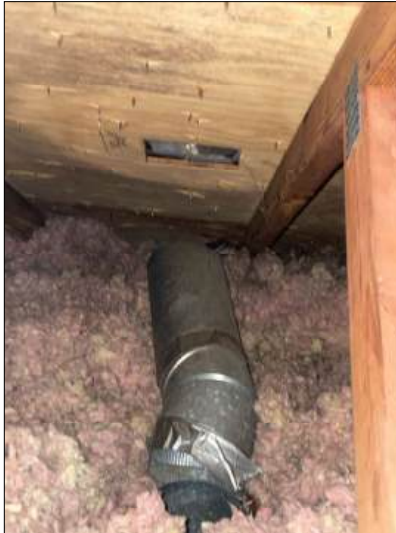
- The direct vent exhaust duct is disconnected in the attic. This results in smoke and grease deposits being discharged into the attic, upon use of the exhaust hood. A licensed general contractor or otherwise qualified repair contractor needs to evaluate and make repairs.

The direct vent exhaust duct is disconnected, in the attic.
