Stonewall Structural Engineering, PLLC  
Raleigh Office  
9203 Baileywick Rd. #200  
Raleigh, NC 27615  
(919) 407-8663

Re: Structural Observation — 202 Briardale Avenue, Cary, NC 27519

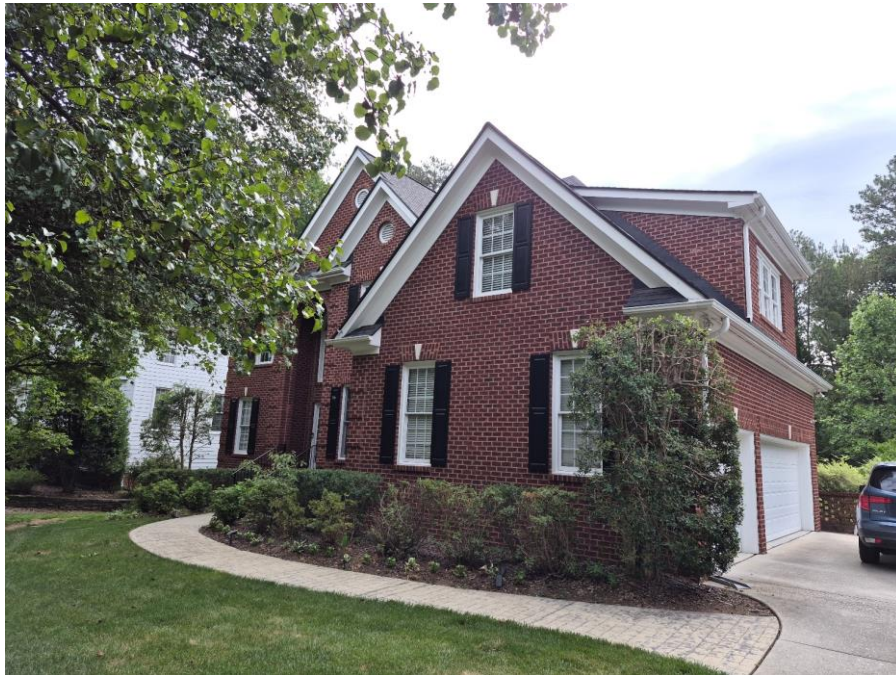
*Picture 1 – 202 Briardale Avenue, Cary, NC 27519*

At your request, on June 15, 2026 we performed a visual structural observation of foundation cracks at the Cary residence noted above. The structure is a conventionally framed, detached, single family residence with raised first floor framing over a partial walk-out basement and partial pier/girder foundation system with perimeter masonry foundation walls (*see picture 1*).
