# Inspection Report

**Property Address:**  
104 Bergeron Way  
Cary NC 27519

**Fuster Home Inspections, LLC**

| <b>Date:</b> 8/20/2026 | <b>Time:</b> 08:30 AM | <b>Report ID:</b> AB082026-1 |

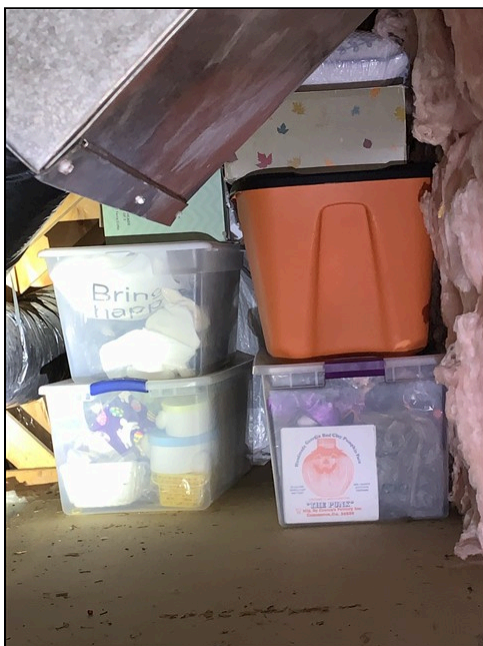
(2) **Limitation:** Attic area to rear of third floor viewed from opened access doors using a standard flashlight but not fully entered due to HVAC equipment blocking passage and visibility. Attic areas to right front of third floor (viewed from rear) and at left rear viewed from opened access doors using a standard flashlight but not fully entered due to stored belongings blocking passage and visibility. Attic area to right of third floor viewed from opened access panel using a standard flashlight but not fully entered due to lack of clearance and flooring. Attic areas not fully inspected.

4.6 Item 2(Picture) Stored belongings block full access to some attic areas

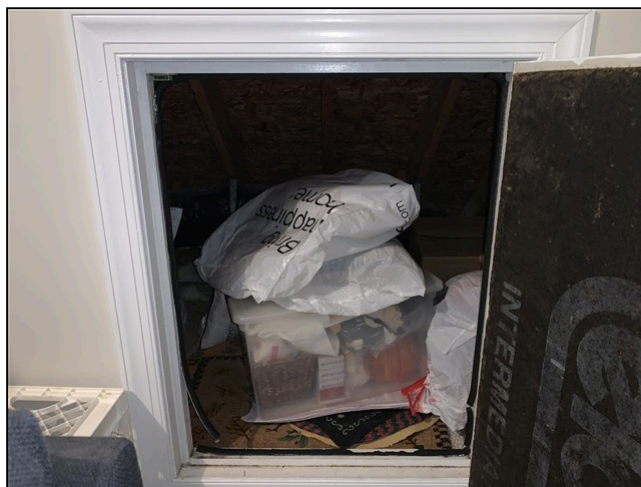
4.6 Item 3(Picture) Stored belongings block full access to some attic areas

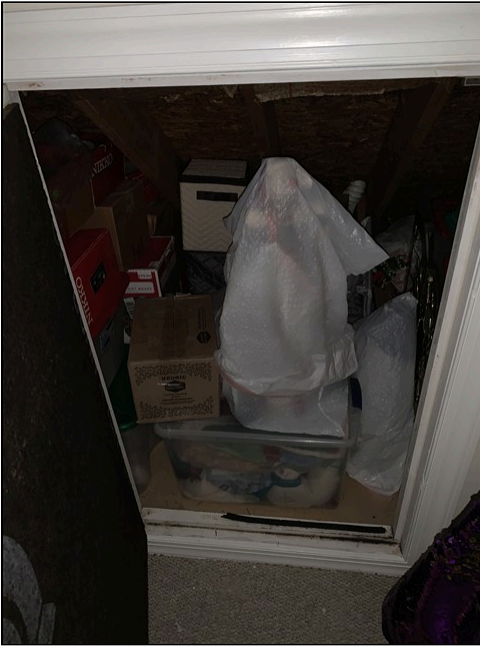
4.6 Item 4(Picture) Stored belongings block full access to some attic areas

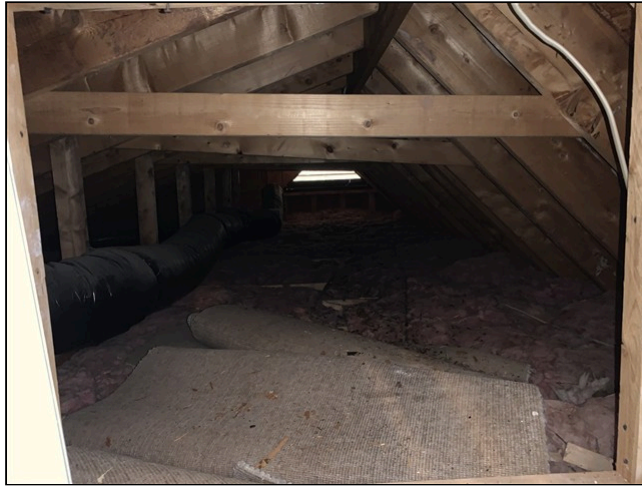
4.6 Item 5(Picture) Attic area to right of third floor not entered due to lack of clearance and lack of flooring

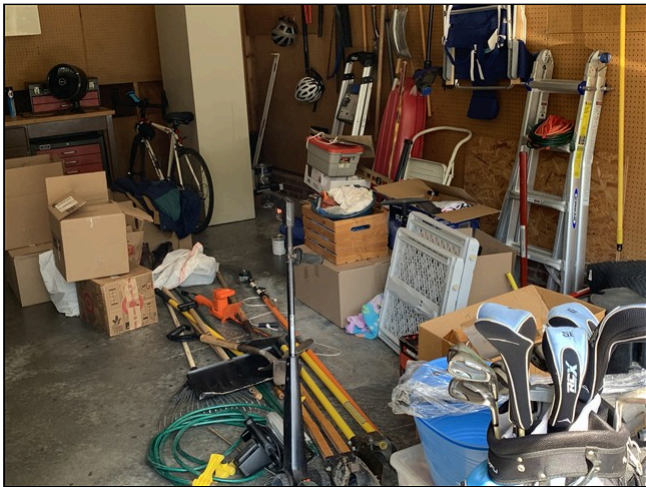
9.5 Item 2(Picture) Belongings in garage block full view of area
