# Property Inspection Report

**Report Number: T0273**

534 Siltstone Place  
Cary, North Carolina 27519

Date of Inspection: Monday, April 27, 2026

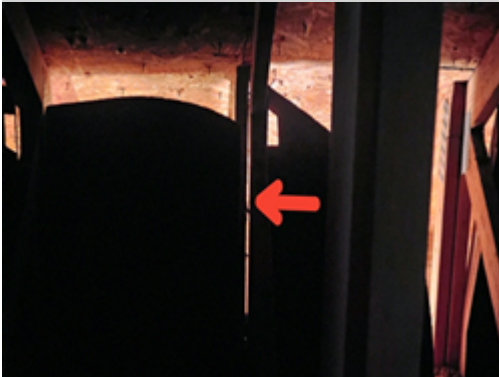
**(A1 - 1.8 ) All Accessible Areas**

5. Cracked truss at front left upper attic.
6. Gaps/separation noted where walk in attic trusses meet upper attic trusses and at 2 ply truss member next to upper attic access

Additional photo of gaps between truss members

Have evaluated by a structural engineer to determine the significance of the concern, effect on the home, and formulate a repair plan as needed. Any needed repairs should be completed by a licensed general contractor.

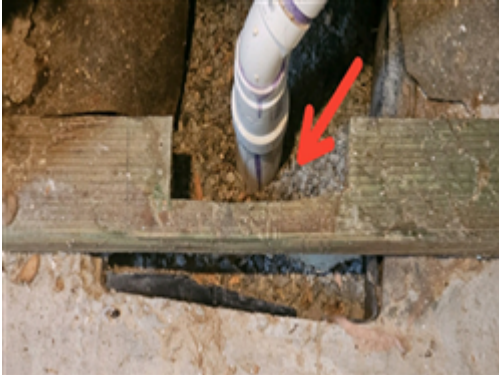
#### **(A4 - 1.1) All Interior Areas**

Sill plate is notched more than typically expected at tub waste line in the basement. Have evaluated by a licensed general contractor to determine the significance of the concern and repair as needed to prevent failures.

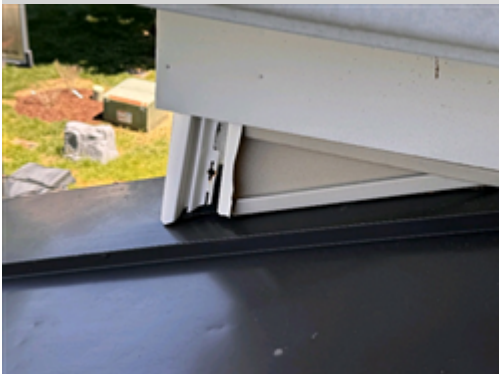
**(B1 - 1.3 ) Main House**

The following was noted at the wall cladding/trim:

1. Front left corner trim damaged
2. Loose siding trim noted above front porch roof (left side). (Pictured)

Have repaired by a siding professional to prevent water penetration.
