Re: Limited Structural Inspection  
534 Siltstone Place  
Cary, NC

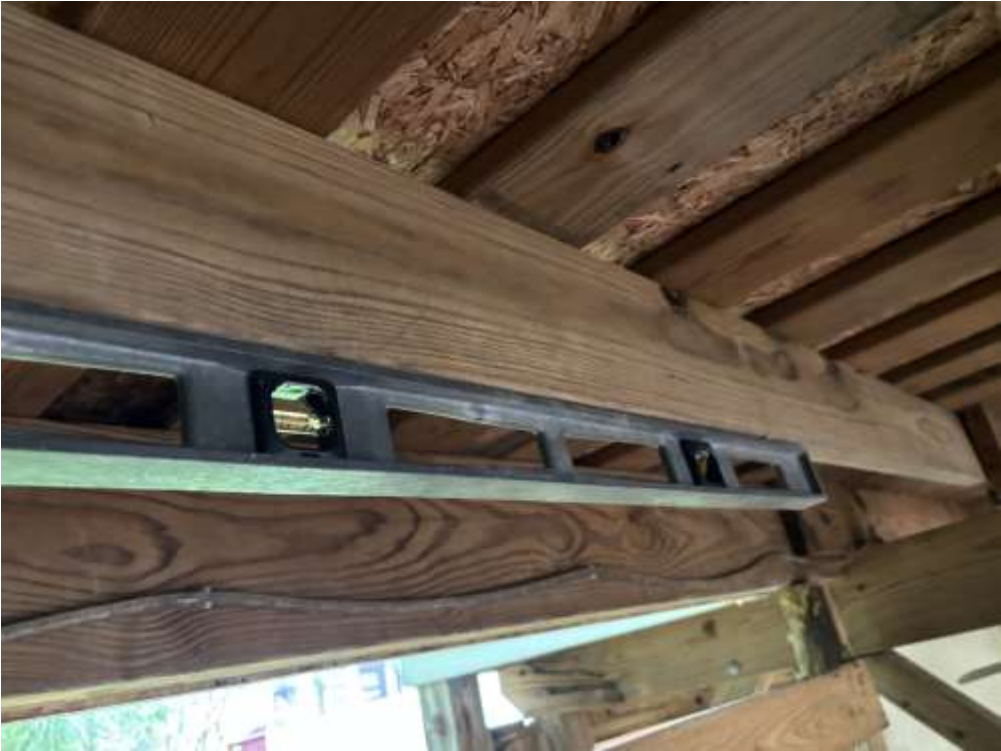
| <p><b>Photo No.</b></p> <p>7</p> | |

| <p><b>Description</b></p> <p>View of slope on the underside of the deck joist.</p> | |

2. We recommend consulting with a structural engineer to perform further evaluation of the deck structure to address the noted concerns in Observation #10 (i.e. lateral bracing, damaged framing, framing bearing concerns, sloped framing). Further evaluation will likely involve soil excavation and selective removal of the finish materials.
