Re: Limited Structural Inspection  
205 Bethabara Lane  
Cary, NC

At your request, a limited structural inspection of the above property was performed on July 7, 2026. The report that follows has been prepared based on that inspection. The inspection was performed by Collin Vaughan, EI of Giles Flythe Engineers.

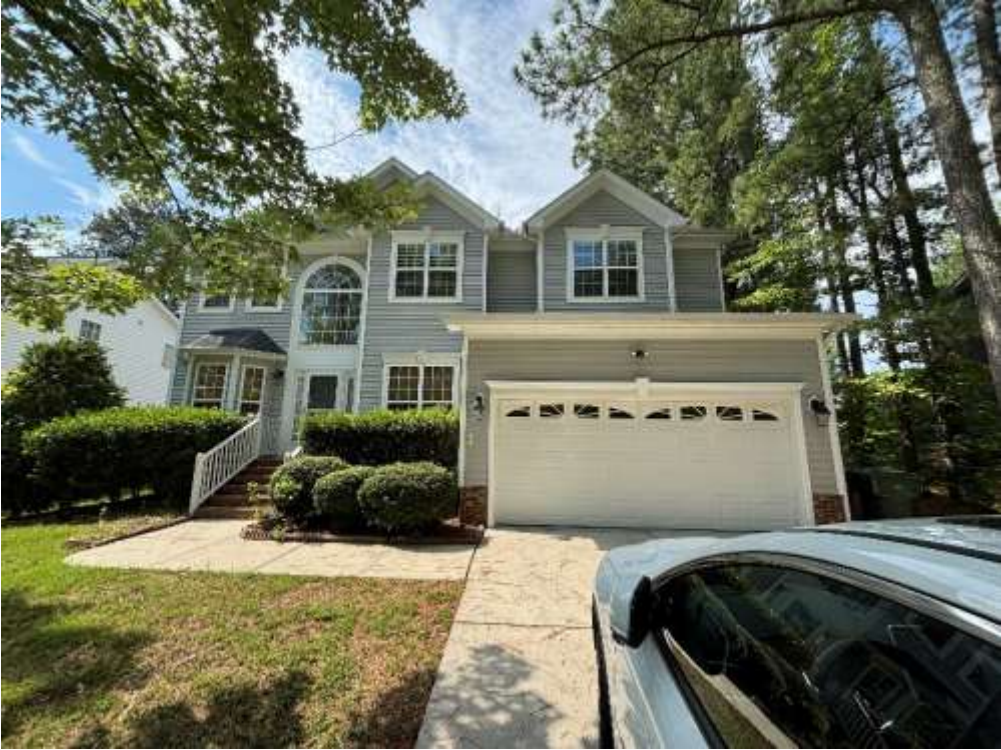
| <div><div>Photo No.</div><div>1</div></div> | |

| <div><div>Description</div><div>General view of the front of the home (for reference).</div></div> | |
