## PROPERTY DISCLOSURE ADDENDUM

PROPERTY ADDRESS: 8433 Whisper Ridge Place  
CITY/STATE/ZIP: Raleigh, NC 27613

# Worldwide ERC® Relocation Property Assessment

**Property Address: 8433 Whisper Ridge Place Raleigh NC 27613**

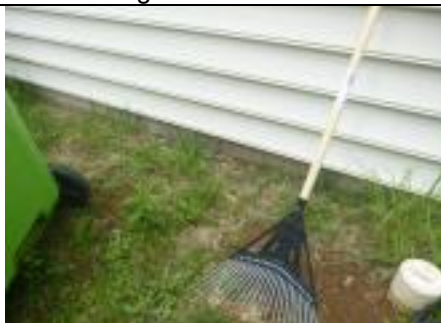
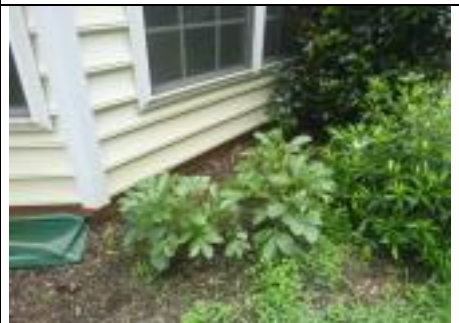
| LIMITED ACCESSIBILITY/NOT ASSESSED |
|---|
| (S) 1 Foundation: Limited evaluation of the structure due to furniture/furnishings (25% visible). |

Slab Foundation

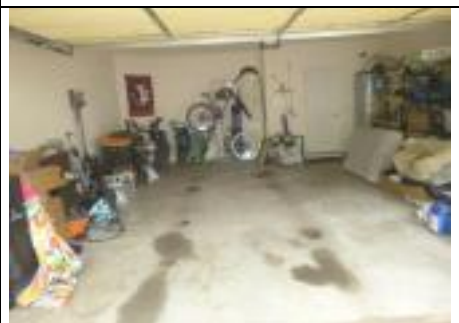
| LIMITED ACCESSIBILITY/NOT ASSESSED |
|---|
| (G/C) 4 Condition: Please Note: Previous repairs were observed to the garage floor. Recommend obtaining all relevant documentation regarding repairs.<br><br>Limited evaluation of the garage due to storage (90% visible). |

Garage Storage

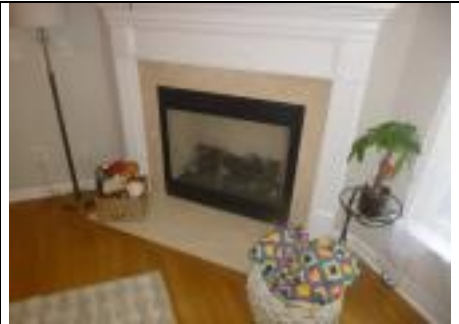
Pilot Does Not Light
