## HOME INSPECTION REPORT

Luis Turner Inspections, LLC

633 Grace Hodge Drive

Cary NC 27519

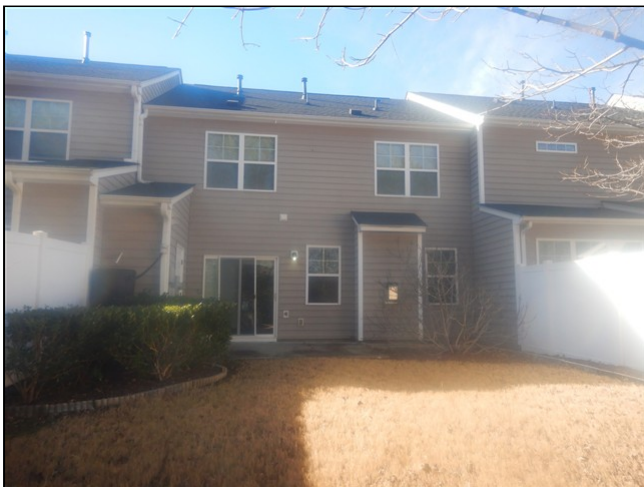
2.0 Item 6(Picture) Rear of house

(3) An exterior perspective photograph is provided below to show the rear of townhome at time of inspection. This comment is for your information.

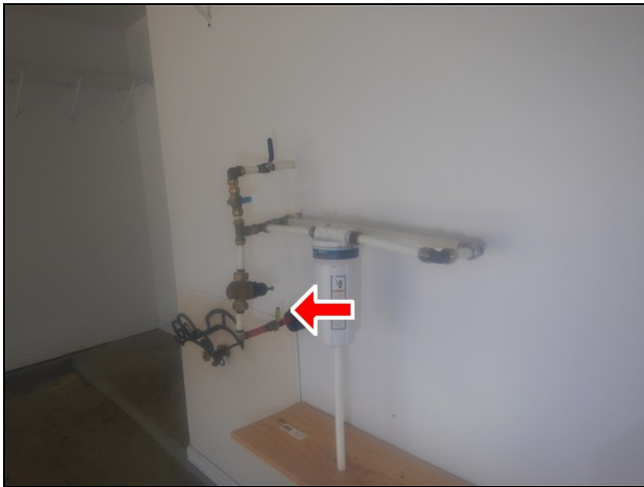
4.2 Item 1(Picture) Main water shut off valve

(1) The main water shut off valve is located at rear wall of garage. See photograph below.

(2) The main water shut off valve at rear of garage was found to be in the closed position at beginning of inspection. The valve was returned to the closed position at end of inspection. This comment is for your information.

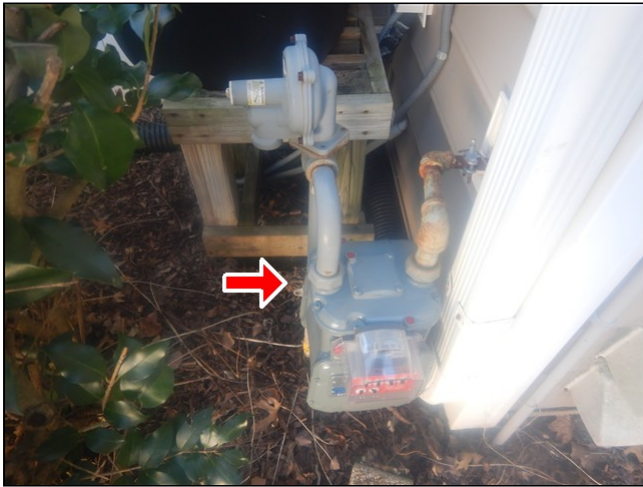
4.8 Item 1(Picture) Main natural gas shut off valve

The main natural gas shut off valve is at the gas meter. See photograph below.

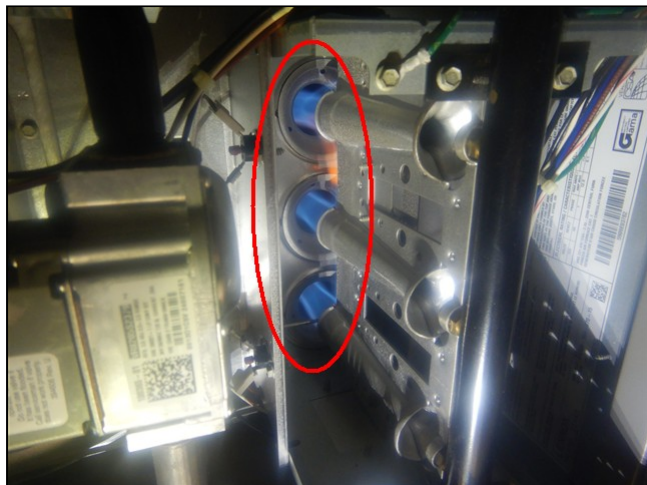
6.1 Item 3(Picture) Blue flames
