**Geological and Geophysical Investigation  
Ronald Gary Strickland Testamentary Trust  
Granville County, North Carolina**

**INTRODUCTION**

**Purpose**

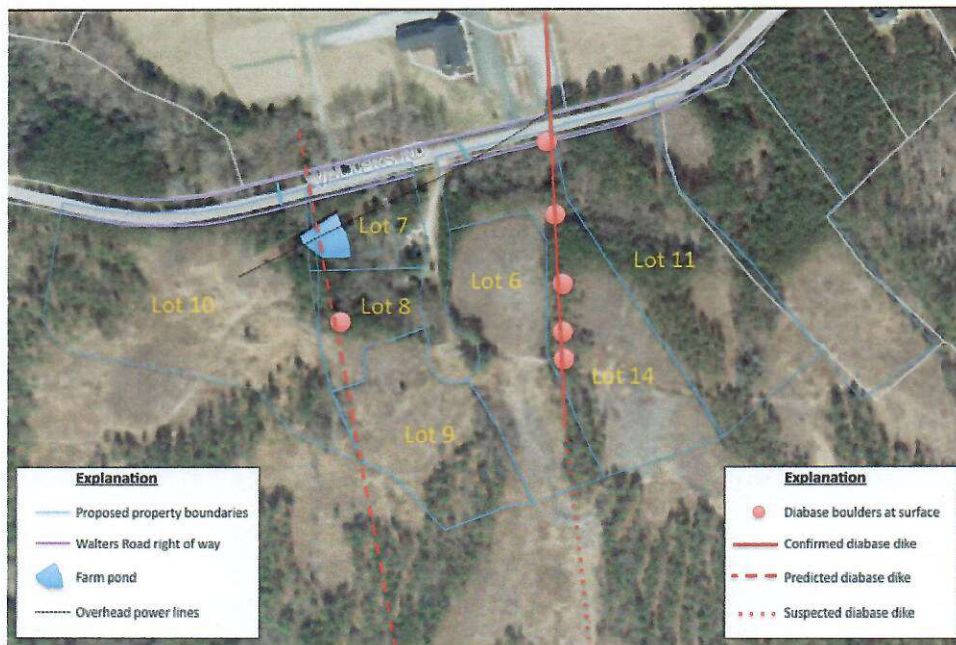
**Figure 3. Partial view (a: overview; b: detail) of proposed subdivision lots showing approximate location of confirmed dike (solid red line) and possible dike (dashed line). Photographic base is from Granville County GIS Services.**

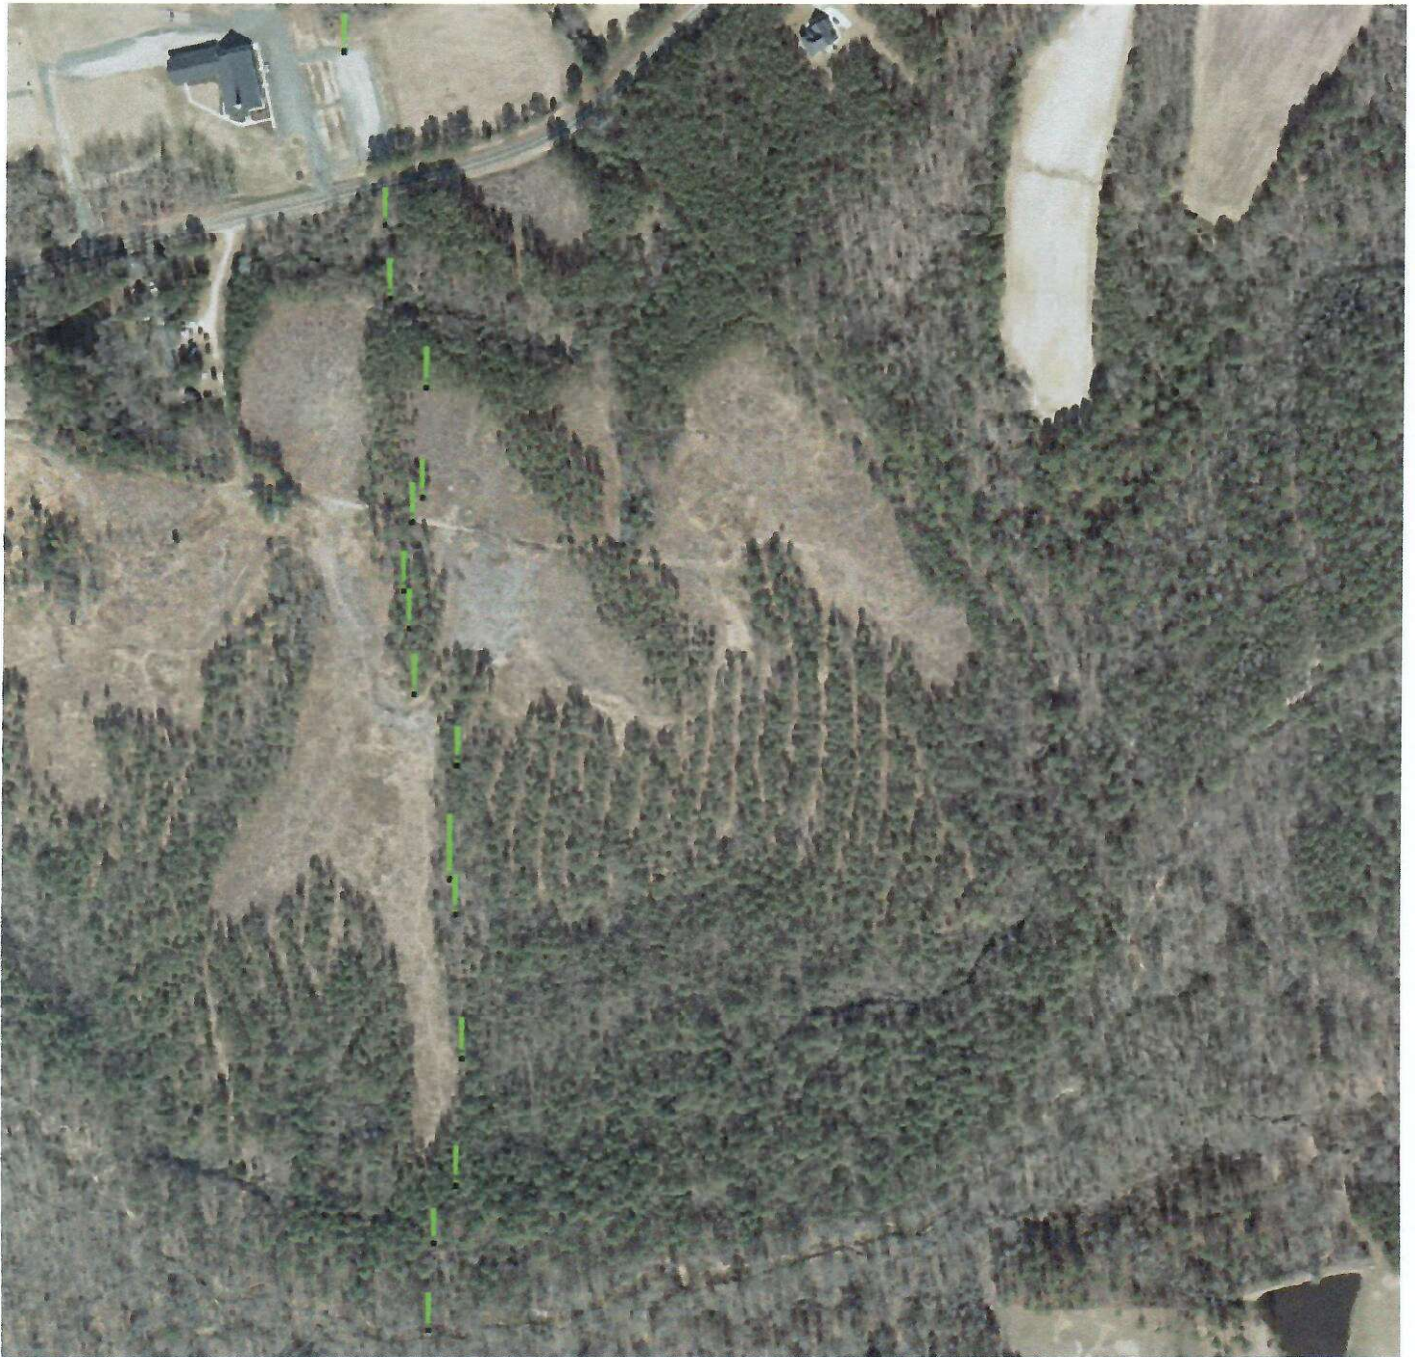
**Figure 7. Locations of magnetic highs along the dike from Walters Road south to the big creek. Locations are at the base of each mark; locations of the two wells are also shown. They are flagged in the field. The Appendix contains GPS coordinates. The dike strikes approximately  $355^{\circ}$  and dips west at about  $85^{\circ}$ .**

In early 2013, a well was drilled just south of Walters Road on the confirmed dike. Its reported yield was exceptionally high compared with other wells in the area. Then, in April 2013, the magnetometer was used to locate and map the confirmed dike with more precision. It was traced in detail all the way south to the big creek. Figure 7 shows the location of the magnetic highs that were measured, and they are flagged in the field. (Appendix C shows the GPS coordinates of these points.)

**APPENDIX C:** GPS coordinates of magnetic highs recorded to trace dike (Figure 7).

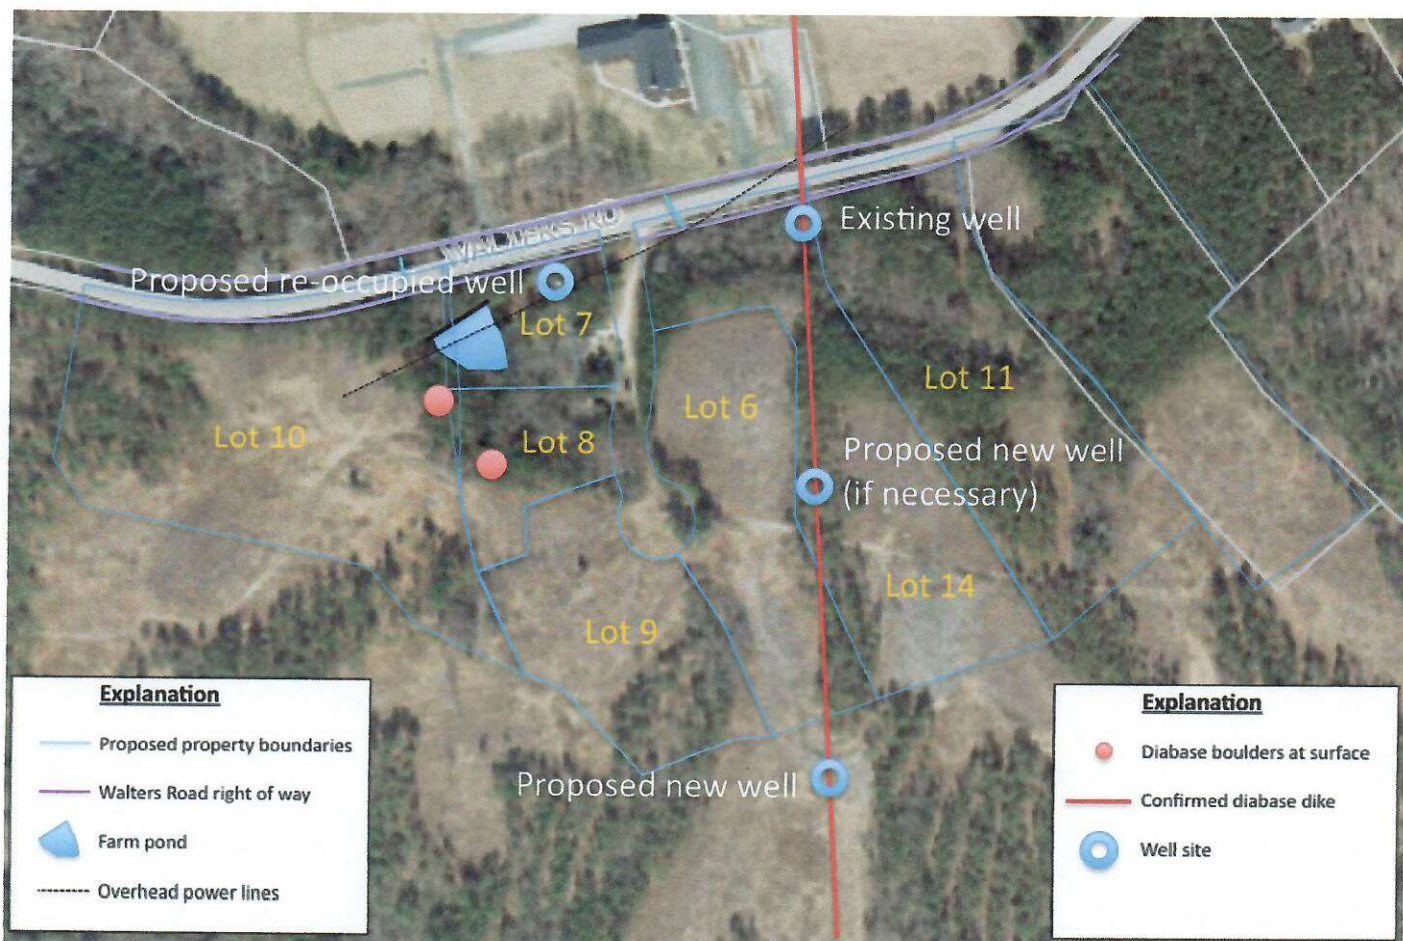
**Figure 12. Schematic map of proposed well locations**

We recommend that a well be drilled along the dike near the southern edge of the subdivision property, possibly south of the southern boundary of Lot 6. We also recommend that the old trailer well be re-occupied. If both of these wells give good yields (say 20 gpm or more), then this may be sufficient to serve all lots. If another well is needed, it could be drilled along the dike halfway between the existing well and the proposed southern well. Figure 12 shows the locations of the proposed wells. If these wells cannot supply the needs of the westernmost parts of the property (Lot 10 for example), then perhaps additional magnetic prospecting could be conducted in the west in search of another possible dike related to the diabase occurrences shown near the western edge of the area, as shown in Figure 4.
