Ambassador Inspections  
Brennan Smith  
[BrennanSmith2896@outlook.com](mailto:BrennanSmith2896@outlook.com)  
Brennan Smith: 984-255-3633  
Robert Smith: 919-339-5633  
PO Box 337  
Bunn, NC 27508

| Property Address | |
| Street: | 1101 Heritage Dr |
| Location of Septic Tank and Septic Tank Details | |

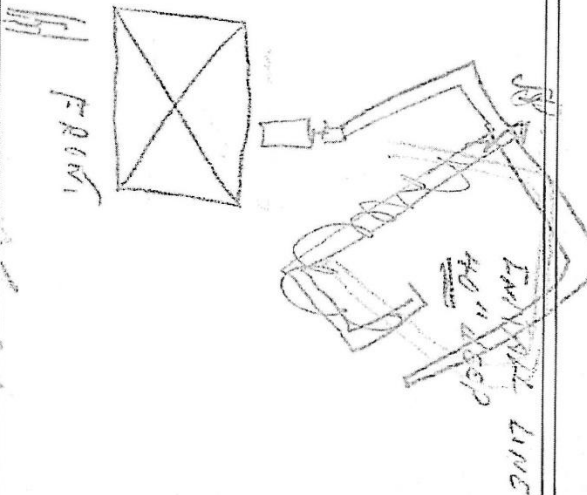
WAKE COUNTY HEALTH DEPARTMENT  
SEPTIC TANK LAYOUT AND PERMIT

SIZE OF TANK

*900*

NITRIFICATION LINE

*6.4 x 150' 900*

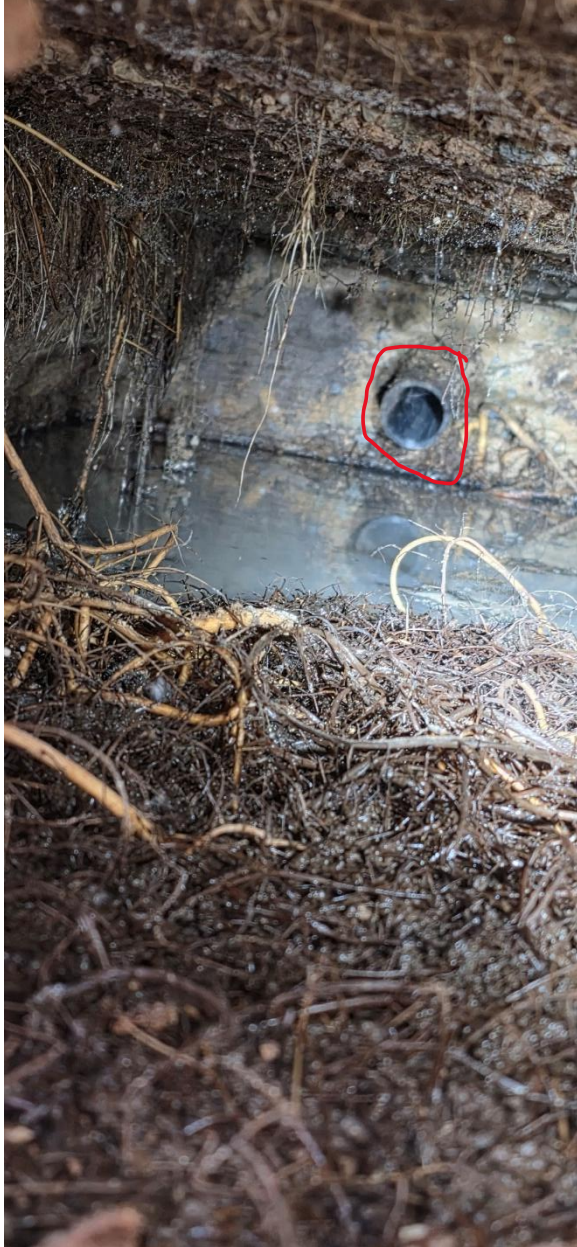
| Percentage of solids in tank: | 35% |

This is the inlet end of the septic tank with the inlet pipe. The septic tank needs to be pumped.

| <b>Summary:</b> | <p>***1. The septic tank needs to be pumped.</p> <p>2. The outlet tee is in fair condition.</p> <p>***3. The distribution box needs to be replaced.</p> <p>***4. The leach lines are full of solids and will not function properly at this time. Recommend contacting a licensed septic company to come out and see what can be done to fix the issue.</p> <p>***5. There are trees in the leach field.</p> <p>6. There were no signs of surfacing in the leach field.</p> |

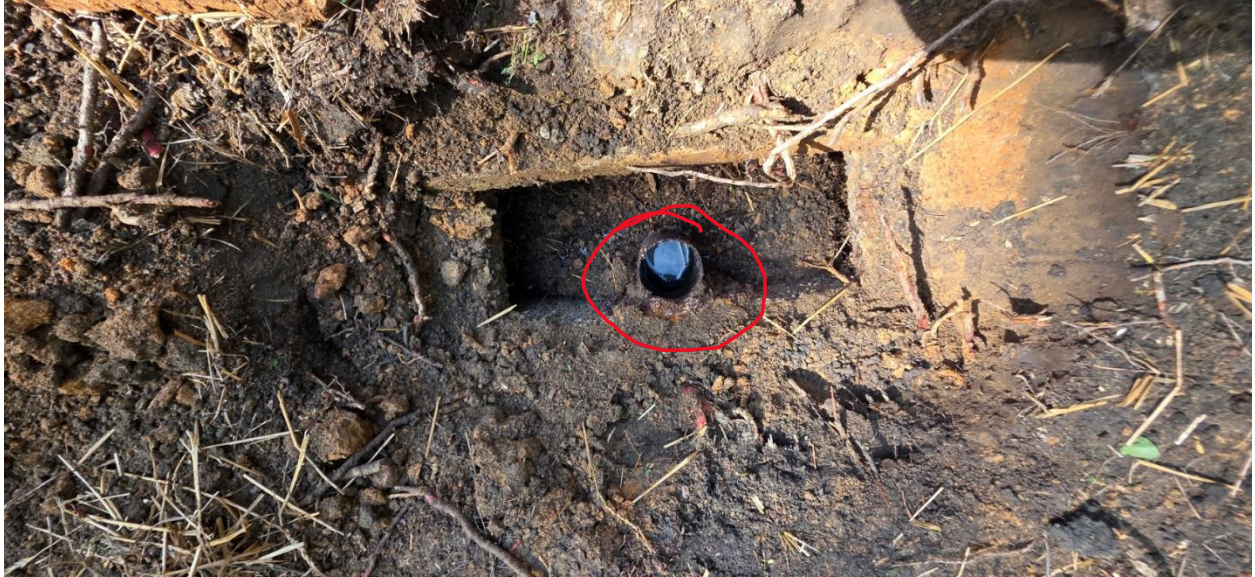
| Outlet T description: | Plastic tee in fair condition. |

This is the outlet end of the septic tank with the outlet tee. The outlet tee is in good condition.

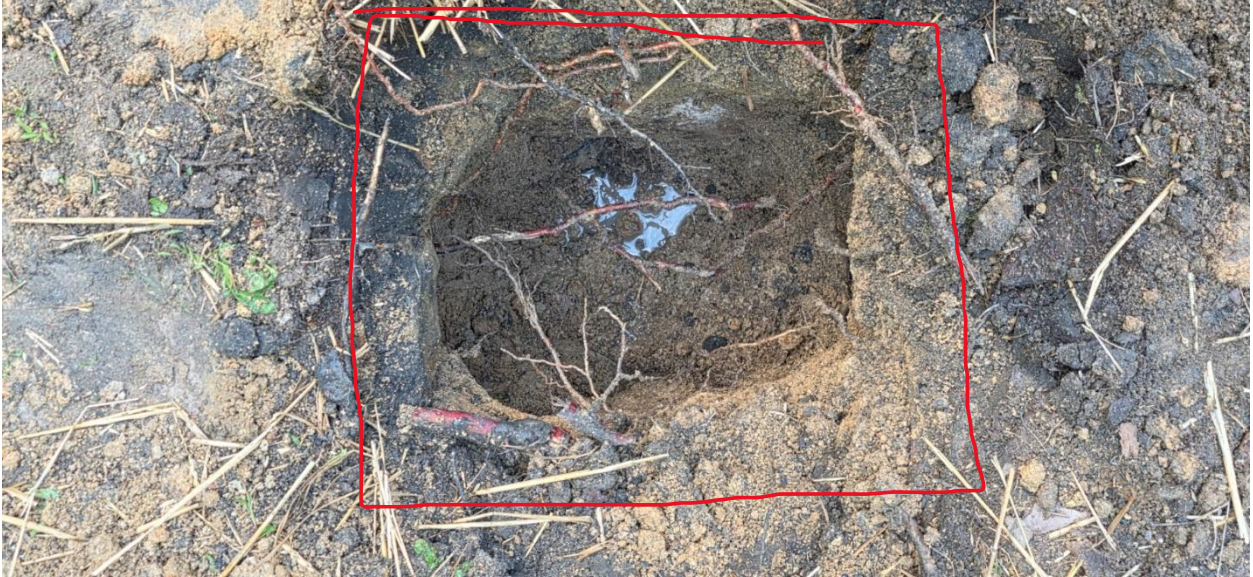
| Distribution box description: | ***** Rectangular concrete box that is corroded and needs to be replaced. Recommend contacting a licensed septic company to come out and see what can be done to fix the issue. |

This is the distribution box. It is corroded and needs to be replaced. Recommend contacting a licensed septic company to come out and see what can be done to fix the issue.

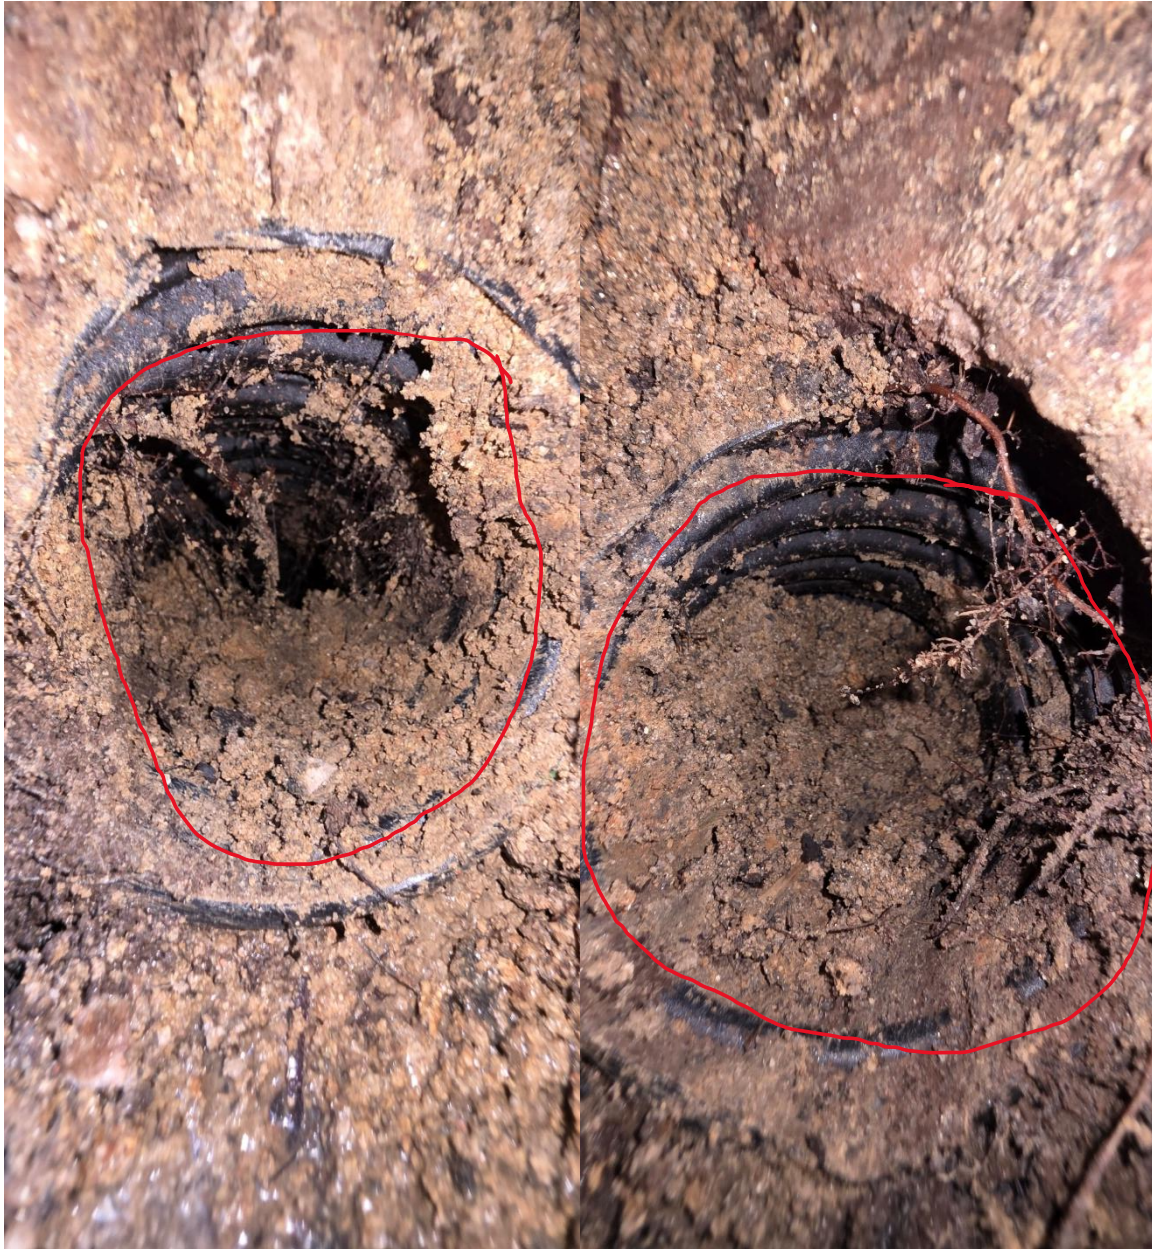
| <b>Other pertinent facts noted during inspection:</b> | *** The leach lines are full of solids and will not function properly at this time. Recommend contacting a licensed septic company to come out and see what can be done to fix the issue. |

The leach lines are blocked and will not function properly at this time. Recommend contacting a licensed septic company to come out and see what can be done to fix the issue.

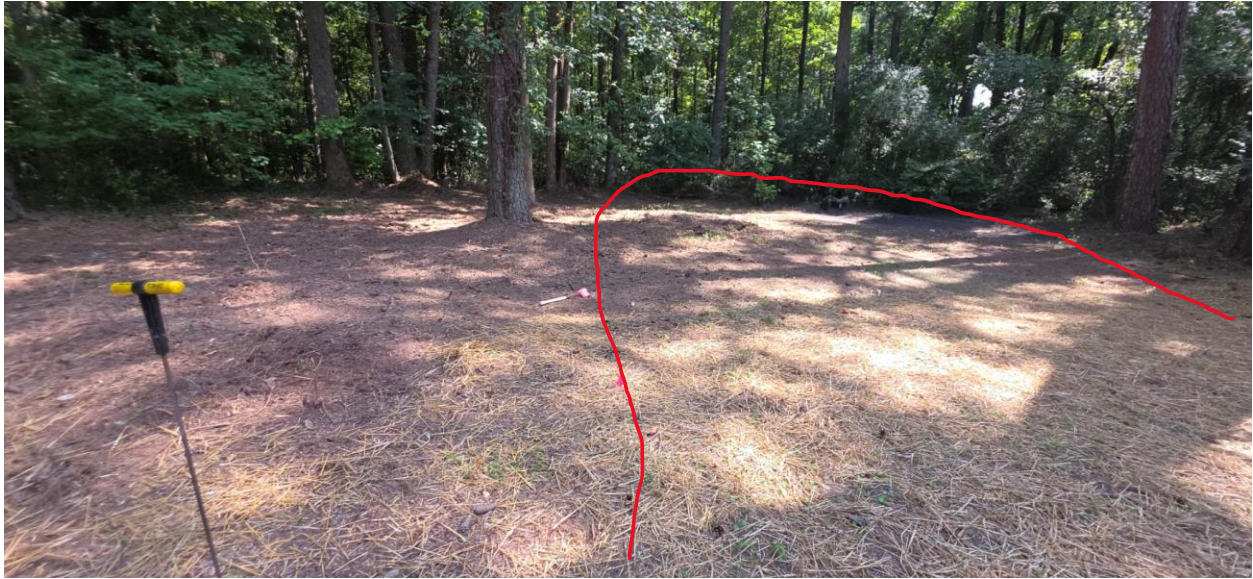
| <b>System conditions description:</b> | There are trees in the leach field. |

This is the leach field. There are trees in the leach field.
