**Prepared for Exclusive Use by:**

211 Park Ave  
Creedmoor NC 27522

11/6/2018

Floor 2 Ceiling Home Inspections, LLC dba HouseMaster

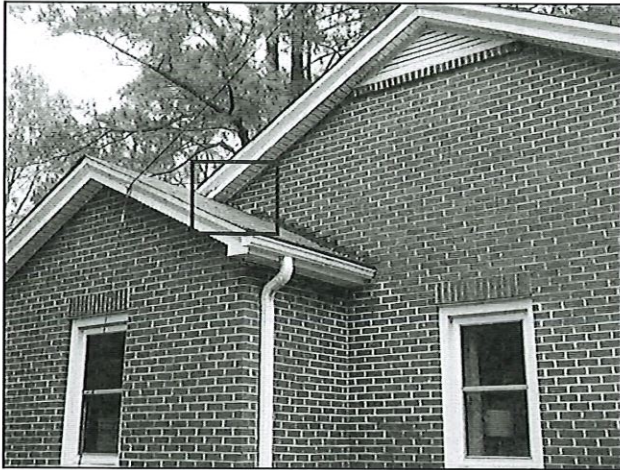
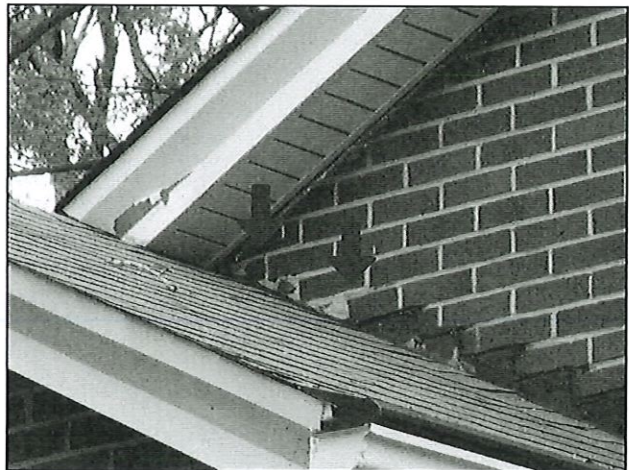
*CORRECTED  
2018-NEW ROOF  
2020*
