## SUMMARY

1315 Alpha Rd, Henderson, NC 27536

Evangeline Mitchell  
09/25/2025

Michael Eldredge  
NC HI Lic# 3527  
Eldredge Home Inspection  
9198303588  
meldredge1@gmail.com

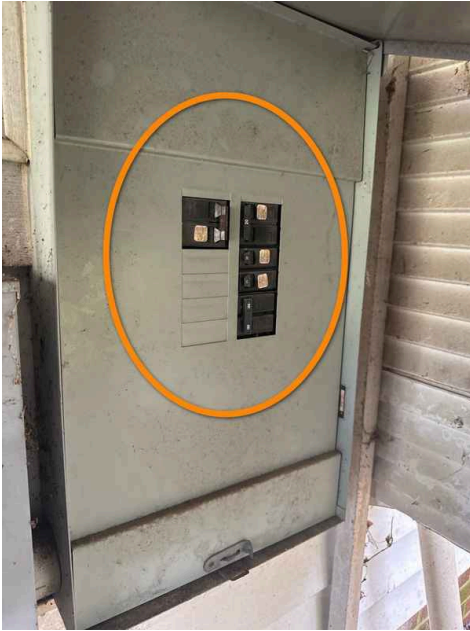
See description for this finding located under the carport.

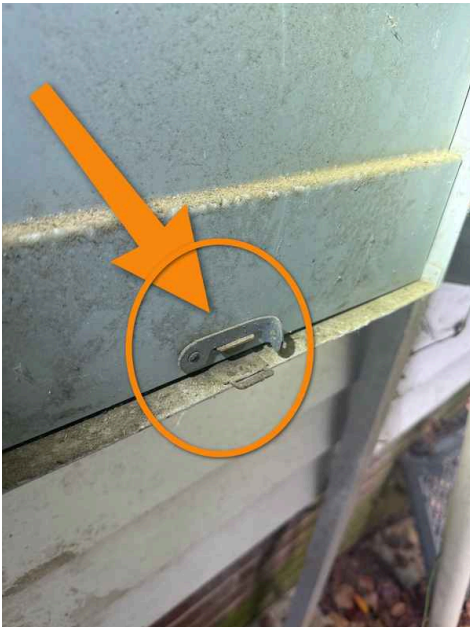
The design of this electrical panel enables a person or child to remove the cover with no tools. See following photo(s)

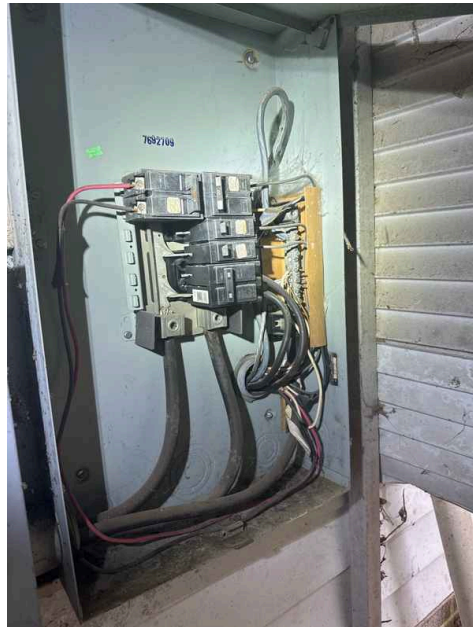
This means a person or child can expose the high voltage wiring with no tools. This is dangerous. Modifications to the panel cover are strongly recommended.

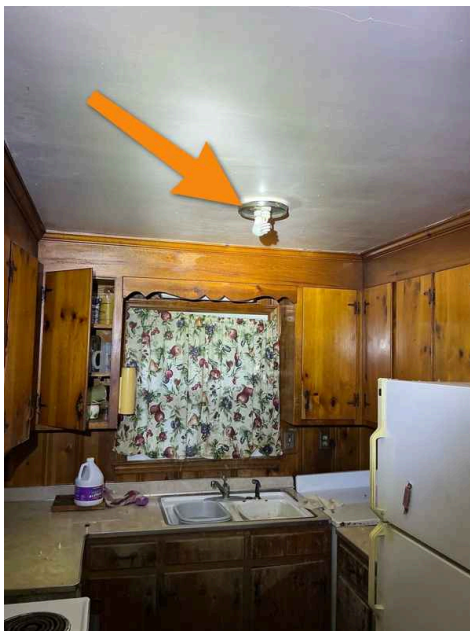
The light fixture was not functional when tested. This could indicate a defective bulb or other more serious problem such as faulty wiring or a defective fixture. If this is an LED light, then an electrician is needed. A licensed electrical contractor should be consulted for further evaluation and repair.

Located in the kitchen, this light is not functional.

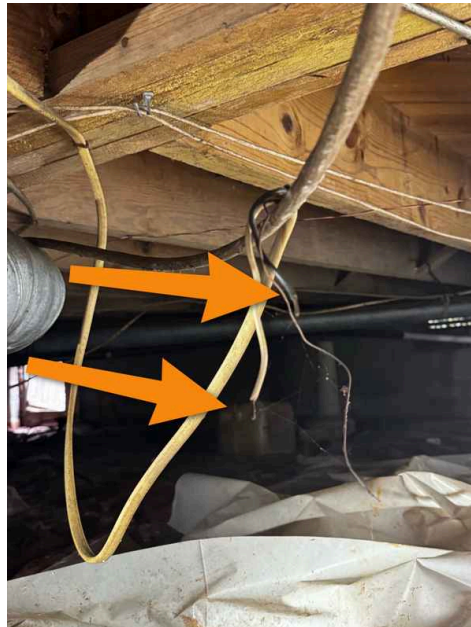
Wires should be enclosed in a junction box to avoid damaging the connection between the wires. Also, this protects occupants from electrical shock. This condition presents a safety hazard that could result in serious personal injury and or property damage. A licensed electrical contractor should be consulted for repair and a complete evaluation of the electrical system.

Similar findings were found here located under the right side of the crawlspace.

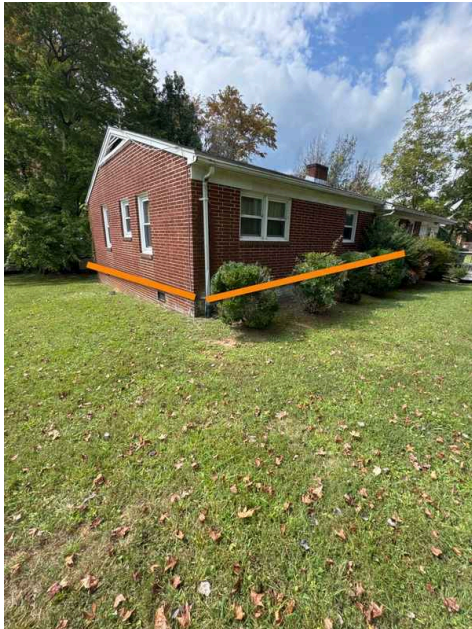
The brick veneer for this home has no visible weep system. The weep system prevents water and condensation buildup behind the brick veneer. Weep openings for homes of this era are typically installed at the foundation vent locations. A licensed general contractor should be consulted for complete evaluation to determine the significance of this concern and repair as necessary.

See description for this finding. Also, hidden damage is more likely because of the constantly overflowing gutters.

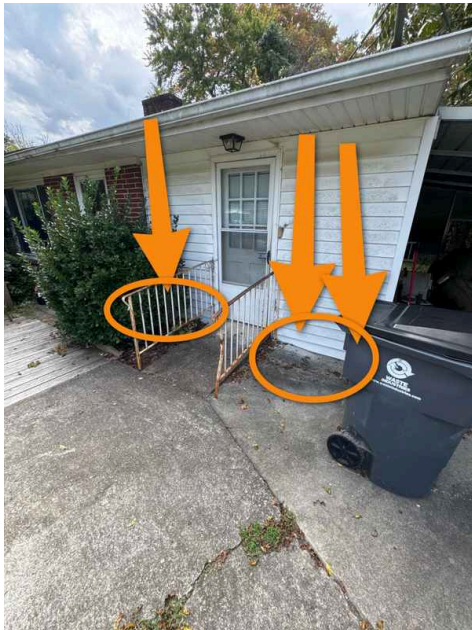
The exterior siding of the home is too close to the grade and needs repair to prevent insect and water penetration. A licensed general contractor should be consulted for a complete evaluation of the siding and to make necessary repairs. At the time of the repair, all adjacent building components should be inspected for possible evidence of water penetration and hidden damage.

See description and following photos.

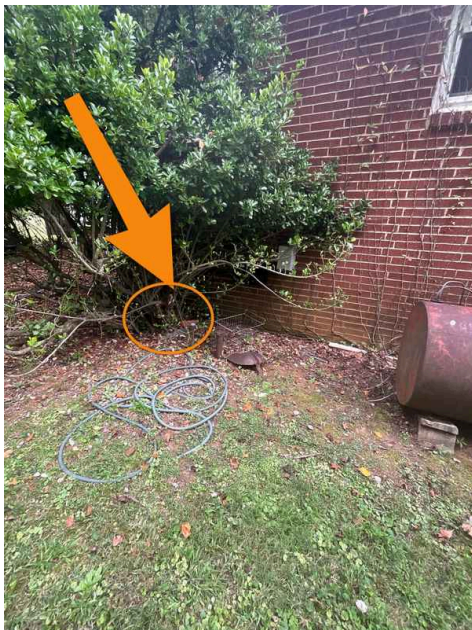
Two metal pipes with mushroom type caps were noted during the inspection of the yard. The pipes are typical of the vent and or fill openings for an underground oil storage tank. A leaking above ground or underground oil tank can be a potential liability related to environmental contamination. Whenever an underground oil fuel storage system is suspected to be present, the buyer should consult a licensed geologist for a complete assessment to determine if a tank is present, the condition of the tank and if any soil contamination is present.

See description and following photos.

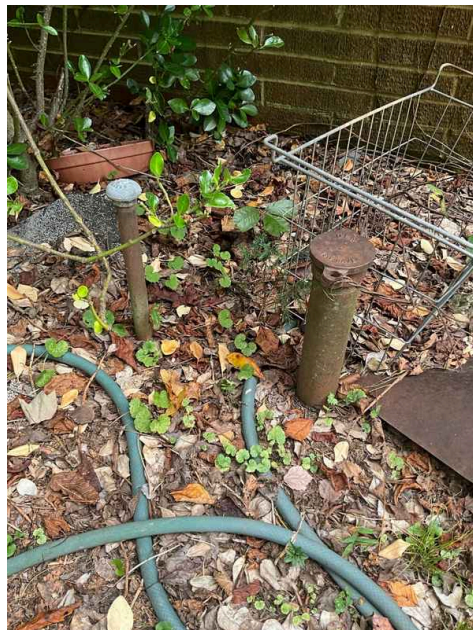
Additional photo of this finding.

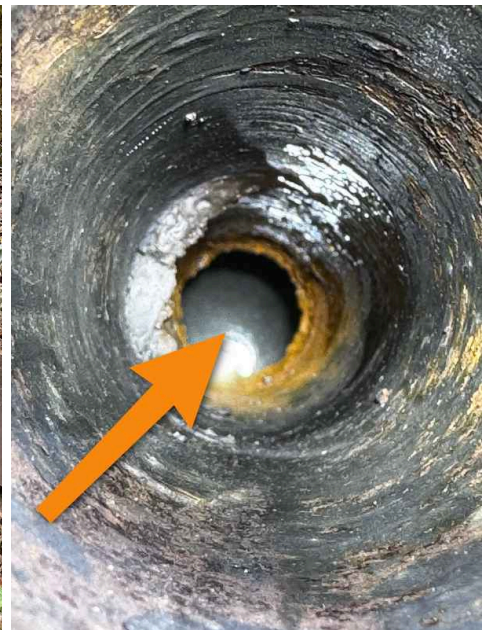
The tank is full of oil and or water which would mean the tank is compromised.

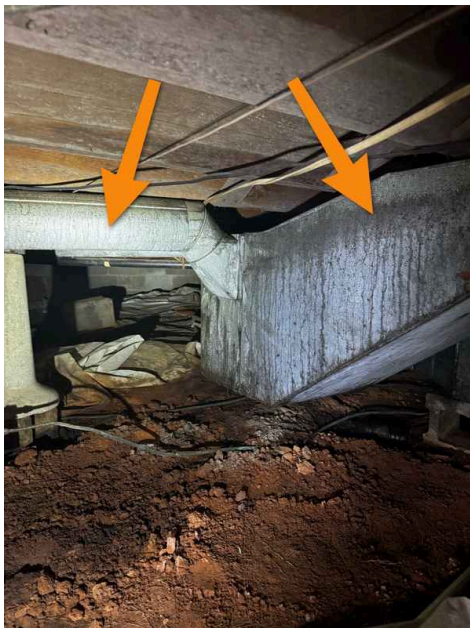
Ducts are not insulated, resulting in energy loss and condensation dripping down. Recommend licensed HVAC contractor insulate ducts.

See description and following photos.

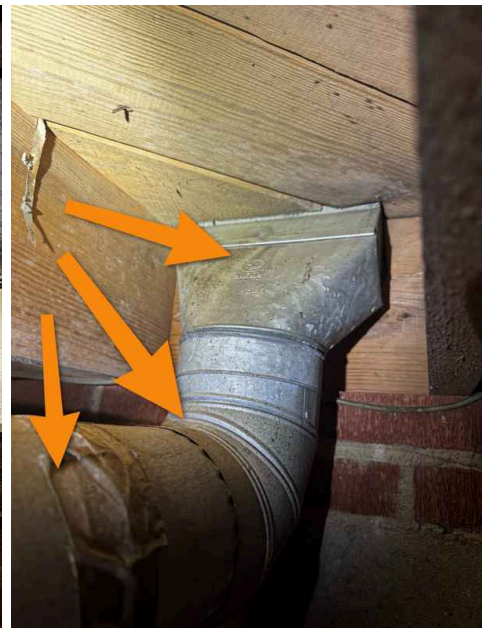
All areas of the home should be assessed for the same finding.

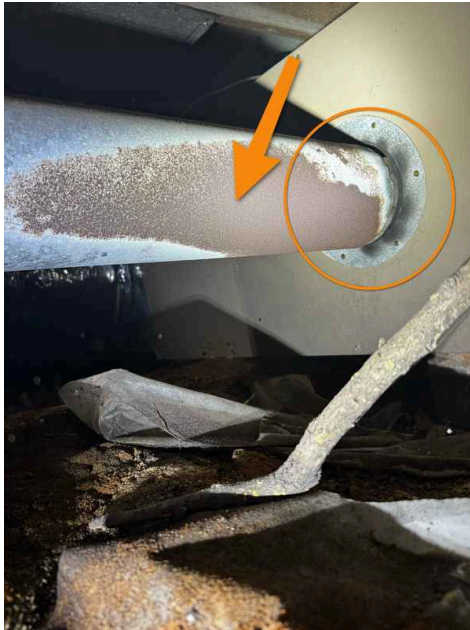
The gas furnace draft exhaust system is disconnected/damaged. This is hazardous that could result in exhaust entering the living spaces of the home and possible carbon monoxide poisoning. A HVAC contractor should be consulted for a complete evaluation and to make necessary repairs to ensure safe, reliable, and proper operation of the HVAC system.

See description and following photos. The flue is loose and deteriorated in multiple areas.

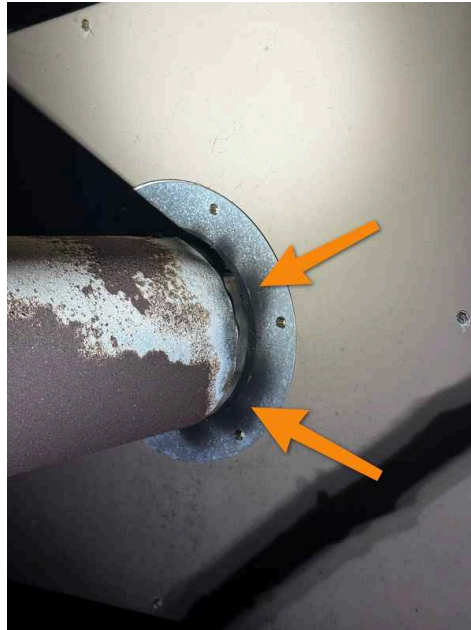
Additional photo of this finding.

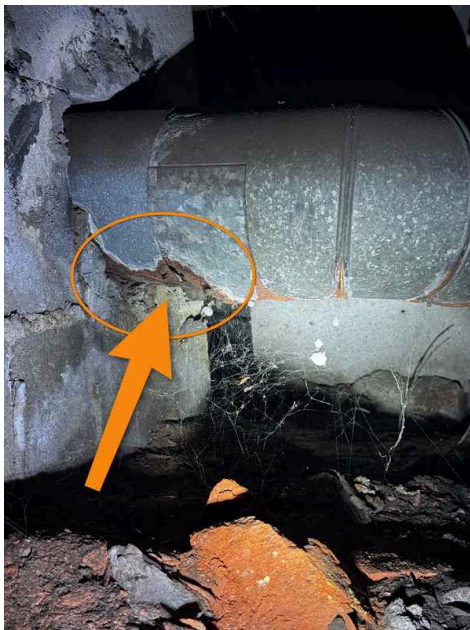
This hole in the flue direct carbon monoxide into the crawlspace. This carbon monoxide then seeps through the floor into the home.

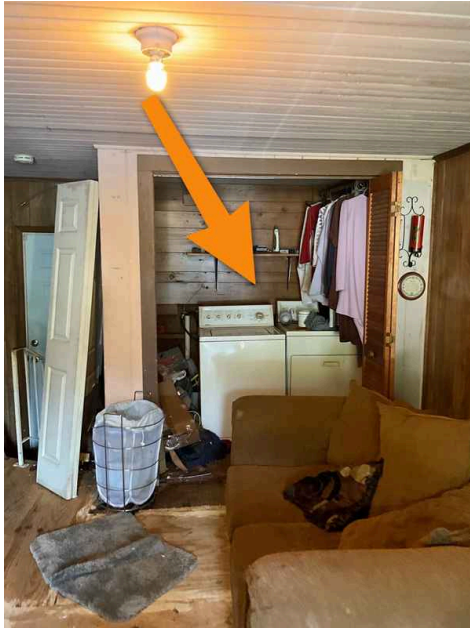
See description and following photos.

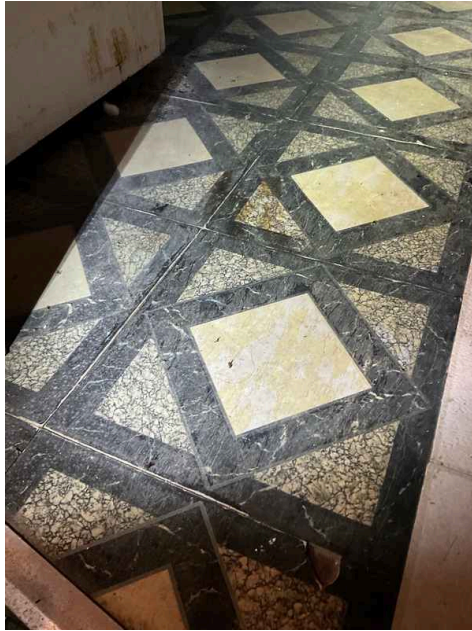
Based on the dimensions of the tile and age, these are likely asbestos as well.

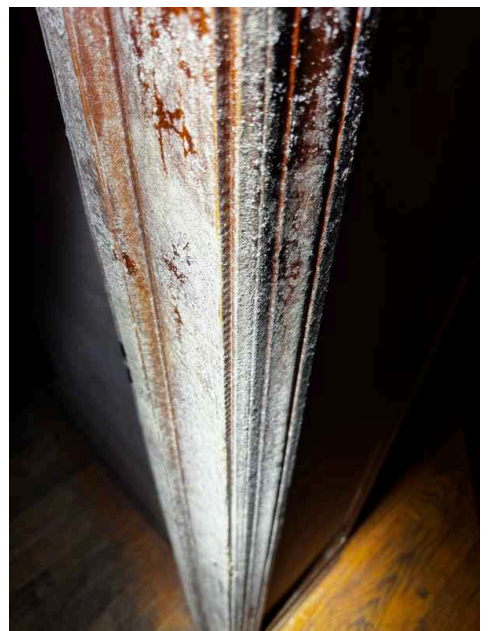
All areas of the home should be assessed for the same finding.

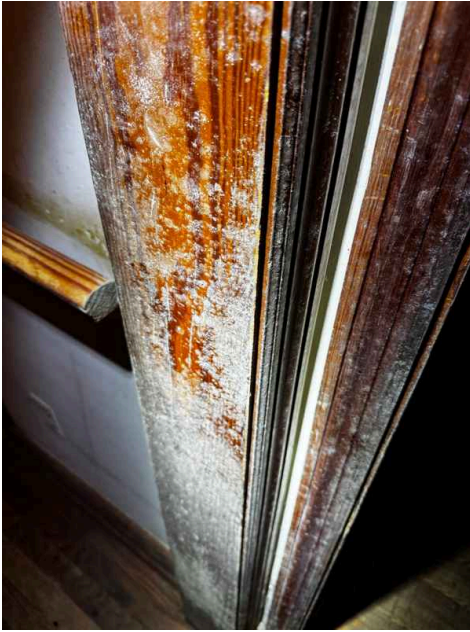
Additional photo of this finding. Sample

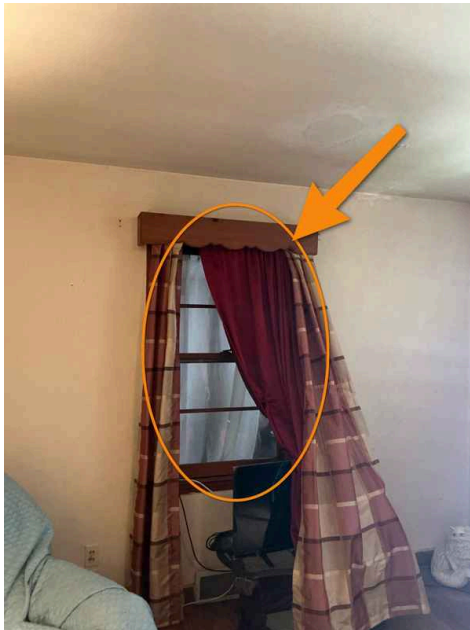
Location of the following finding in the living room.

Further evaluation and repair are needed for the window(S). see photos regarding needed repairs for the windows.

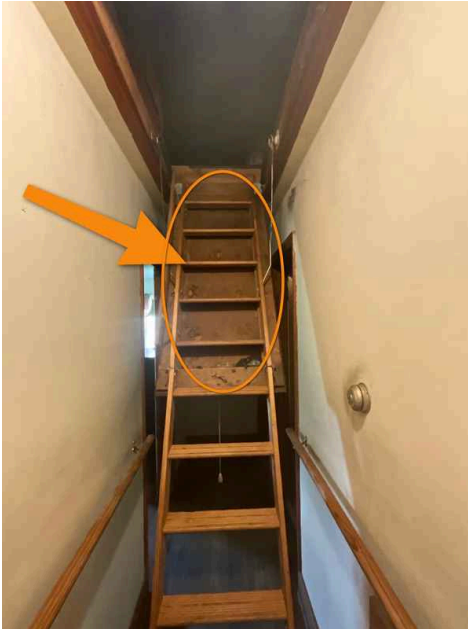
### **INSULATION IS MISSING ON ATTIC ACCESS**

The access to the attic is not insulated. This will result in significant heat loss. Repairs should be made to insulate all attic access areas of the home.

See description for this finding.

Contact a qualified professional.

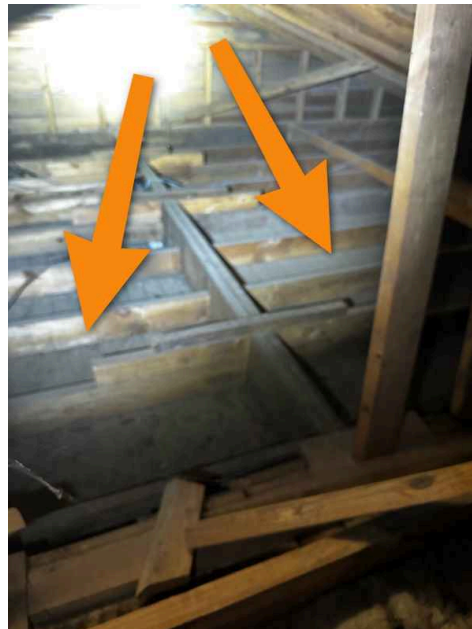
There is no insulation at all above the partially finished carport conversion room. There's also no insulation under the carport room. Insulating under this room is significantly challenging. Insulation also possibly may not be installed in the walls.

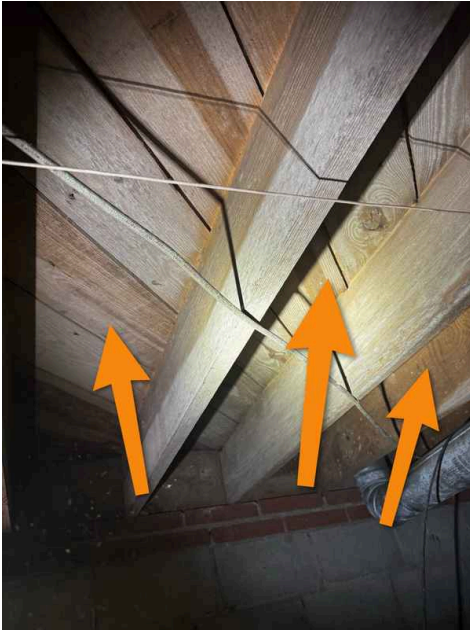
The insulation is missing in all areas under this home. Air conditioned homes can develop large scale mold and wood destroying fungus defects when no insulation is under a home as the wood structure sweats. Adding insulation would be beneficial to heating and cooling cost. This would need to be done professionally paying careful attention to insulating the HVAC ducts and vent boots. This is to avoid mold and wood deterioration as the crawl space environment is being changed. A licensed general contractor should be consulted to evaluate and insulate the crawl space.

See description and following photos.

Contact a qualified professional.

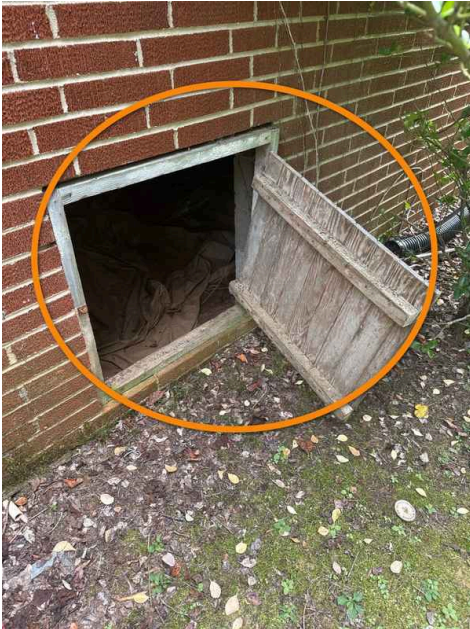
#### **VENT OR DOOR IS/ARE DAMAGED OR MISSING**

The crawl space vent(s) or door is/are damaged or missing. When the vents are damaged, including damaged or missing screens, animals are given access to the crawl space which can damage the home and also be dangerous for anyone working under the home. The vents should be assessed and repaired by a general contractor.

See description for this finding.

Contact a qualified professional.

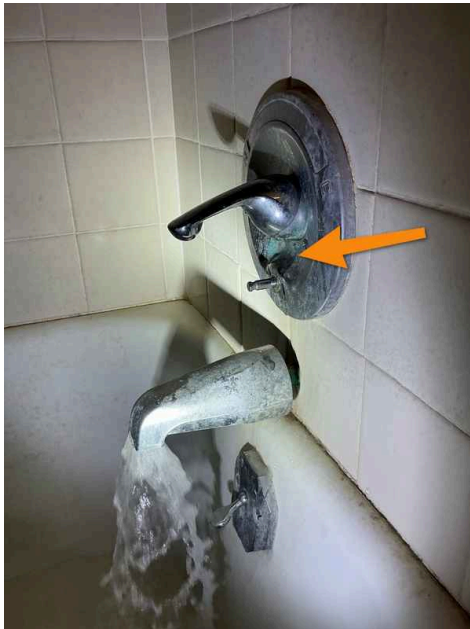
##### **FAUCET LEAK AT HANDLE TUB/SHOWER**

The tub/shower faucet leaks at the handle base area when turned on. The leaks could result in damage behind the wall and should be repaired as soon as possible. A licensed plumbing contractor should be consulted for a complete evaluation to determine the significance of this concern and make necessary repairs to prevent leaks and ensure sanitary conditions.

A major leak from the tub handle was noted in the hallway bathroom. See description for this finding.

Contact a qualified professional.

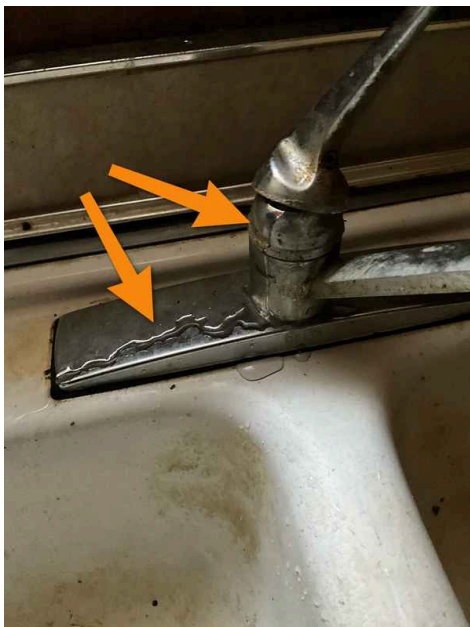
##### **FAUCET LEAKS AT THE HANDLES**

This plumbing fixture is leaking at the handles. This can or has caused damage to the area below. This repair should be completed by a licensed plumber.

See description for this finding located in the kitchen.

Contact a qualified professional.

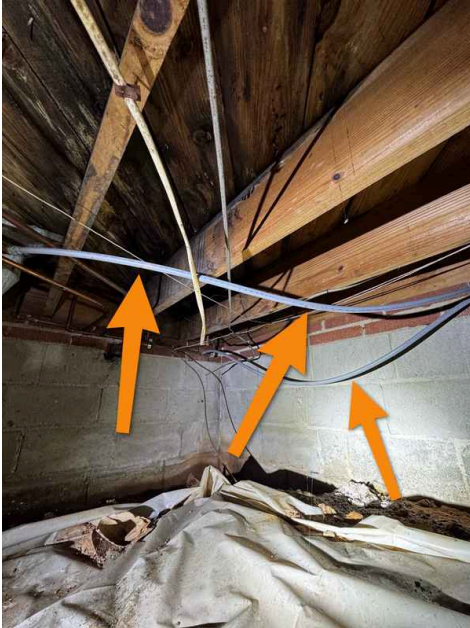
Similar findings were found here under the right side of the home.

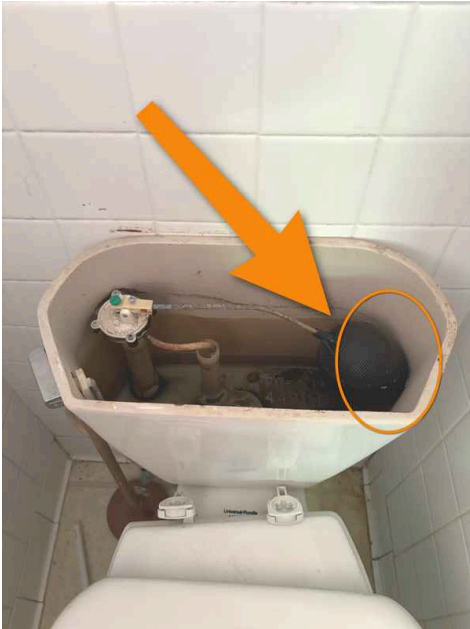
The float is rubbing the tank which means the valve can be stuck in the on position. This can result in flooding.

A licensed plumber should be consulted for a complete evaluation of this finding and repair to avoid leaks and property damage.

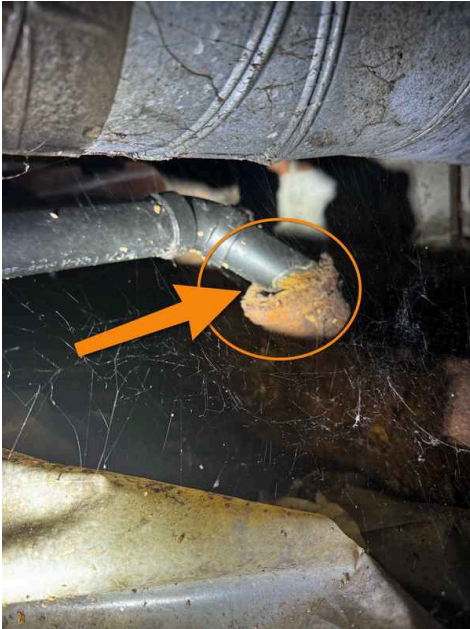
The drain line from the kitchen is not actually plumbed or connected into the main drain. This means this is a leak.

A licensed plumber should be consulted for a complete evaluation of this finding and repair to avoid leaks and property damage.

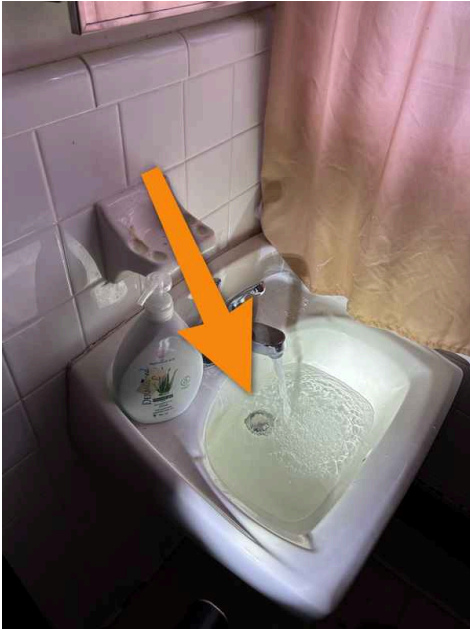
See description for this finding in the master bathroom.

Contact a qualified professional.

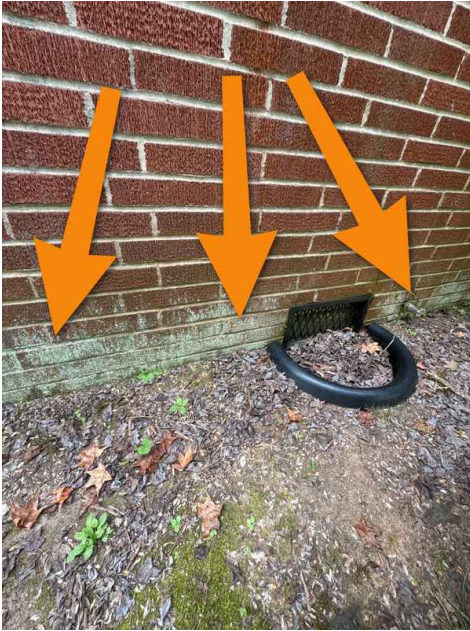
See description and following photos regarding this small crack on the front middle portion of the foundation.

Contact a qualified professional.

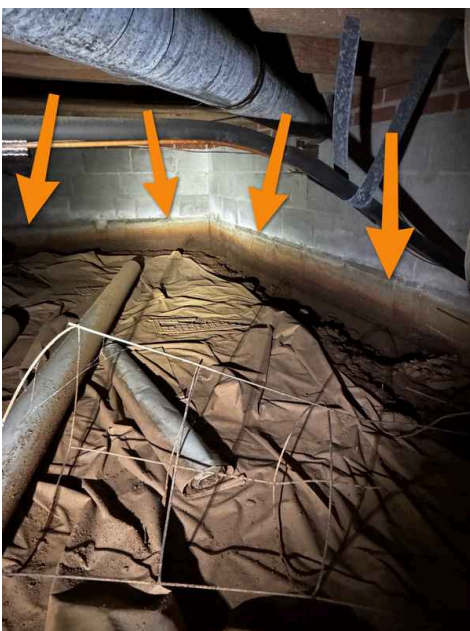
In the crawl space, the foundation walls were wet and the soil adjacent to the foundation was muddy from direct water penetration in the area. Direct water penetration damages the foundation, the wood structure, and creates an undesirable environment in the crawl space areas that encourages insects and or fungal growths such as mold/mildew. Water in the crawl space indicates an absent or damaged waterproofing and foundation drain system. Repairs are needed to prevent water penetration. A licensed general contractor should be consulted for further evaluation to determine the source of the moisture and to make necessary repairs.

See description and following photos.

**Recommendation**  
Contact a qualified professional.

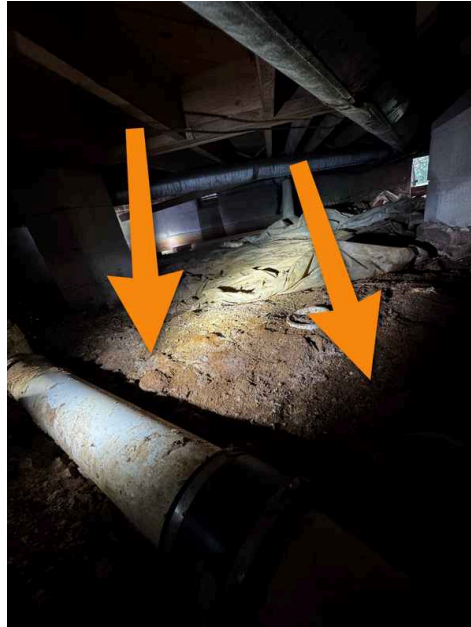
All areas of the home should be assessed for the same finding.

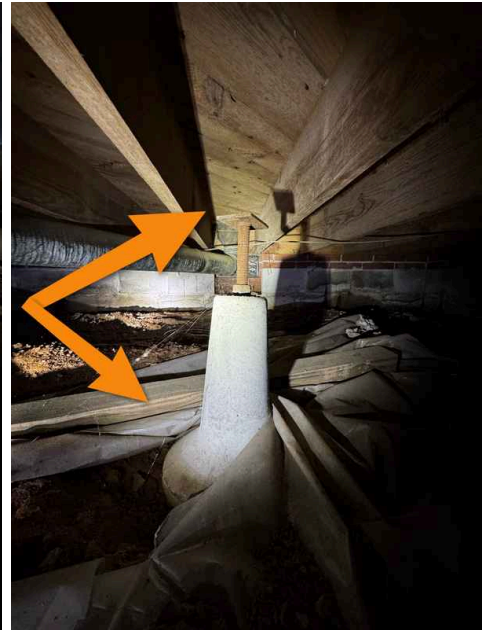
Also, the lumber was never fastened into place. Multiple areas have fallen down.

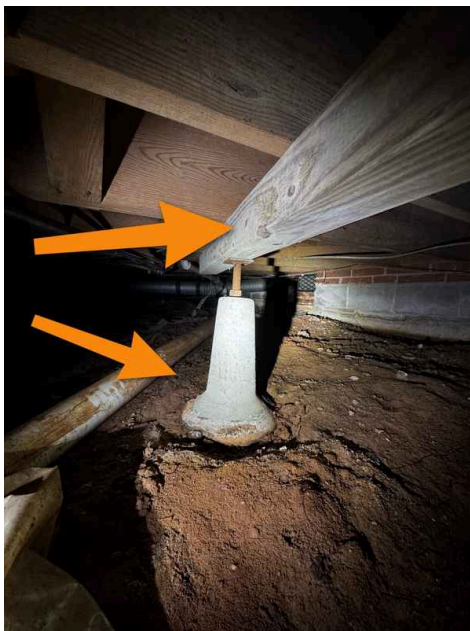
Additional photo of this finding.

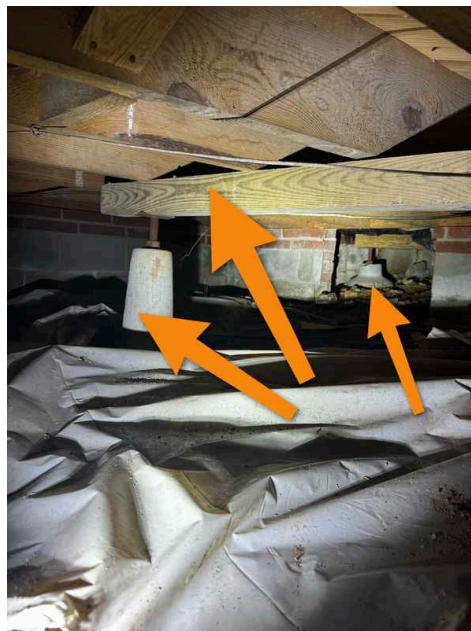
Additional photo of this finding.

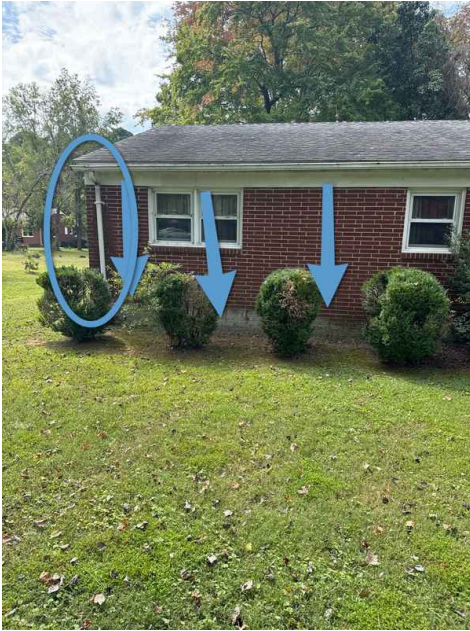
See description for this finding. the gutter is loose and hanging. Hidden damage is expected. The gutter has been overflowing for a long period of time.

Contact a qualified professional.

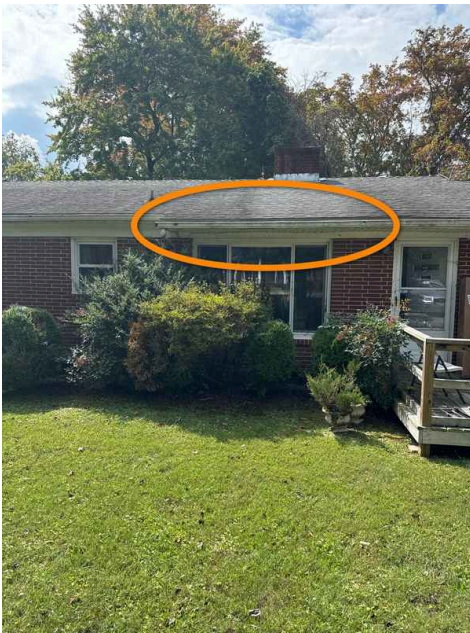
Similar findings were found here. the downspout is clogged, the gutter is loose and falling. Hidden damages likely.
