## SUMMARY

3421 Oak Trail, Clayton, NC 27520

July 20, 2026

Jason Ross  
NC License #3561  
New Leaf Home Inspections  
9105848502  
[jason@newleafinspections.com](mailto:jason@newleafinspections.com)

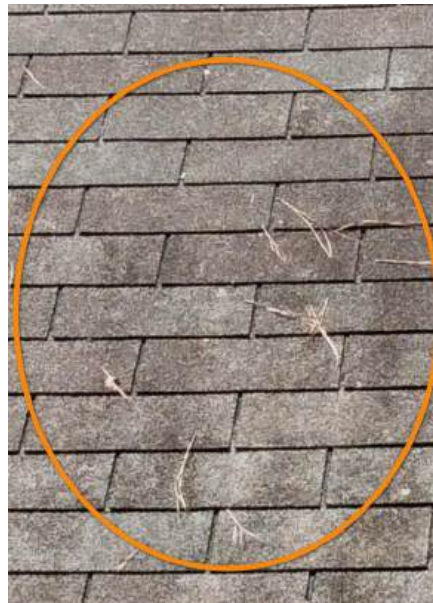
There was mineral granule loss on the roof coverings in several locations. Loss of granules can contribute to a shortened roof lifetime if found to be accelerated. There are many possible causes including, but not limited to, age, foot traffic, contact with vegetation, defective products, improper installation, hail damage, etc. We recommend monitoring this for future leaks or accelerated wear and contacting a qualified roofing professional for further evaluation if desired.

There was mineral granule loss on the roof coverings in several locations

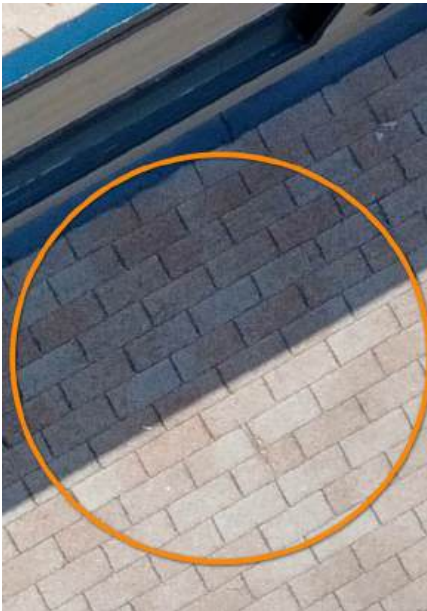
There was mineral granule loss on the roof coverings in several locations

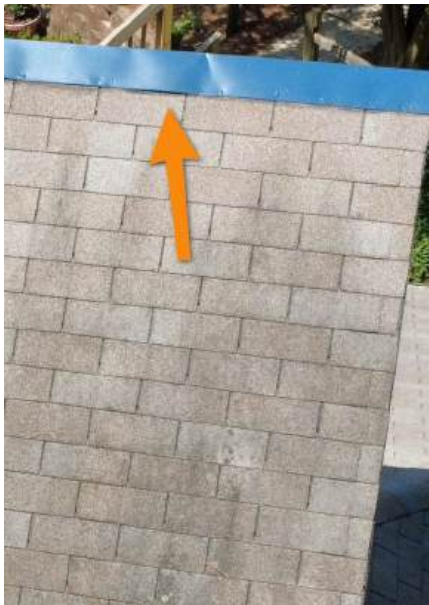
The flashing was either damaged, incorrect, or missing. This can indicate improper repairs, or allow moisture intrusion if not flashed properly. Recommend roofing or siding contractor evaluate and replace / repair as needed.

Uplift/gaps in areas of flashing on middle roofing of home

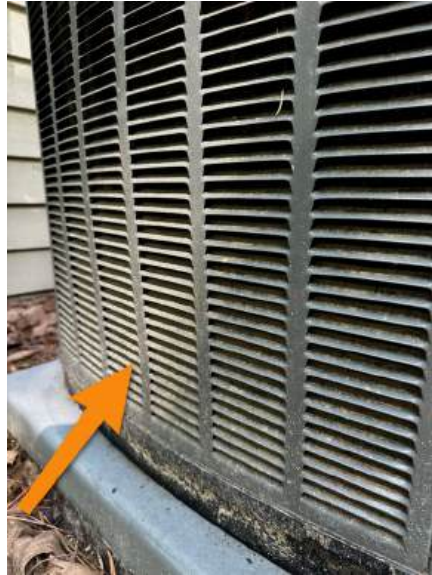
The HVAC system(s) should be cleaned and serviced periodically, especially in scenarios of older age to ensure proper chemical levels and operation as a typical home inspection can only determine proper operation with the use of normal controls. Recommend a qualified HVAC contractor clean and service to ensure proper operation.

Condenser fins need cleaning on exterior HVAC condenser unit/heat pump

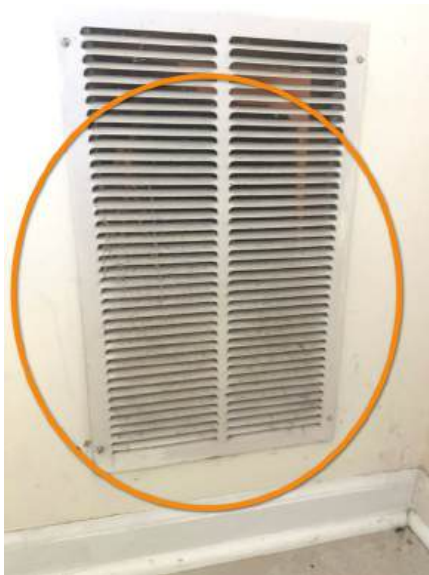
Dirt/debris and suspected organic growth was noted in ductwork at distribution registers and returns throughout home. This can affect indoor air quality or pose a health concern in some scenarios. Recommend air quality testing and consulting a licensed HVAC company for evaluation and cleaning or replacement as needed.

Dirt/debris and suspected organic growth was noted in ductwork at distribution registers and returns throughout home

Recommendation  
Contact a qualified professional.

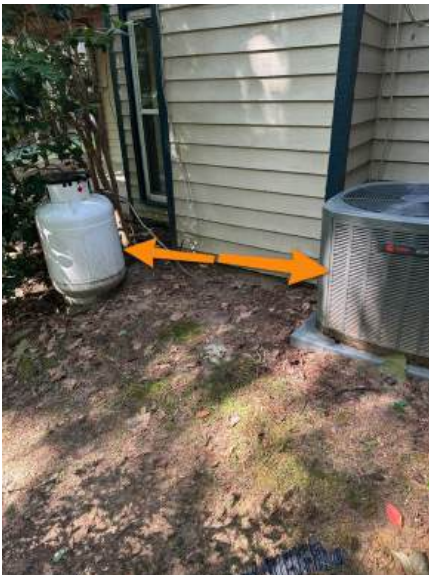
The propane tank has improper clearance from HVAC condenser unit on left side exterior of home (6' 8"). A stationary propane tank must be at least 10 feet away from an HVAC condenser unit. The National Fire Protection Association (NFPA) considers an air conditioner compressor to be a potential source of ignition (due to sparking relays or motors) and requires this 10-foot buffer. This is a potential safety concern. We recommend local rules are followed, and contacting the local service provider for relocation of tank as needed.

The propane tank has improper clearance from HVAC condenser unit on left side exterior of home (6' 8")

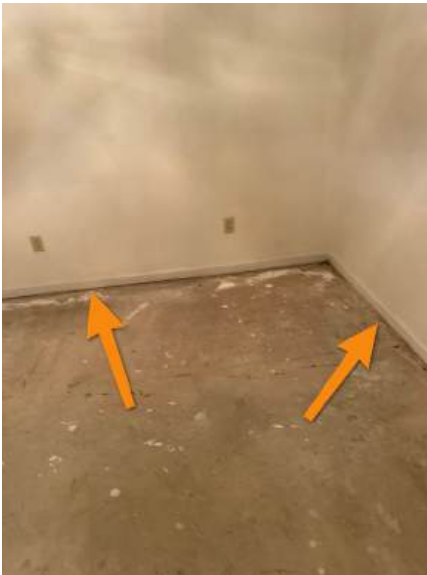
There was a moisture stain during the time of inspection. This could indicate current or past moisture intrusion within the structure, or from surrounding components. We recommend a licensed contractor further evaluate and make appropriate repairs as needed.

Moisture staining observed on baseboards in several locations throughout lower level of home

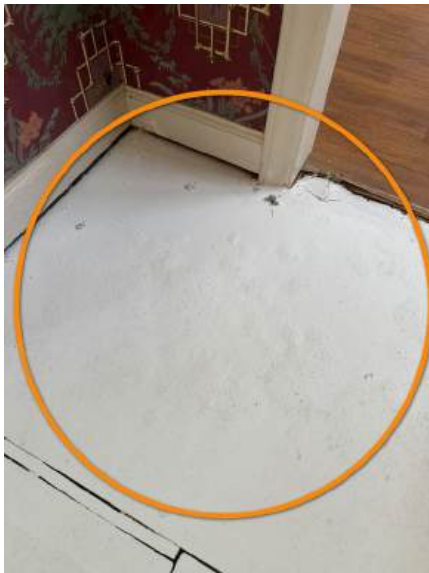
Subflooring had areas of possible moisture intrusion. This can accelerate deterioration and damage surrounding components over time. Recommend a qualified flooring contractor evaluate & repair areas affected as/if needed.

Subflooring had areas of possible moisture intrusion (Main level, dining room)

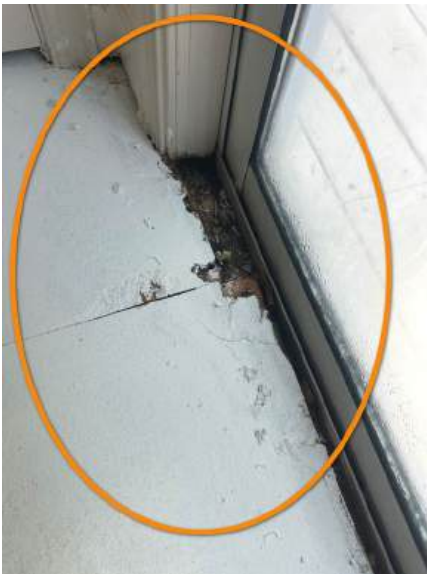
There was an area of deterioration in areas of the subflooring. This can indicate a moisture intrusion and can damage surrounding components. Recommend licensed contractor further evaluate to determine source of moisture intrusion and repair/replace all affected areas/components as needed.

There was an area of deterioration in areas of the subflooring (At rear exterior door, main level primary bedroom)

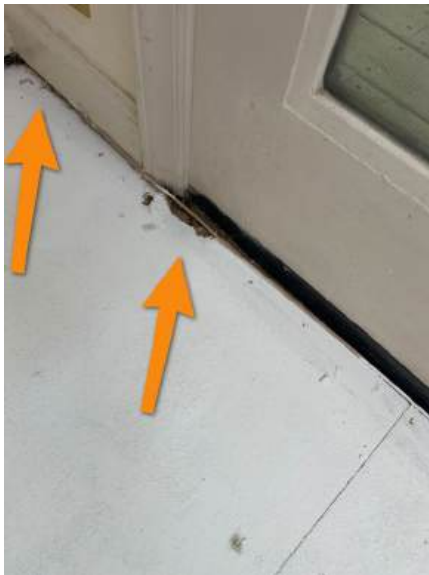
There was an area of deterioration in areas of the subflooring (At rear exterior door, main level living room)

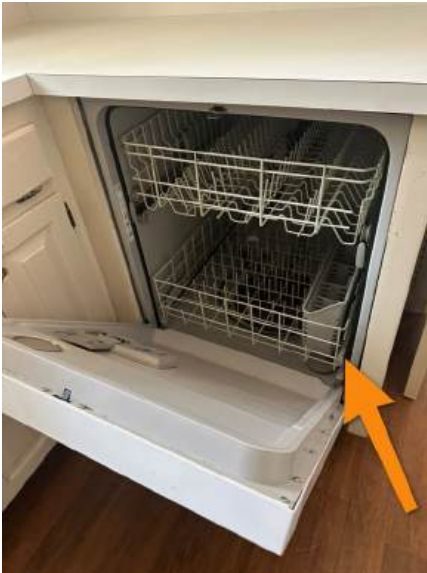
The dishwasher is not secured properly and has movement. This can worsen over time, and possibly damage surrounding components. Recommend plumber further evaluate and repair as needed.

The dishwasher is not secured properly and has movement

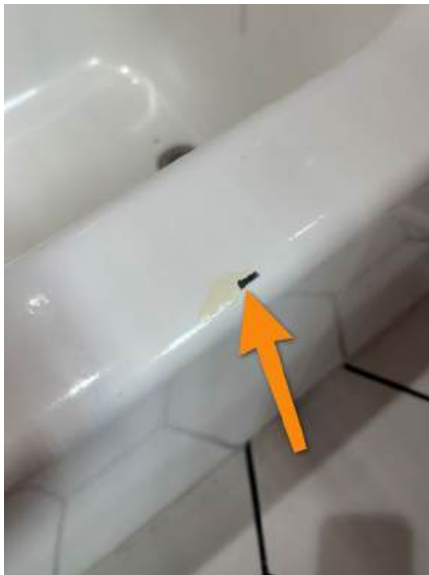
One or more fixtures, components, or Shower/Tub areas were damaged, missing, or detaching. This can hinder proper operation, allow moisture intrusion, or cause damage to surrounding components. We recommend a qualified contractor further evaluate to determine if moisture intrusion has occurred to components around fixture and to make appropriate repairs / replacements as needed.

Damage (chipping) observed in areas of tub in main level primary bathroom

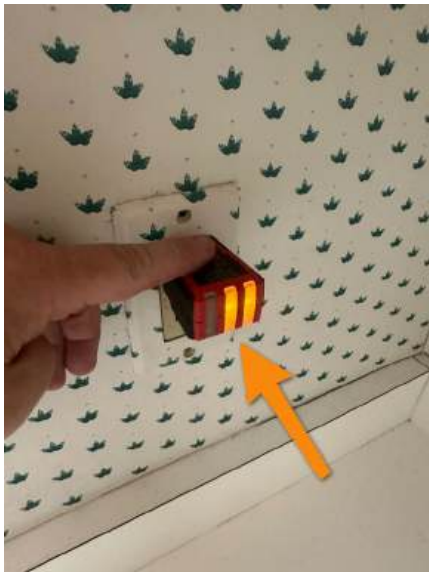
No GFCI protection present in one or more locations. This can contribute to electrical shock. Recommend licensed electrician upgrade by installing or repairing existing ground fault receptacles in all required locations.

No GFCi protection present in kitchen electrical receptacles

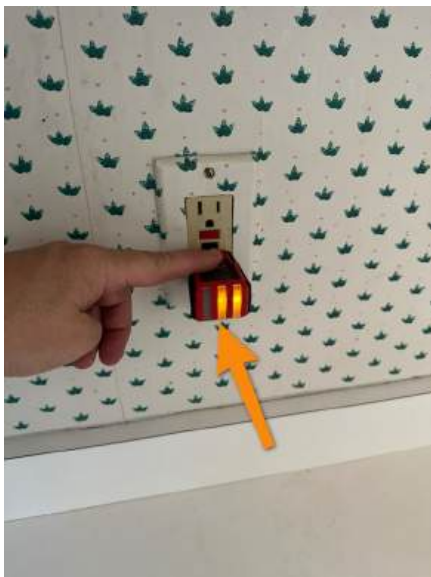
No GFCi protection present in kitchen electrical receptacles

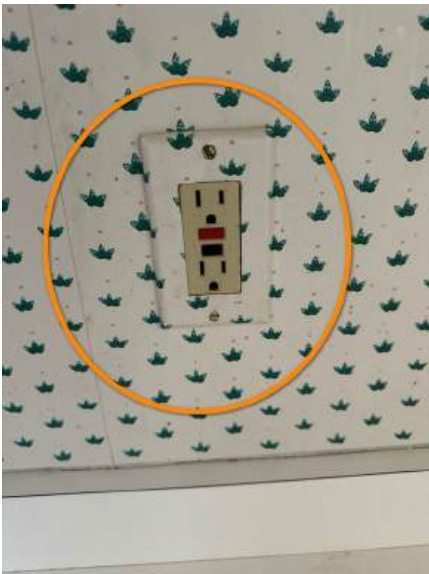
The GFCI receptacle in the did not work/trip off when tested at the time of inspection. This can cause a potential safety hazard and nullifies GFCI protection at all receptacles on the circuit. Recommend a qualified professional replace/repair as needed.

The GFCI receptacle in the did not work/trip off when tested at the time of inspection (Kitchen, left side)

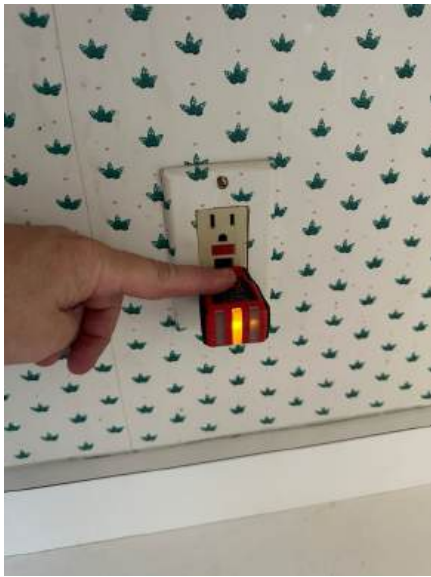
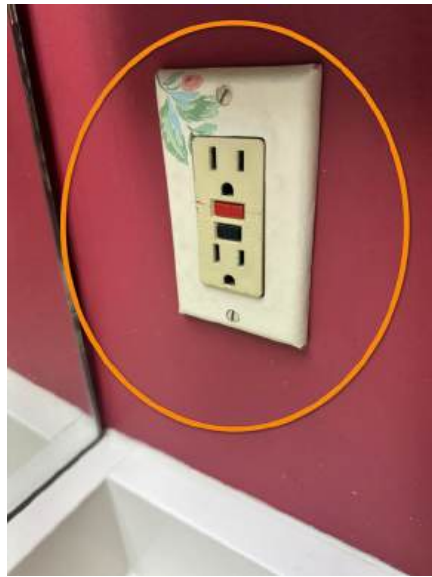
The GFCI receptacle in the did not work/trip off when tested at the time of inspection (main level primary bathroom)

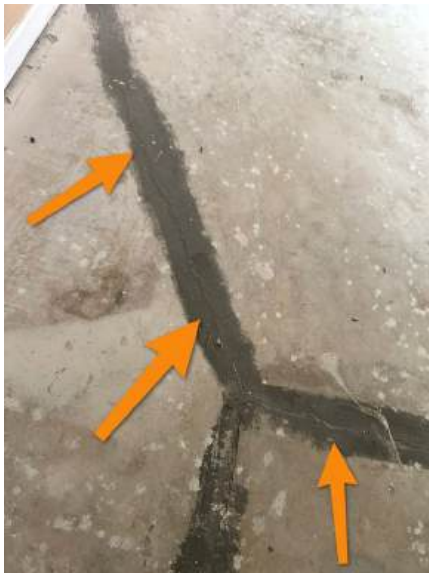
The interior foundation/slab flooring was cracked in noted areas. This can sometimes prevent proper installation of flooring, be noticeable once flooring is installed, or may indicate minor settlement in some scenarios. Recommend qualified professionals repair/seal as needed or further evaluation by a structural engineer if desired.

Interior foundation slab cracks observed in lower level right rear bedroom
