Inspection report for the property at  
228 Kelso Ct, Cary, NC 27511

This report is prepared exclusively for **Sam Watson**  
Inspected On: **05-19-2026**

Matthew Betts, NCHILB #4129

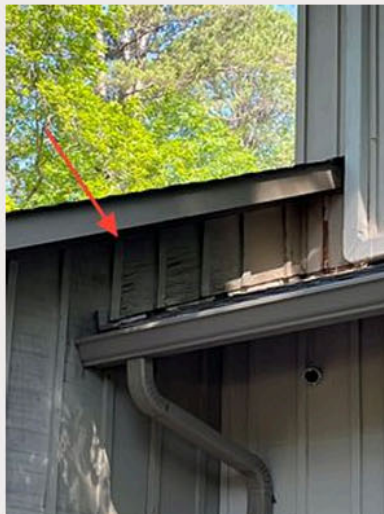
*Location*

**E-1 Exterior - Wall Cladding, Flashing and Trim:** Localized rot repairs are needed to the exterior siding and trim at a few locations. Damage may spread to adjacent materials if not corrected. A professional home maintenance specialist should evaluate this situation further and **repair or replace** all damaged and decaying exterior wood as needed. Please note that this condition can indicate additional concealed damage that is not visible to inspection. Consult your home owners association regarding maintenance responsibility. During inspection, I noted:

*Left rear corner of unit*

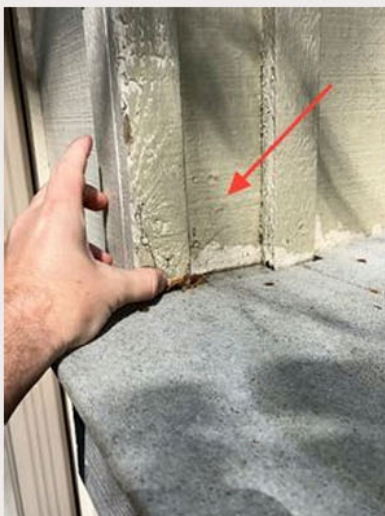
*Left rear corner of deck*

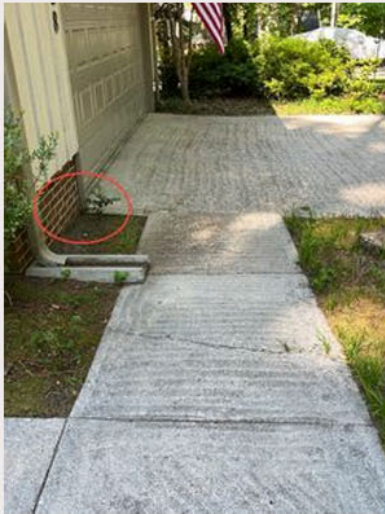
*Location*

*Left corner of Garage - siding/trim should not contact the ground*

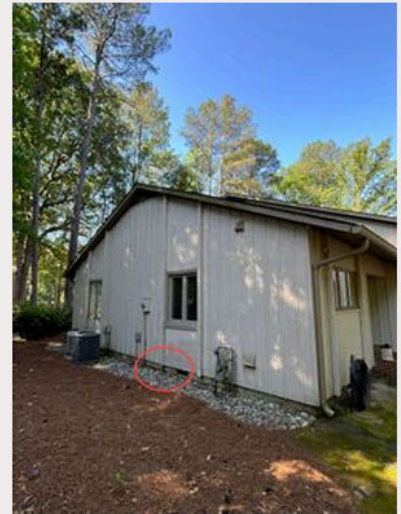
*Location*

*Left side of unit*

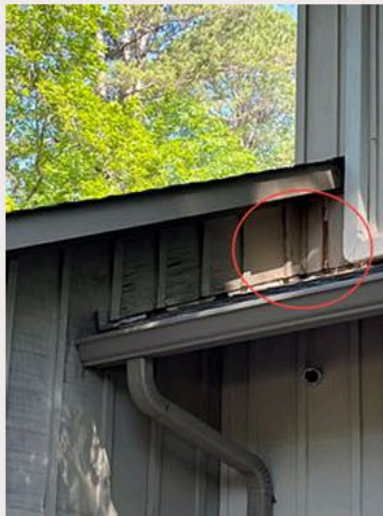
*Location*

*Squirrel damage at rear side of house*

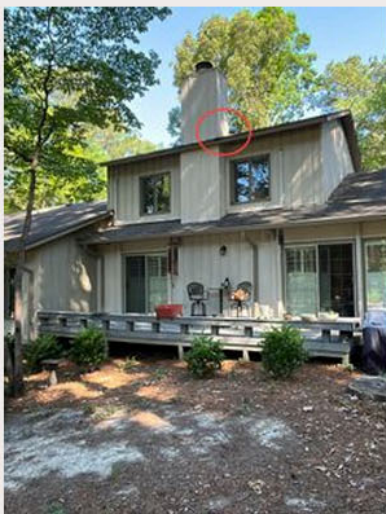
*Location*

*Left side of chimney chase*

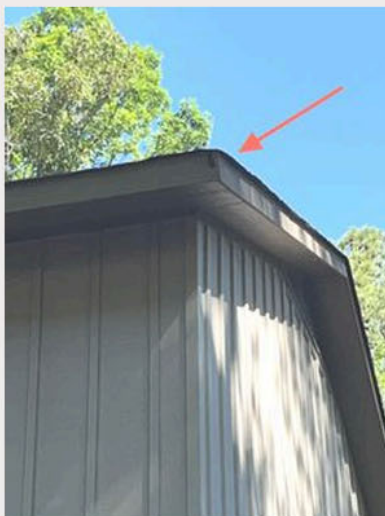
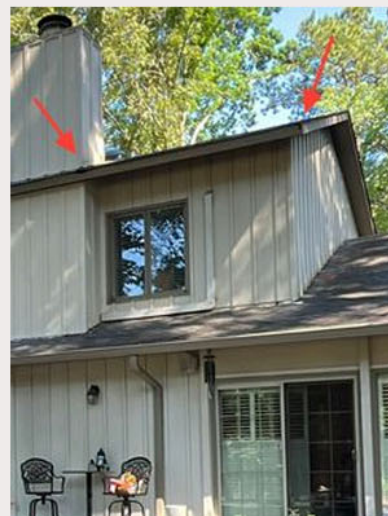
*Location*

**E-2 Exterior - Eaves, Soffits and Fascia:** Localized wood rot was noted at the rake and fascia trim at a few second floor locations. Damage may spread to adjacent materials if not corrected. A professional home maintenance specialist should **repair** or **replace** as necessary. Consult your home owners association regarding maintenance responsibility.

*Rear side of unit*

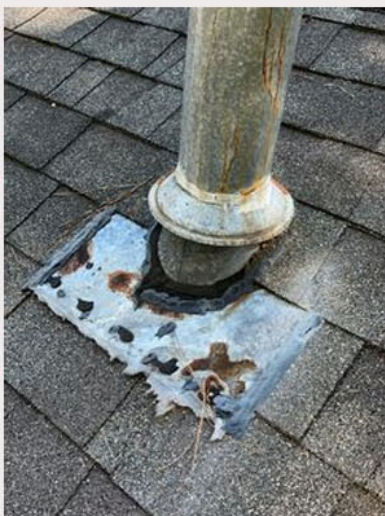
*This is a very old furnace flue that should be replaced*

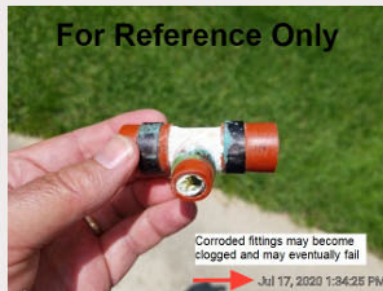
*Brass fittings are problematic at homes of this age*
