# SIERRA DELTA HOME INSPECTIONS LLC

## RESIDENTIAL INSPECTION

515 E Cornwall Rd  
Cary, NC 27511

Cathy Williams  
07/28/2026

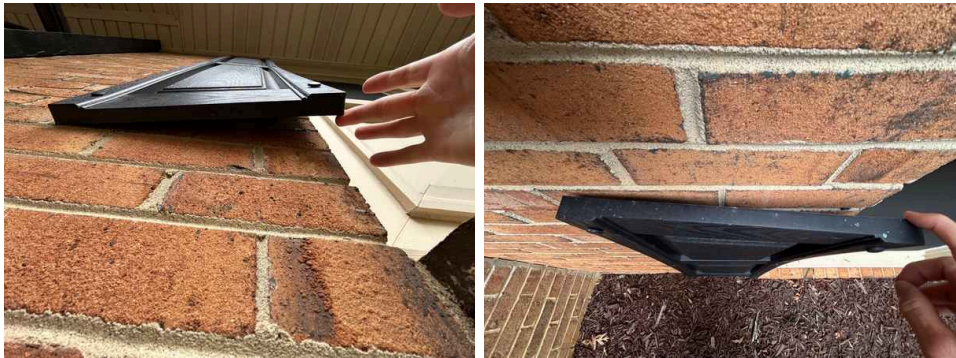
## 5.1.2 General Info

**EXTERIOR – WASP ACTIVITY**

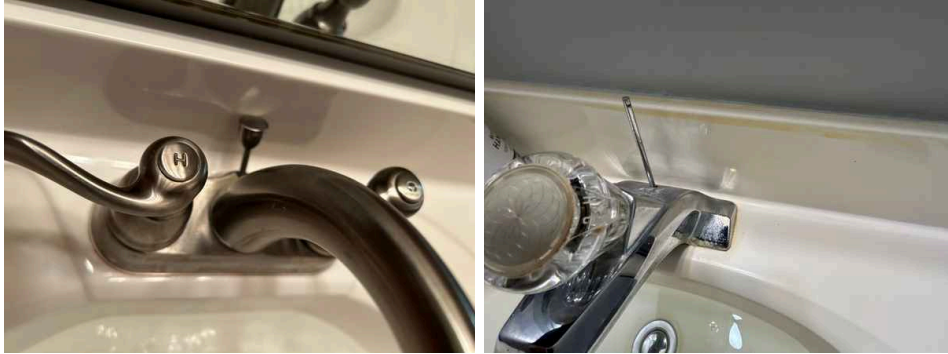
## 8.4.2 Sink(s)

- ⊖ 8.4.1 Bathroom(s) - Sink(s): Bathroom Sink Fixture Deficiencies
- ⊖ 8.4.2 Bathroom(s) - Sink(s): Hallway Bathroom Vanity – Loose Installation
- ⊖ 8.7.1 Bathroom(s) - Shower(s) / Enclosure(s): Reversed Hot and Cold Water Supply – Basement Shower

## Recommendation

Contact a qualified professional.

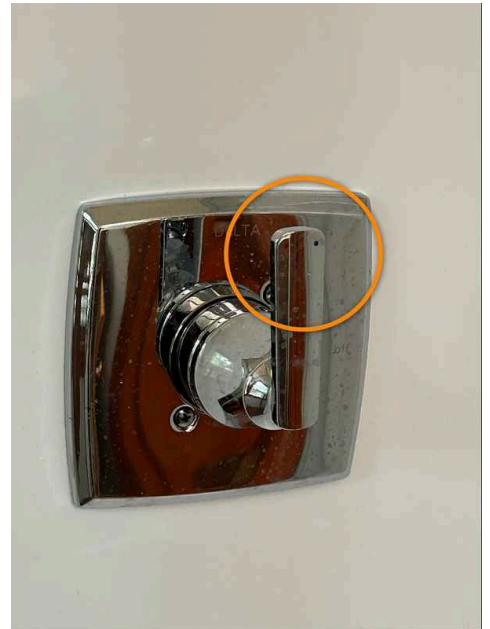
## 8.7.2 Shower(s) / Enclosure(s)

- ⊖ 8.7.2 Bathroom(s) - Shower(s) / Enclosure(s): Primary Bathroom – Shower/Tub Surround Caulking
- 🔧 9.1.1 Interior Areas and Items - Interior - General: Cosmetic Defects Information

## Recommendation

Contact a qualified professional.

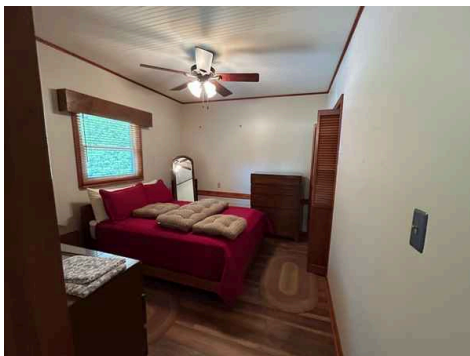
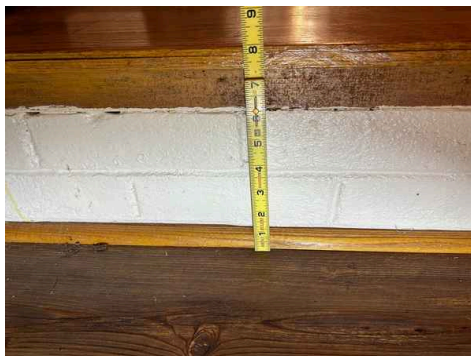
## 9.7.1 Stairs, Rails, &amp; Guards

- ⊖ 9.6.1 Interior Areas and Items - Floor Condition: Interior – Family Room Floor
- ⊖ 9.7.1 Interior Areas and Items - Stairs, Rails, & Guards: Interior – Floor Level Change

## Recommendation

Contact a qualified professional.

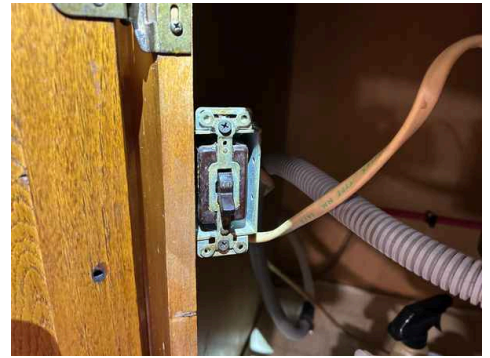
## 14.1.2 General Electrical Information

**OPEN JUNCTION BOX – CRAWLSPACE**
