# 7225 Rex Rd

# Holly Springs, North Carolina 27540

| Type | <b>Home Inspection and Floor Plan Report - 7225 Rex Rd</b> |
| Inspected by | <b>Spectris Inspections</b> |

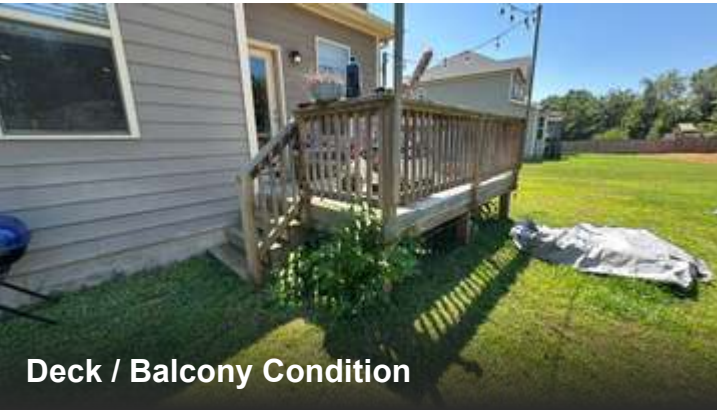
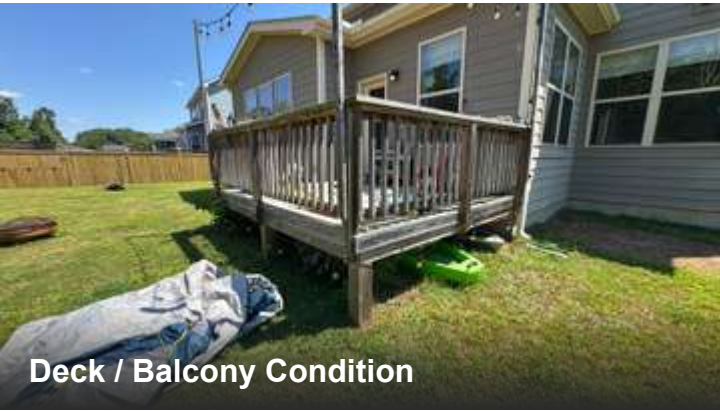
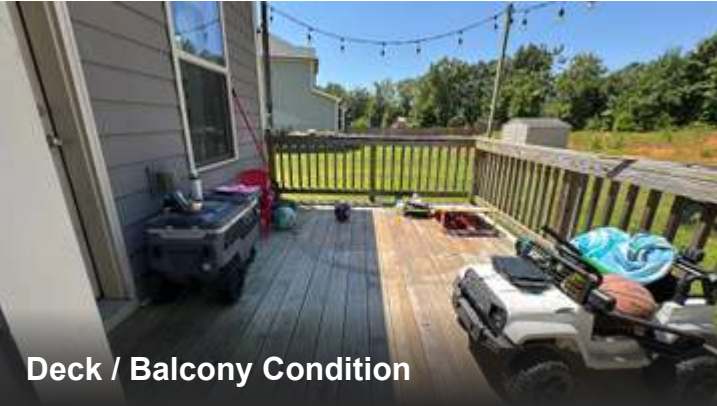
Deck / Balcony Condition

**Fair (Some Repairs)**

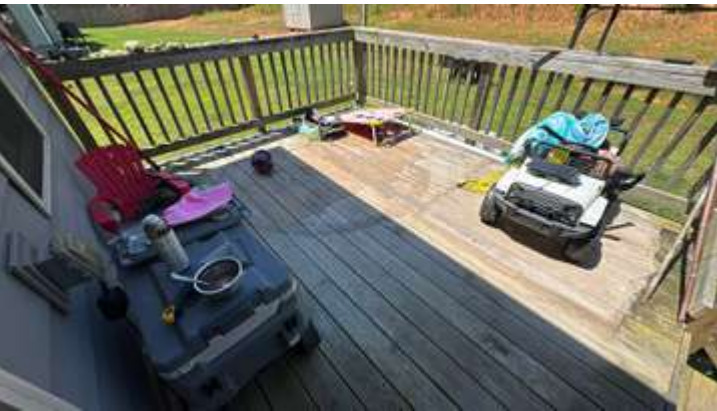
**Repair deficiency**

Missing / Deteriorated Deck Paint

The deck paint is missing / deteriorated.

**Deck stain/paint has not been applied.**

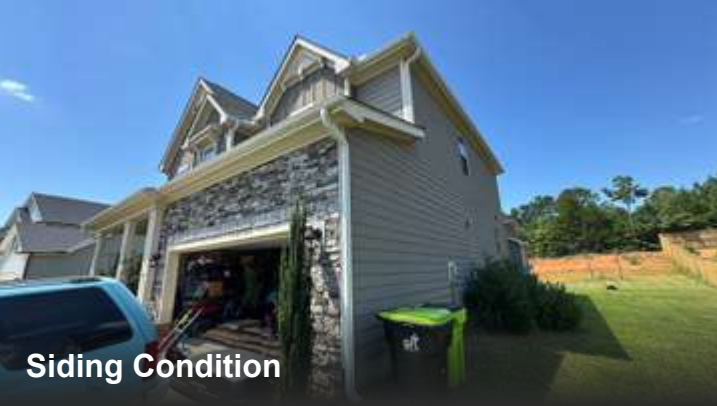
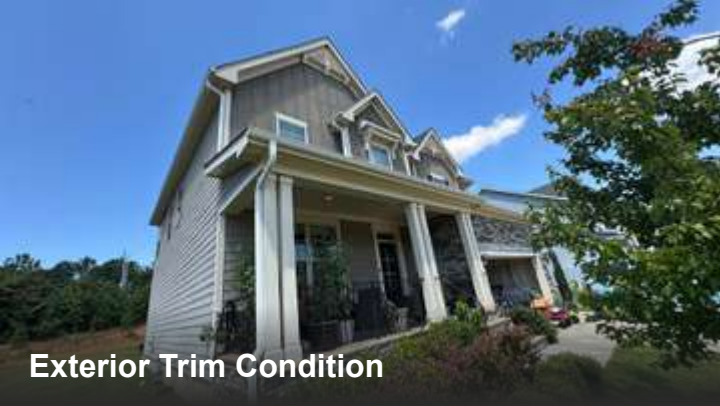
There are some areas of faded paint. Primarily on the rear and left side of the home.

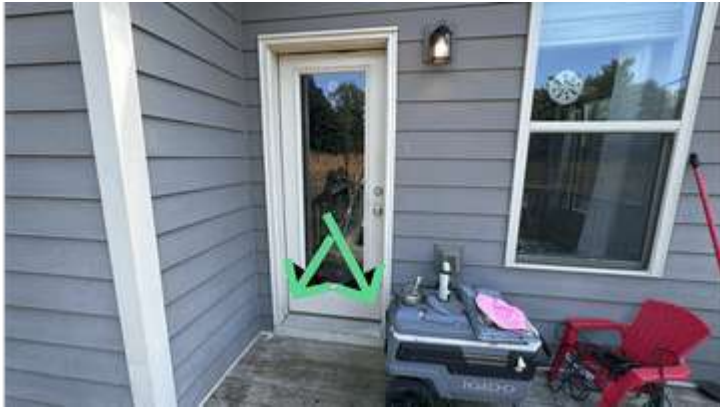
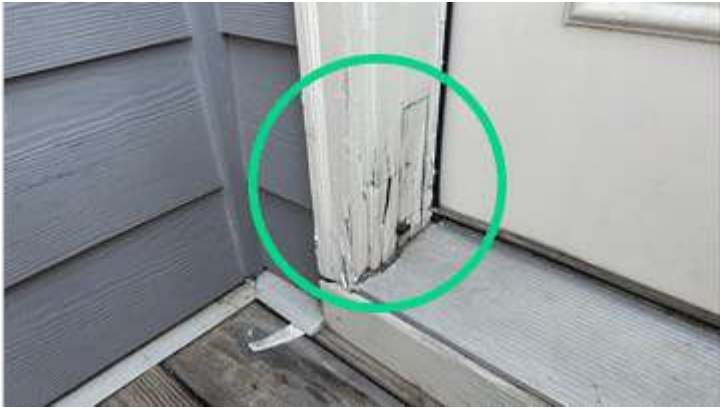
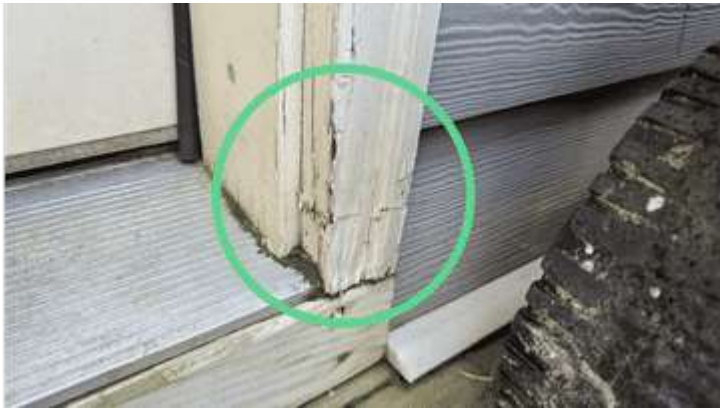
**Loose / Deteriorated Sill or Trim**

The door sill or trim is loose, deteriorated, or worn.

**Rear entry door.**

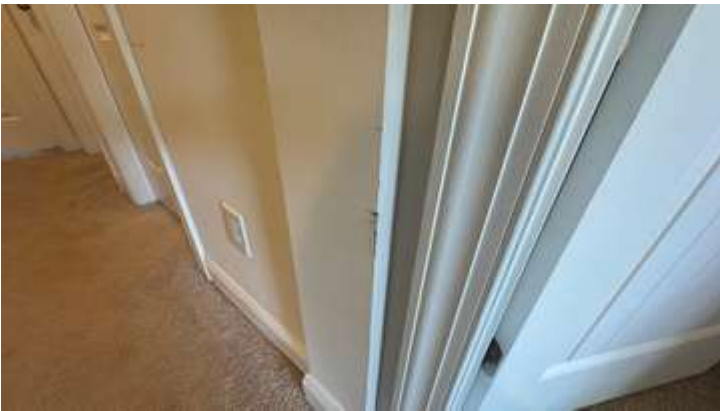
**Repair deficiency**

The interior paint needs to be touched up.

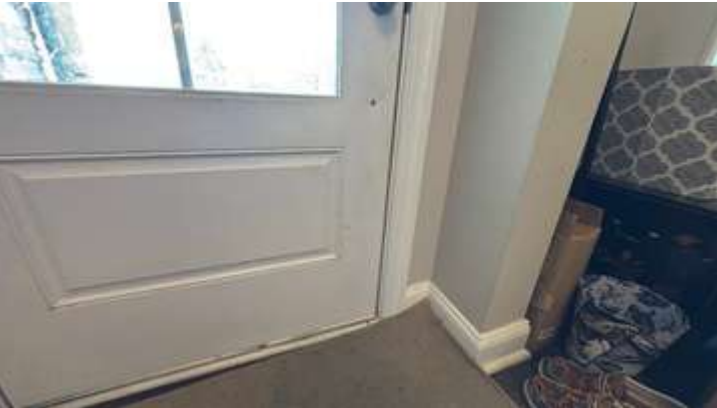
**Repair deficiency**

The interior paint needs to be touched up.

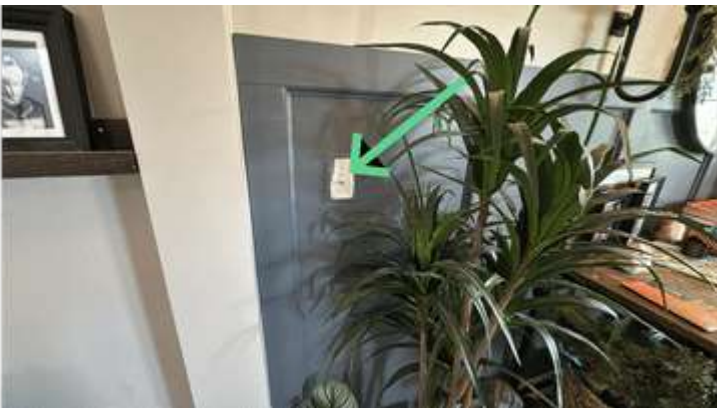
**Monitor deficiency**

An electrical cover is painted.

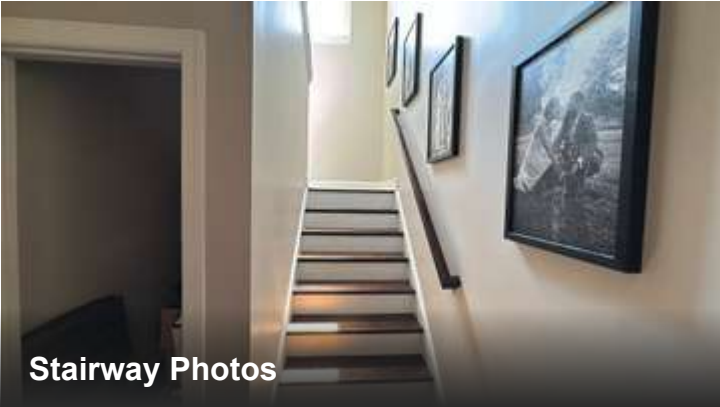
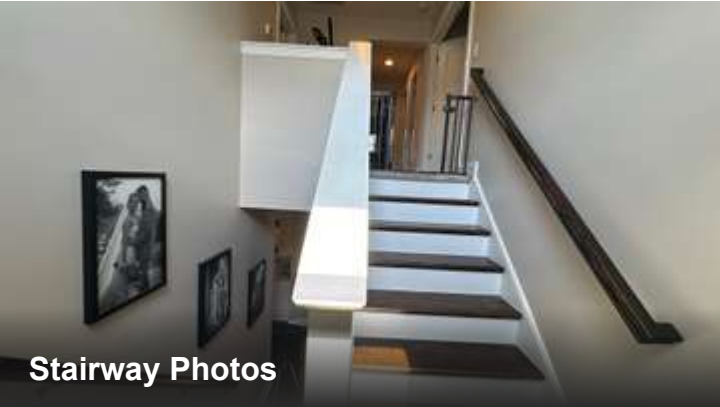
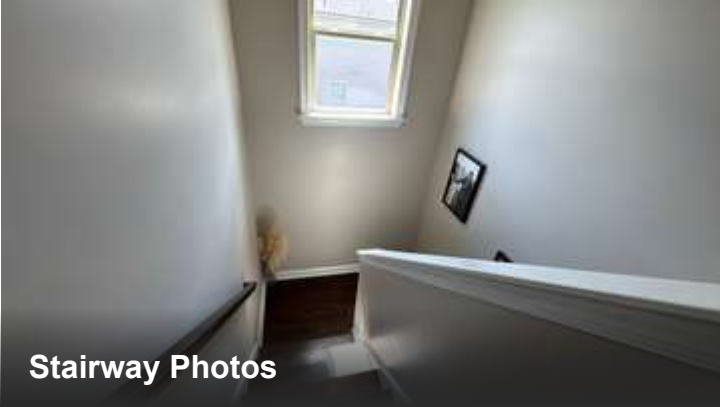
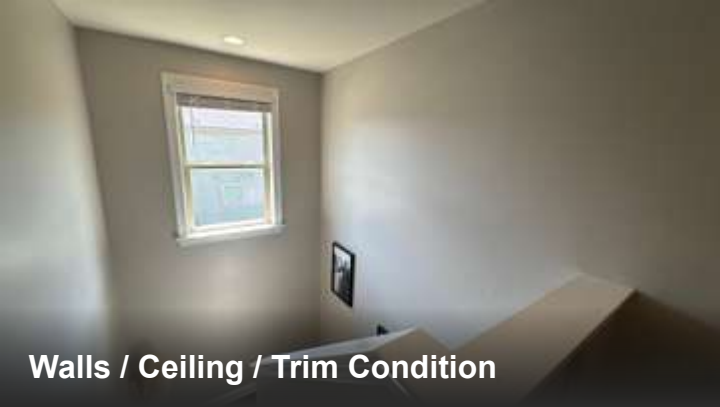
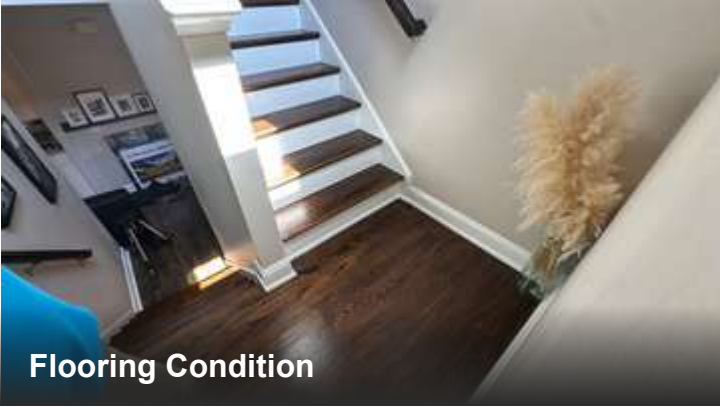
Stairway photos / videos

Well Maintained (Only Minor Imperfections / Visible Wear)

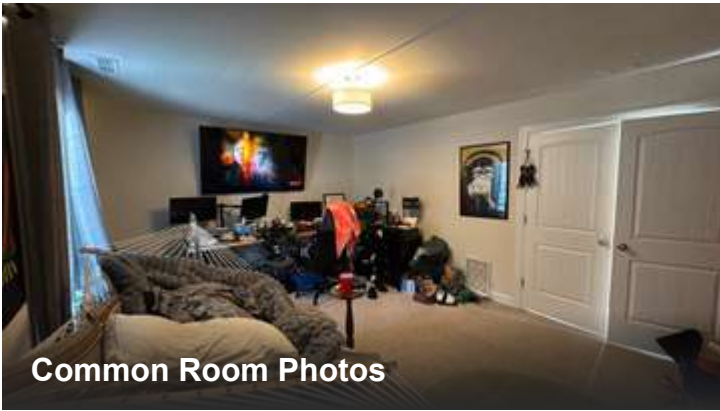
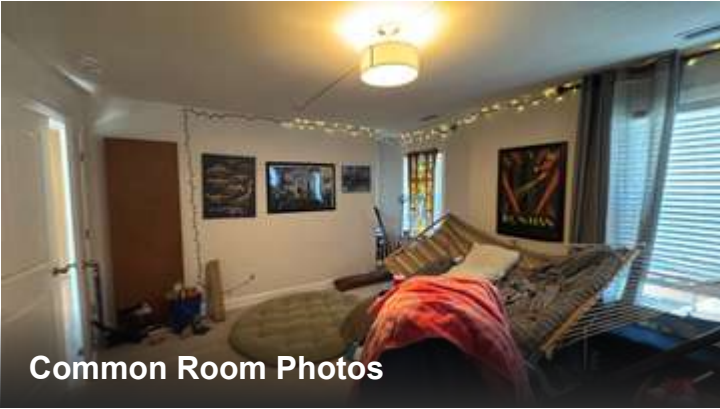
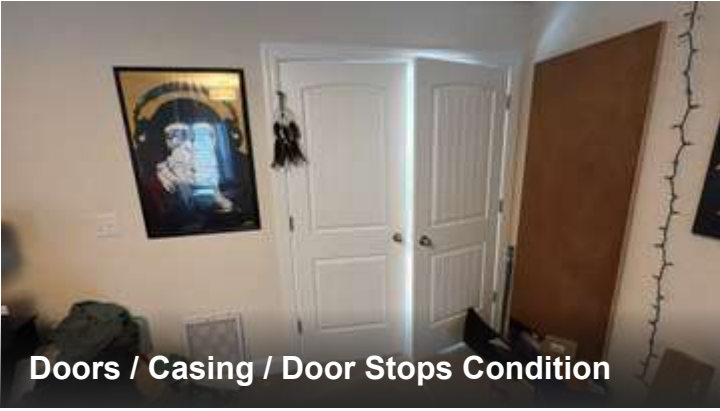
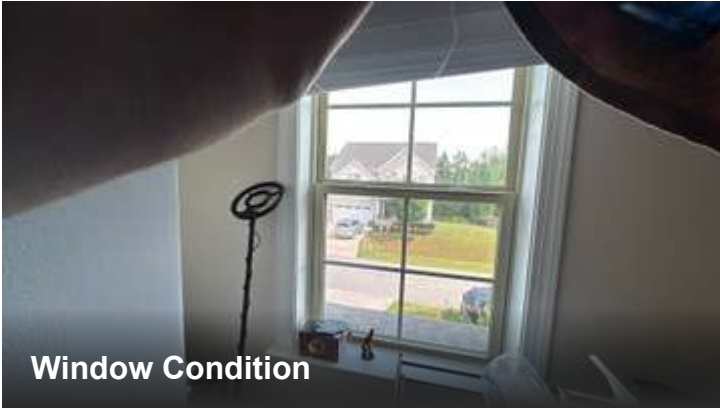
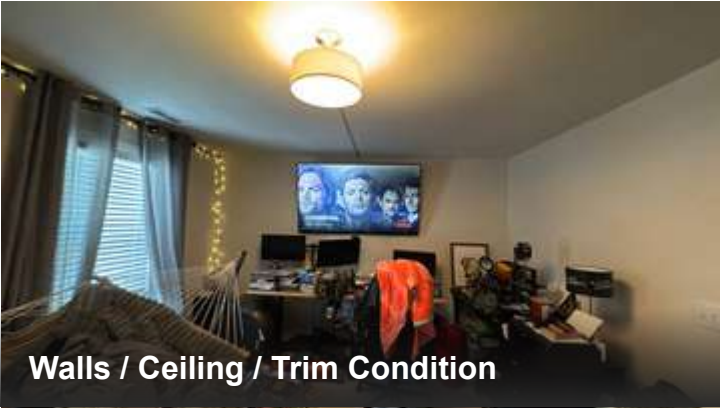
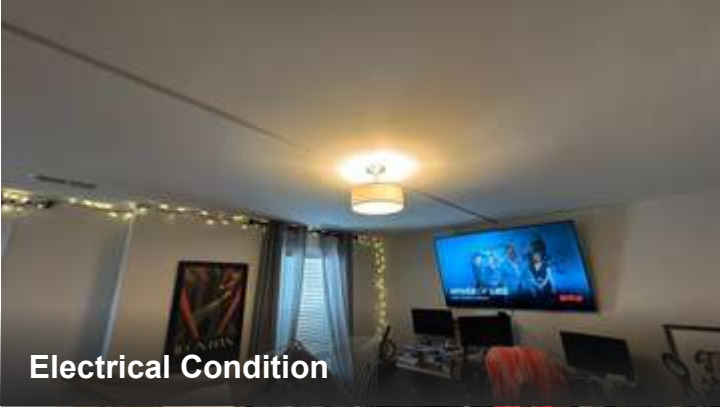
Common Room 3 photos / videos

**Well Maintained (Only Minor Imperfections / Visible Wear)**

**Good (Cosmetic Issues Only)**

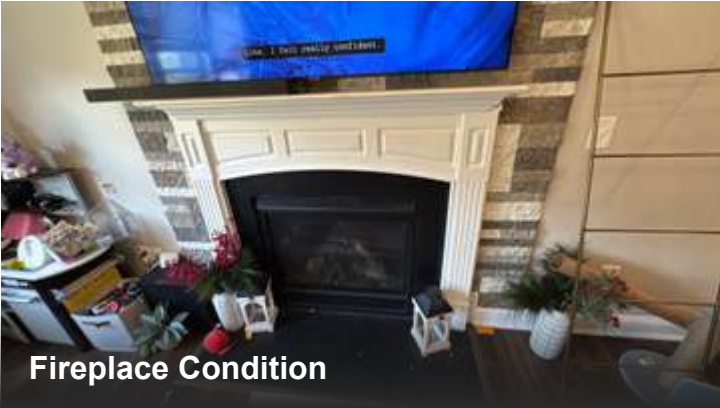
Fireplace photos / videos

Great (No Repairs)

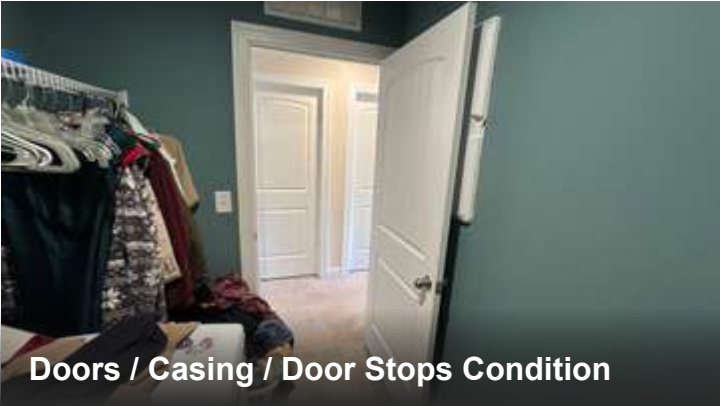
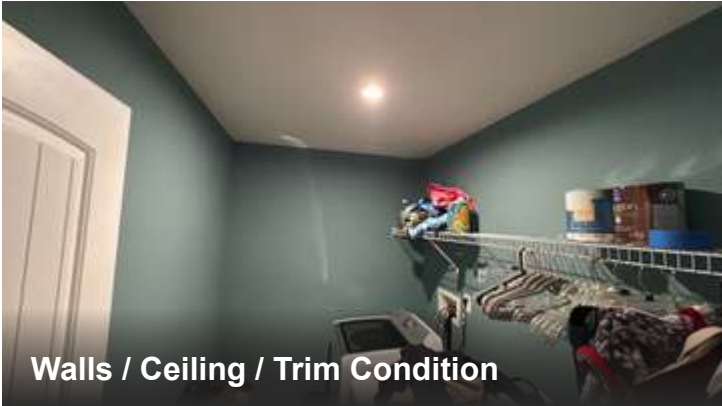
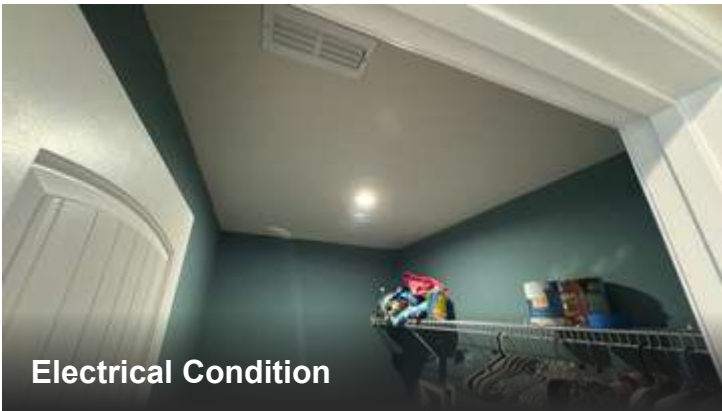
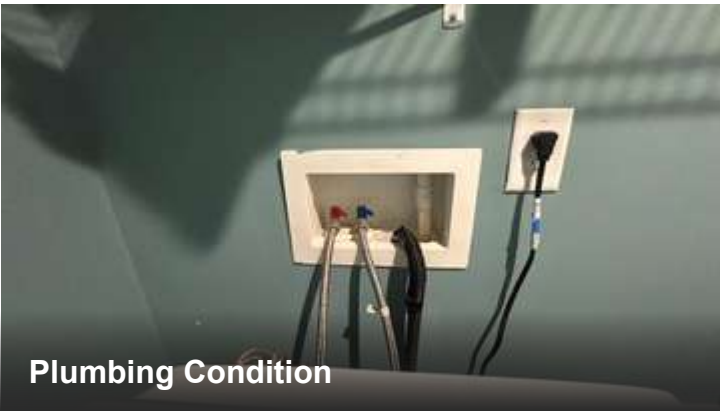
Laundry Area photos / videos

**Well Maintained (Only Minor Imperfections / Visible Wear)**

**Good (Cosmetic Issues Only)**

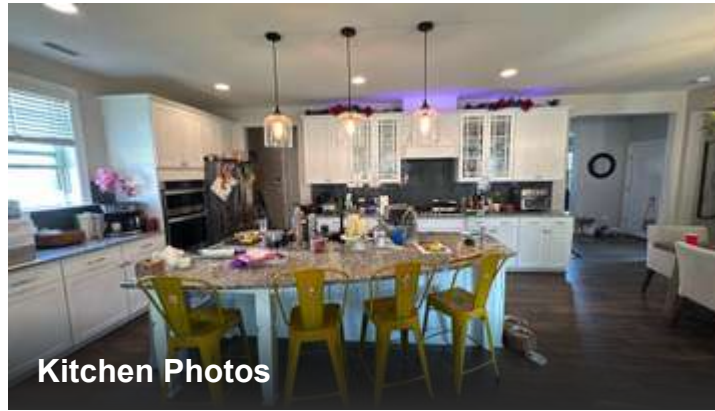
## Kitchen General photos / videos

Well Maintained (Only Minor Imperfections / Visible Wear)

Great (No Leaks)

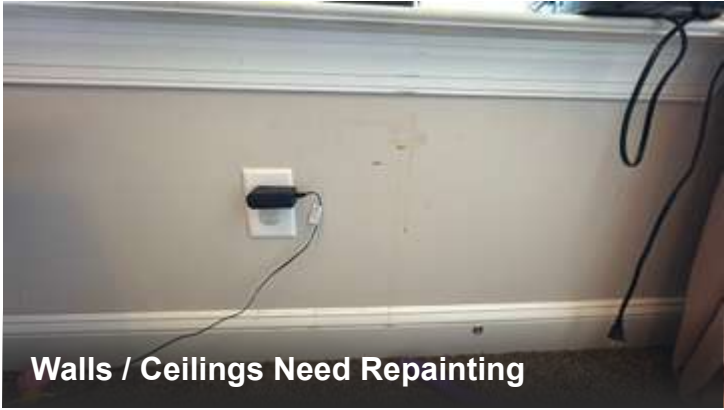
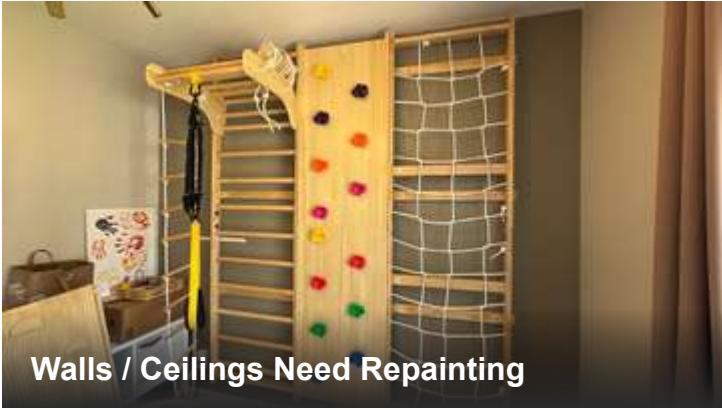
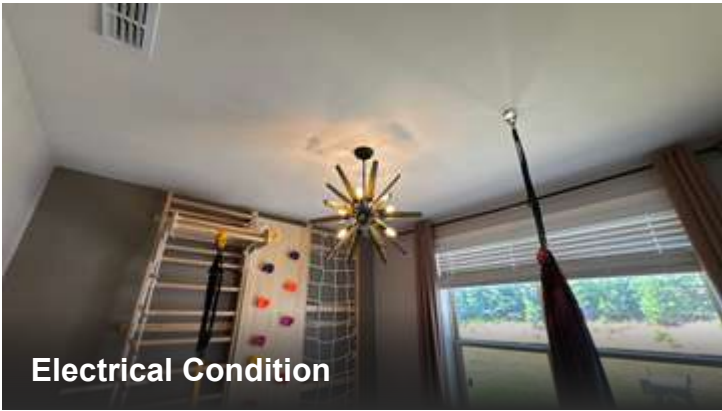
**Repair deficiency**

**Damaged Drywall**

The drywall is damaged.

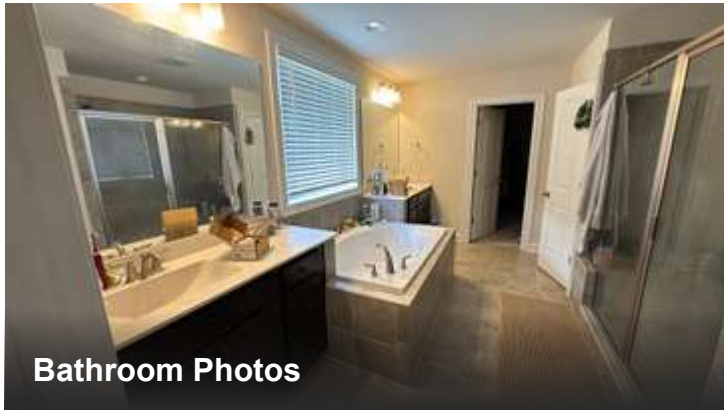
Primary Bathroom photos / videos

**Good (Cosmetic Defects Only)**

**Good (Cosmetic Issues Only)**

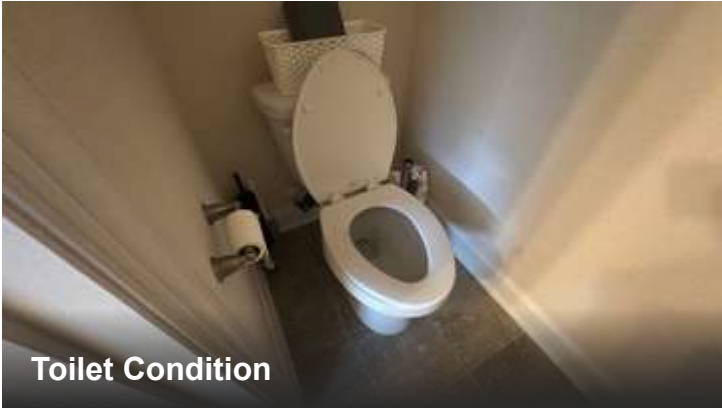
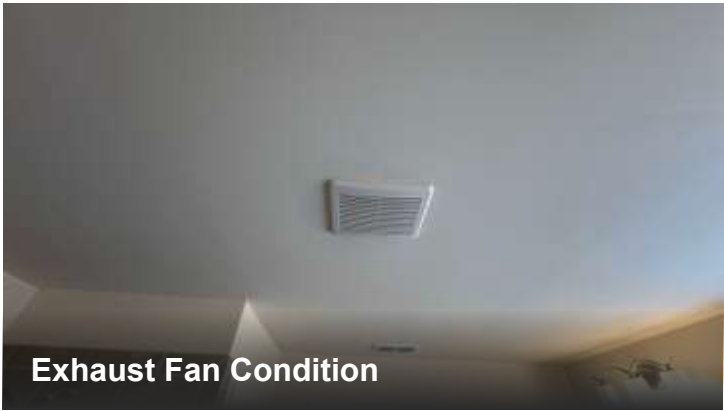
**Repair deficiency**

**Interior Paint Needs Touch-Up**

The interior paint needs to be touched up.

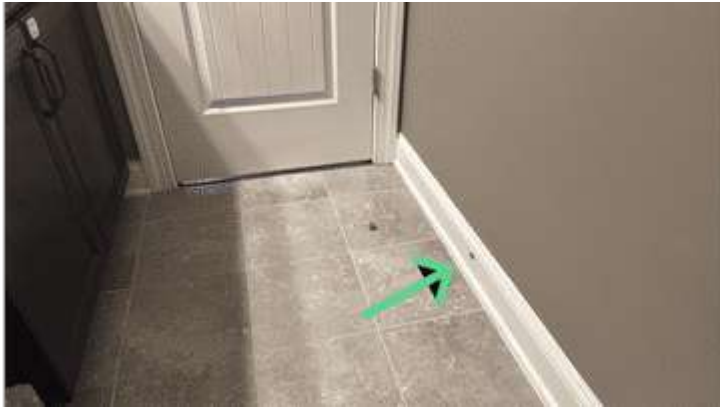
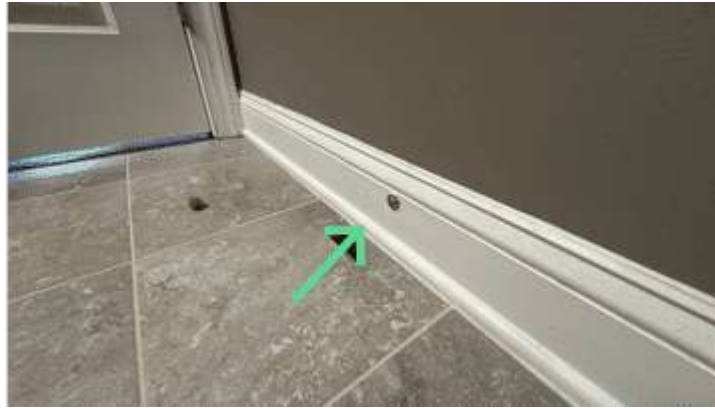
### Bathroom 3 photos / videos

## Missing / Damaged Door Stop(s)

Door stops are missing or damaged for an interior door.

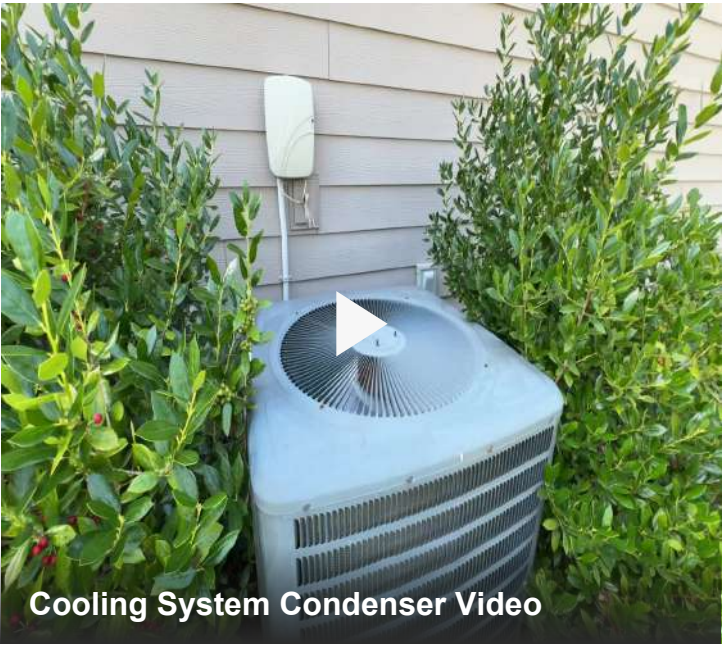
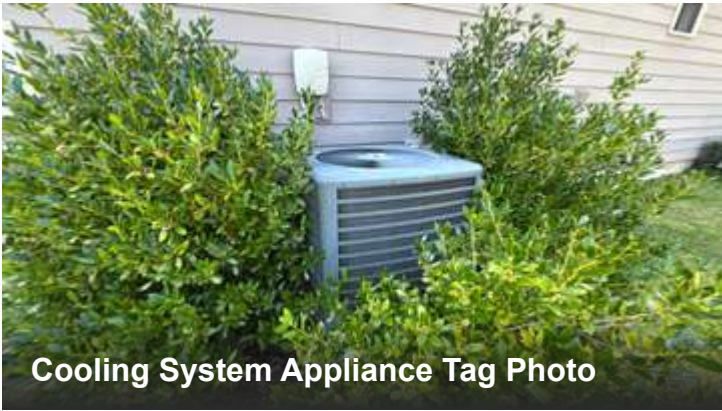
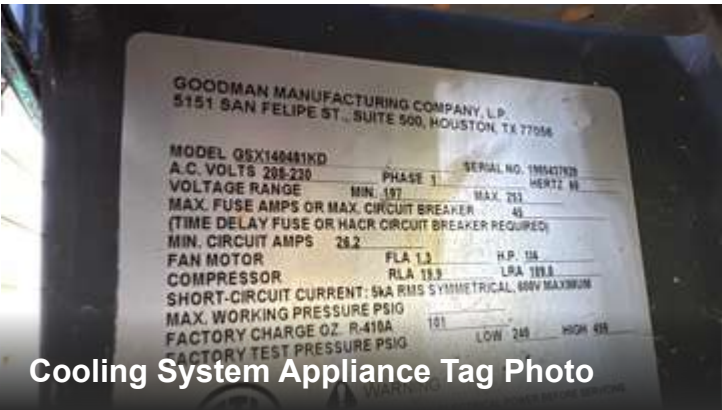
**Repair deficiency**

The vegetation is too close to the air conditioning compressor.
