# Inspection Report

**Property Address:**  
104 Bergeron Way  
Cary NC 27519

**Fuster Home Inspections, LLC**

| <b>Date:</b> 8/20/2026 | <b>Time:</b> 08:30 AM | <b>Report ID:</b> AB082026-1 |

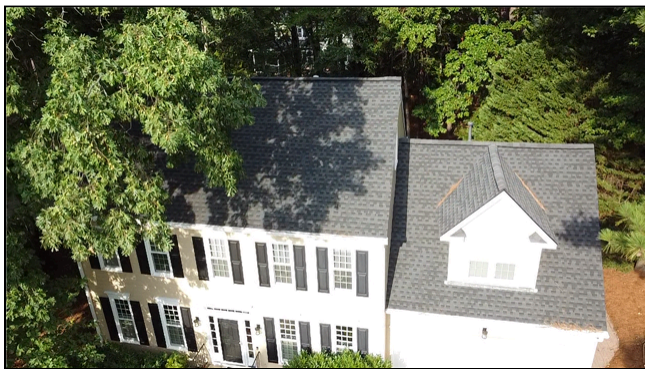
3.0 Item 2(Picture)

(2) **Informational:** Roof was viewed, in part, with a drone camera.

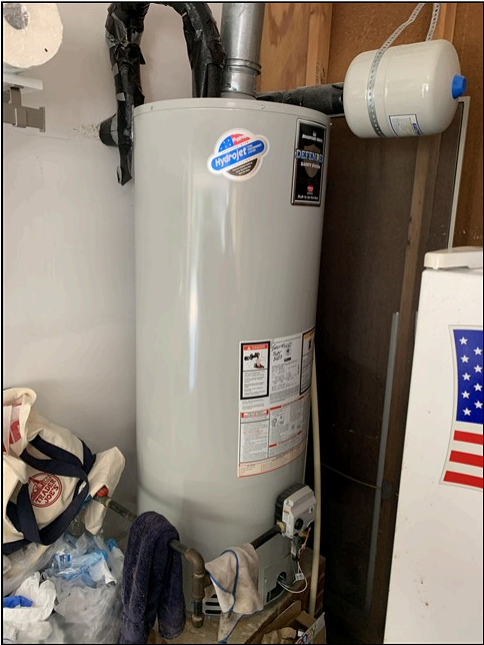
(3) **Informational:** The water heater is three years old.

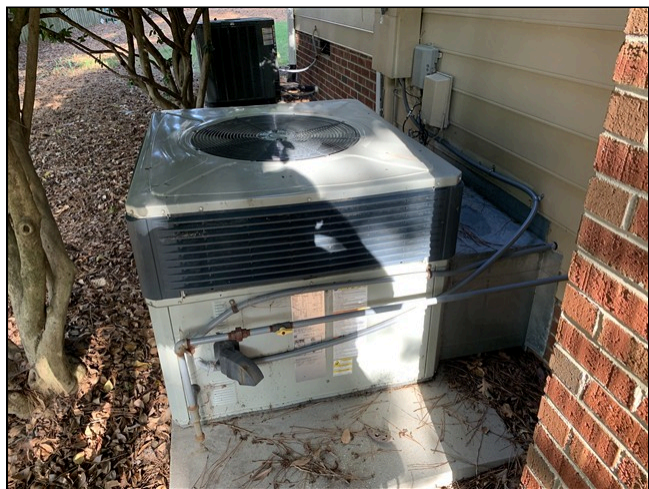
(2) **Limitation:** The gas pack is ten years old. Gas forced-air package units (Gas-Pack) contain both the heating and air-conditioning components all in one cabinet. A comprehensive evaluation of the combustion compartment and heat exchanger is specifically excluded from this inspection due to visibility and design limitations of the equipment. Access panels are not removed for inspection of unit interior. Comprehensive evaluation can only be obtained by dismantling or specialized testing, which is beyond the scope of this home inspection.

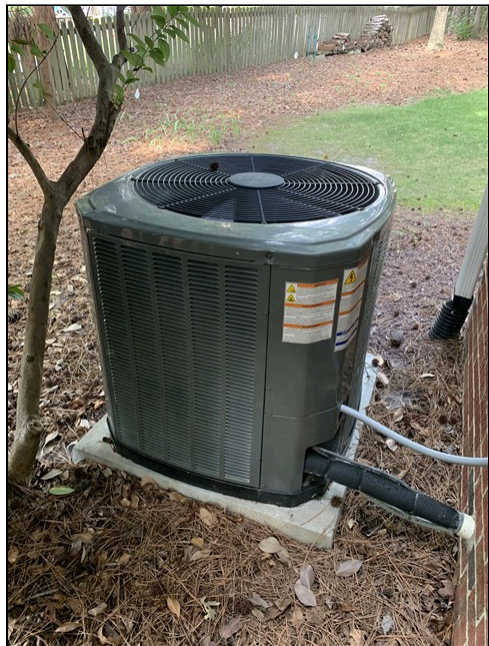
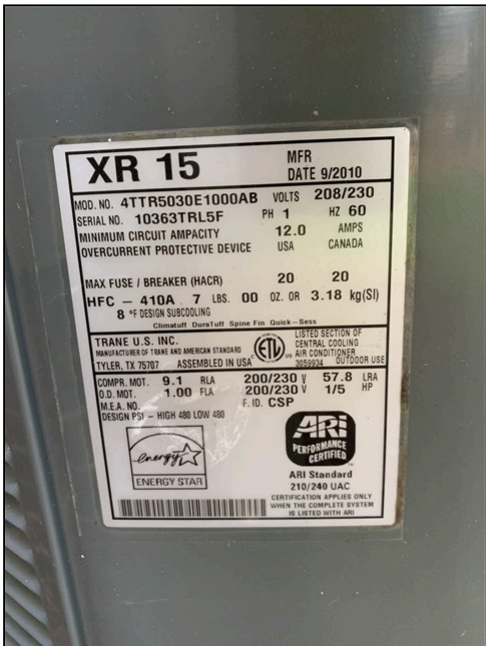
**8.1 (1) Informational:** The rear left side HVAC system compressor is 16 years old. Access panels are not removed for inspection of unit interior.

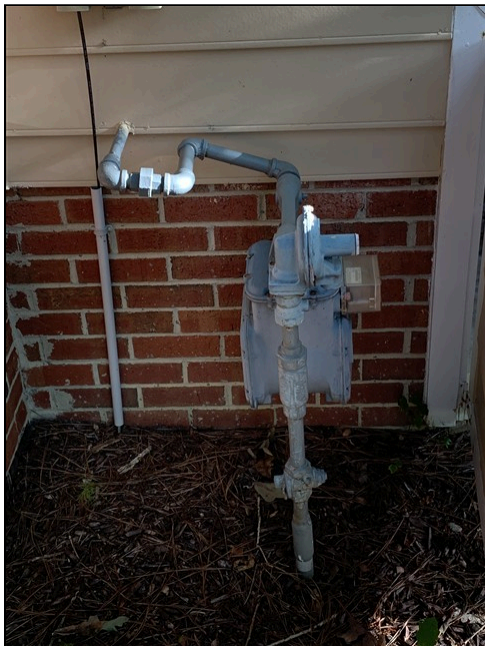
8.3 Item 2(Picture)

(2) **Informational:** The main gas shut-off valve is located at the left side meter.

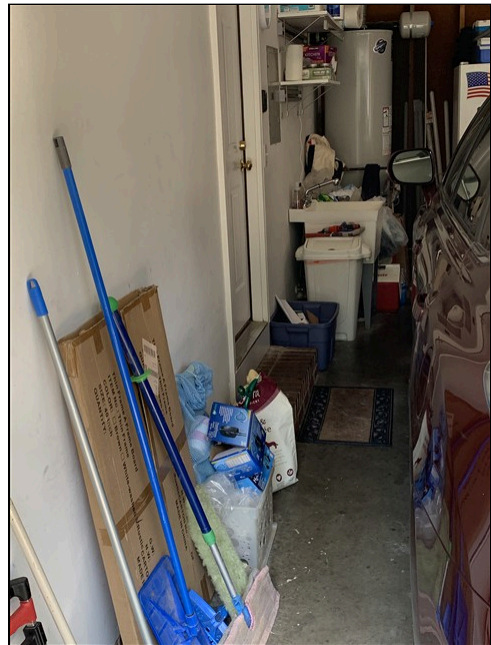
**9.5 Limitation:** Belongings in garage block full view of area.

9.5 Item 1(Picture) Belongings in garage block full view of area
